Efficient use of natural stone in the Leningrad region and South-East Finland

SOUTH-EAST FINLAND - RUSSIA ENPI CBC PROGRAMME

Granite in SPb and Helsinki architecture

Stability of a stone in the city environment

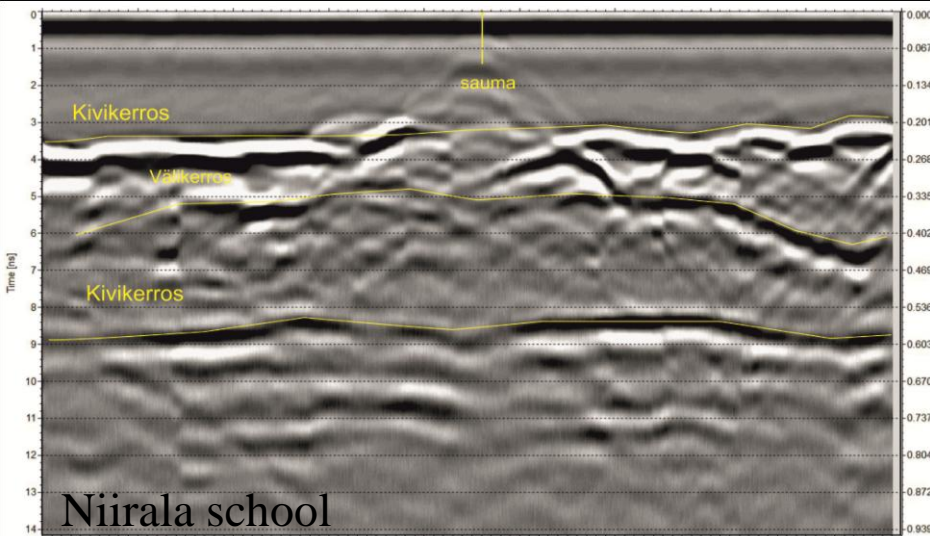
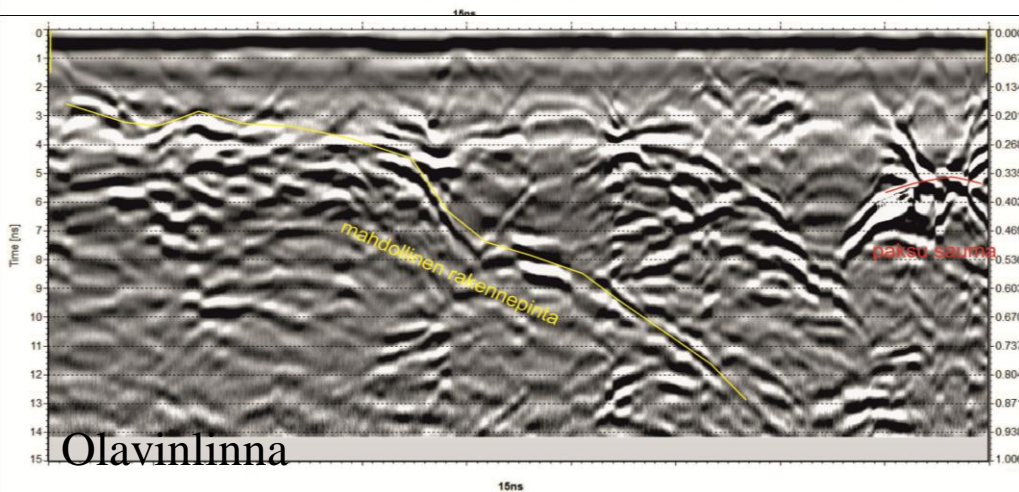
Ground penetrating radar (GPR)

RESULTS: effective in visualization of internal structures

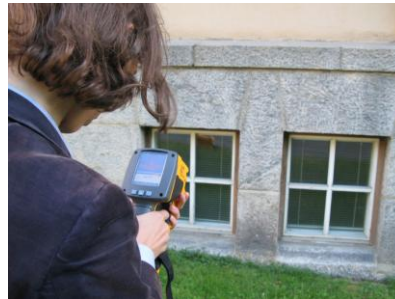
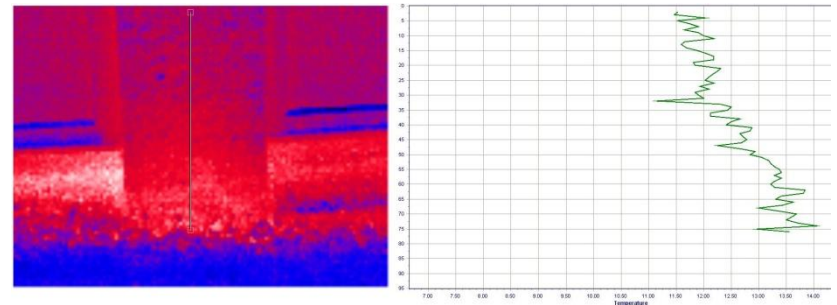
Thermal images

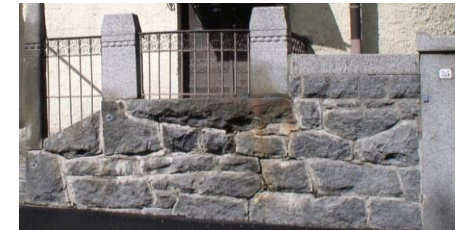
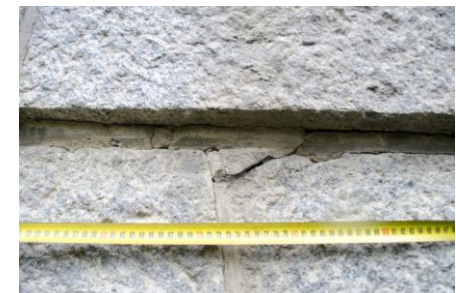
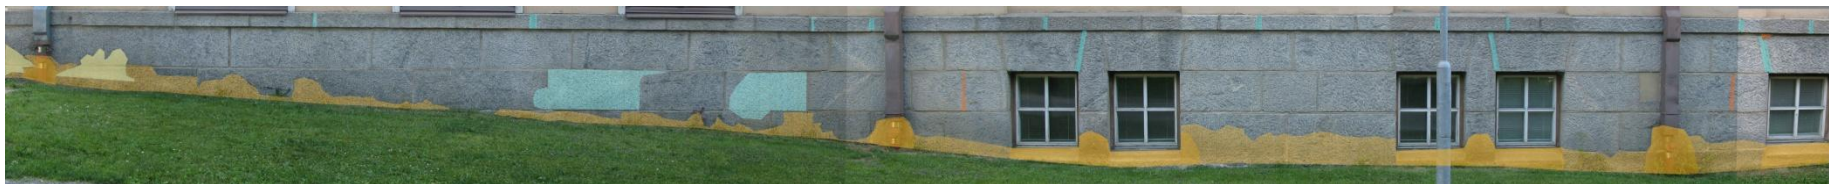
The detailed visual inspection checked for damages of surface material, changes in visual appearance, structural changes and biological colonization. In Niirala school it was attempted a color coding map.

RESULTS: Buildings showed to different extent surface changes on the stone

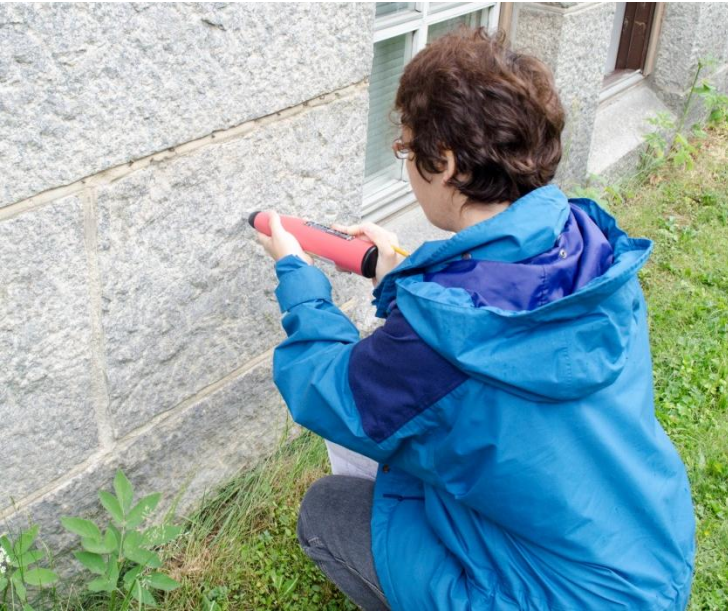
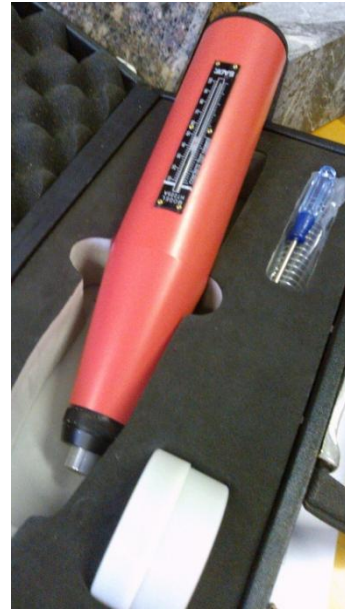
RESULTS: changes in speed caused by surface cracks and oxidation level. In the boulder blocks results affected by weathering

Diagram of measurement results performed over Niirala school

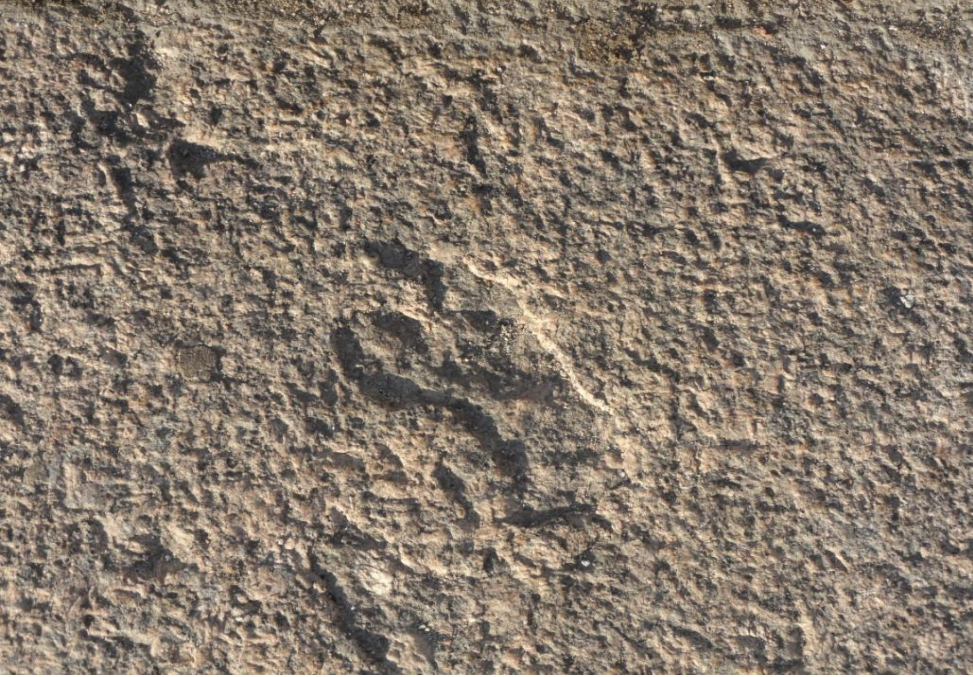
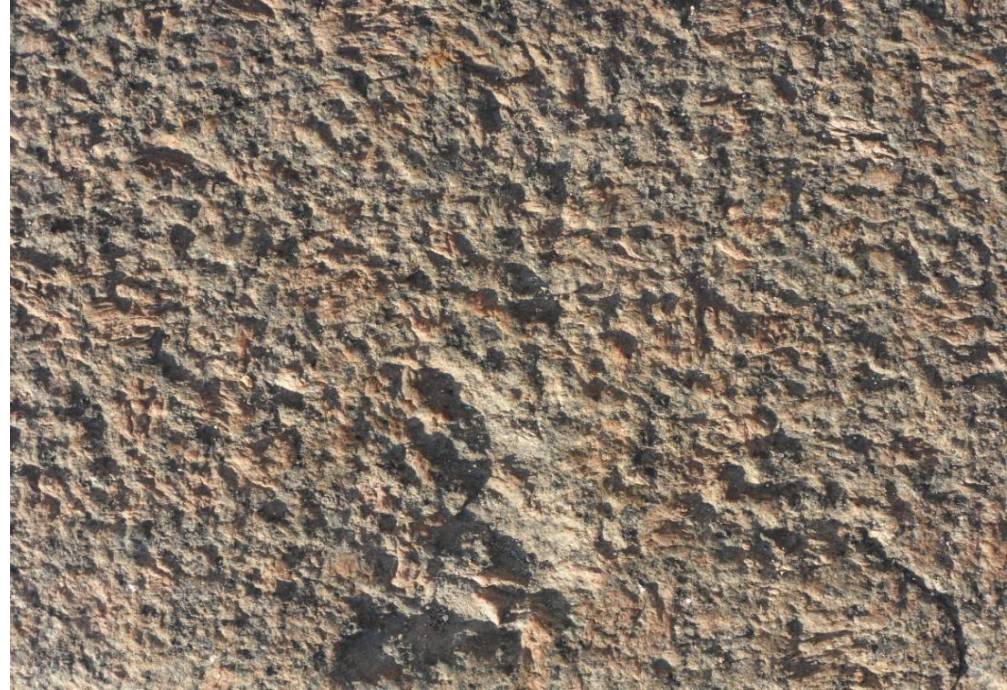
IA. Surface roughening
(R_r)

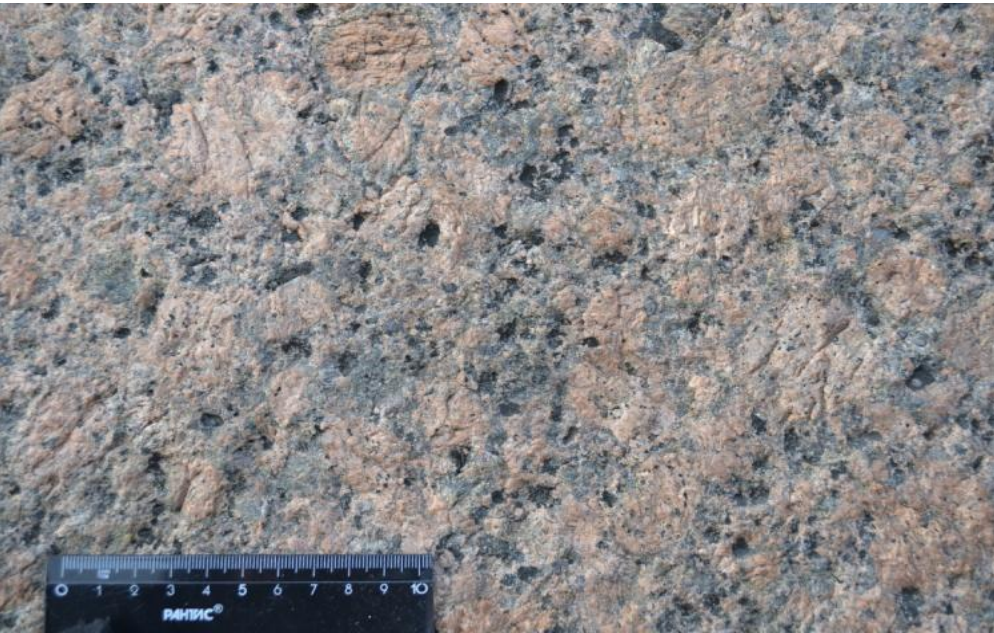
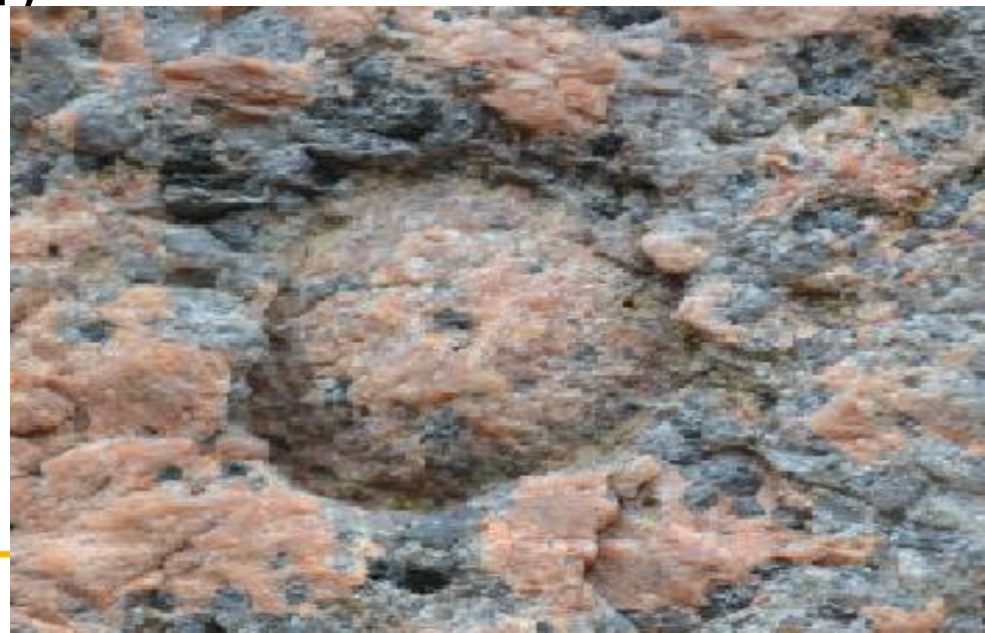
IB. Hollows and deepening (R)

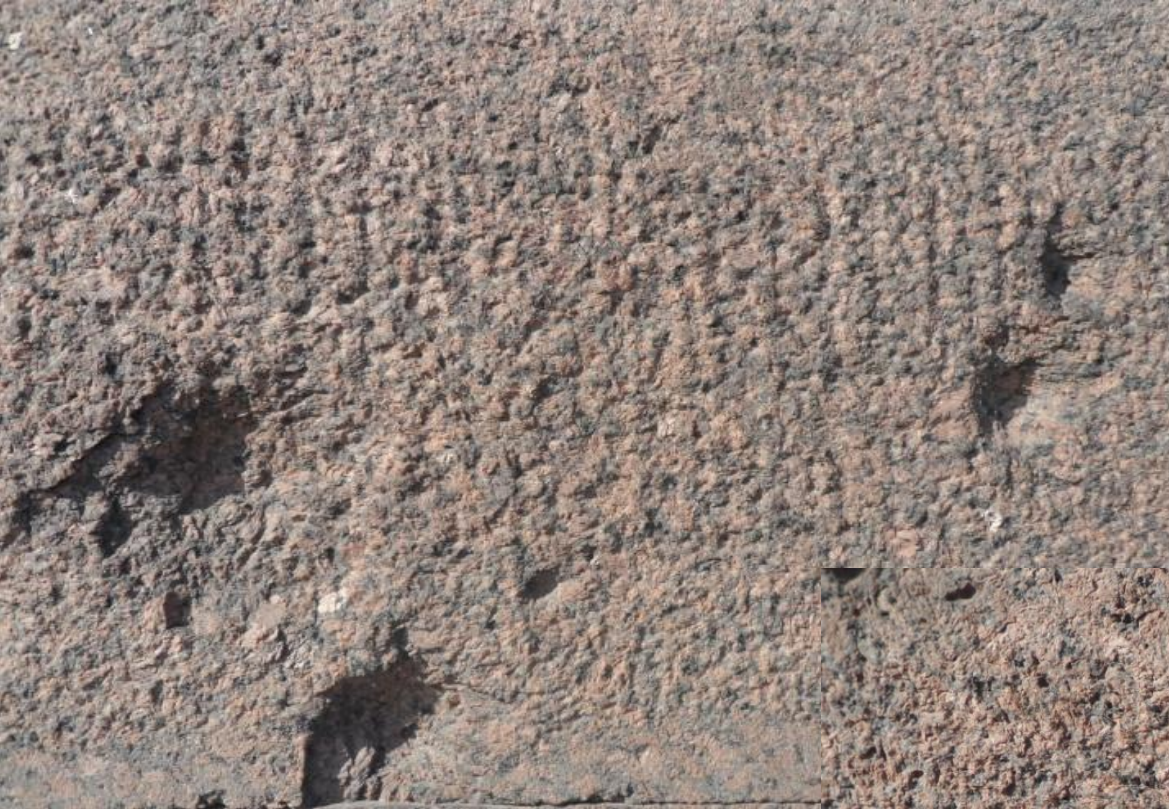
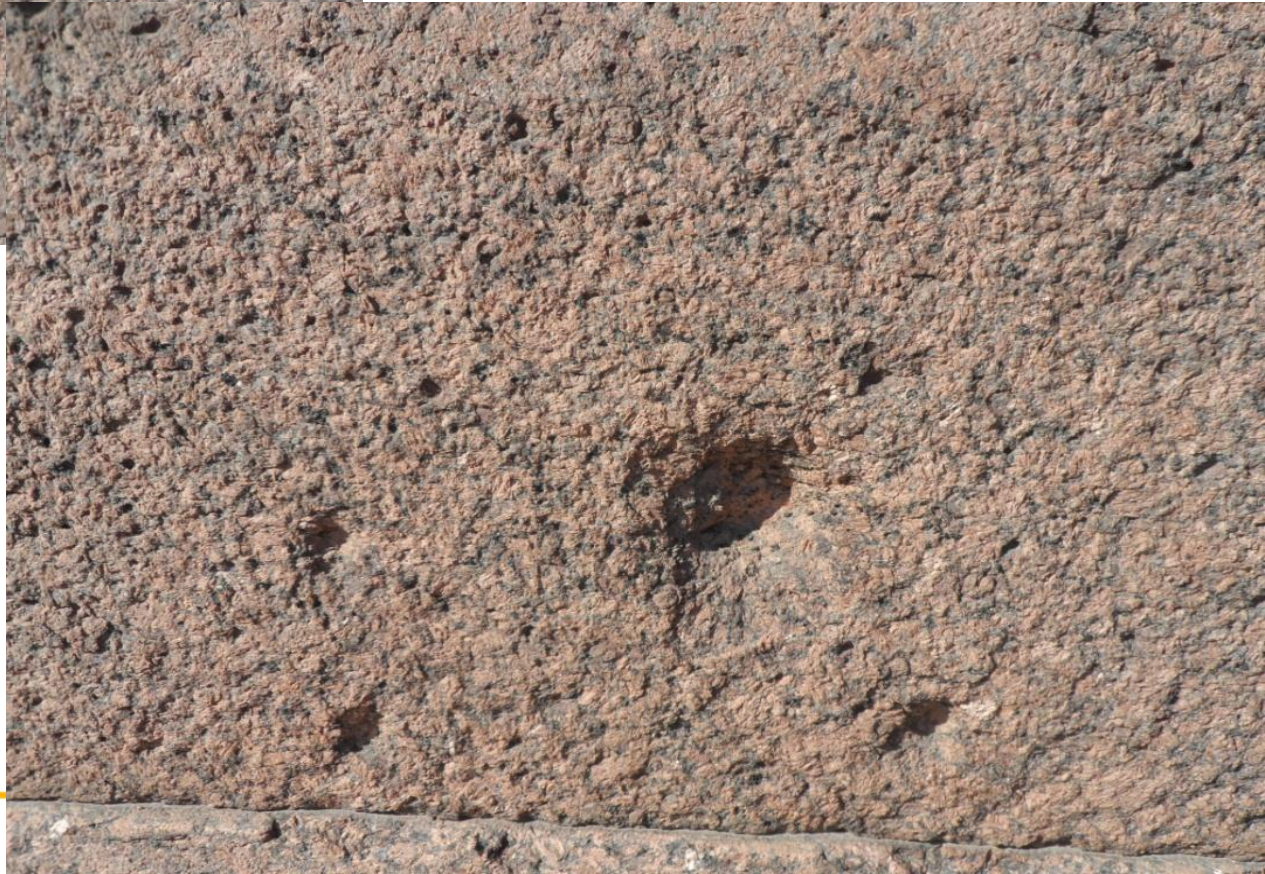
IC. Exfoliation (S)

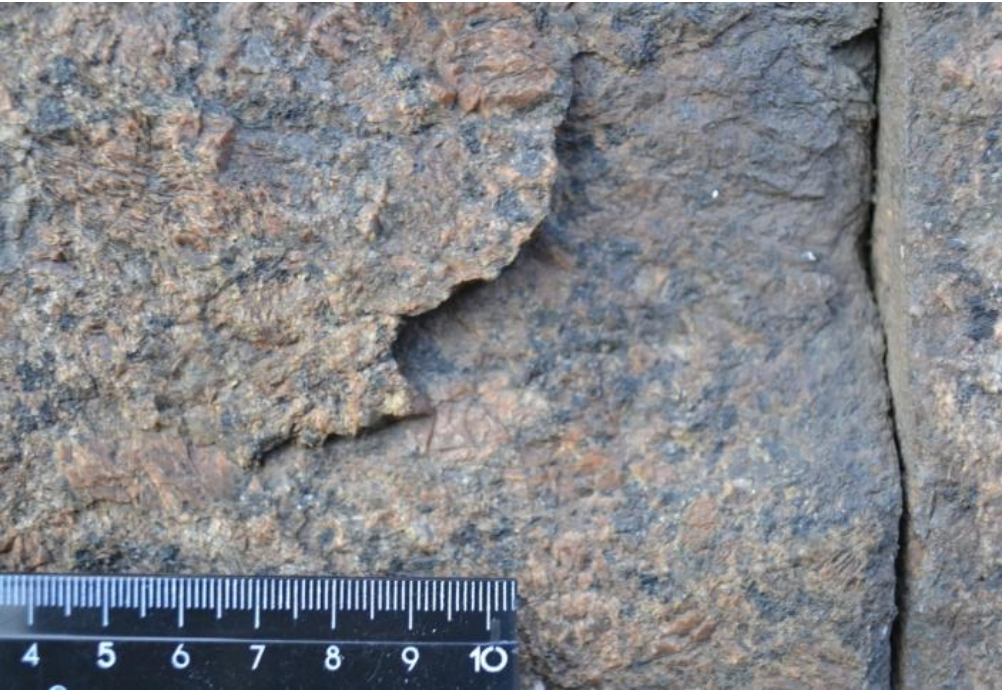
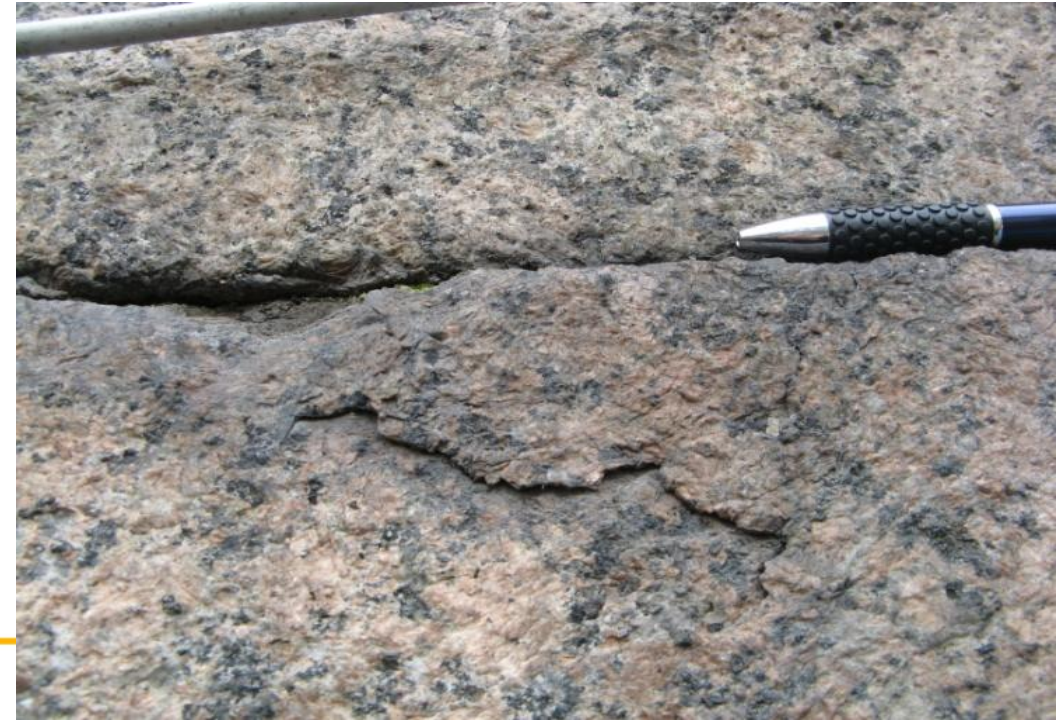
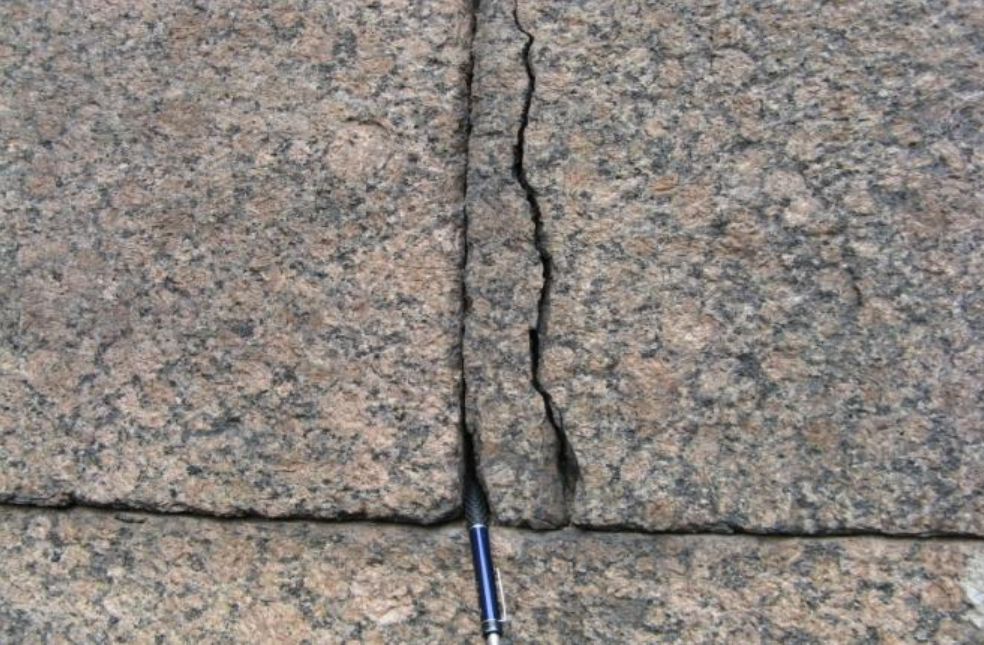
ID. Fissures (L)

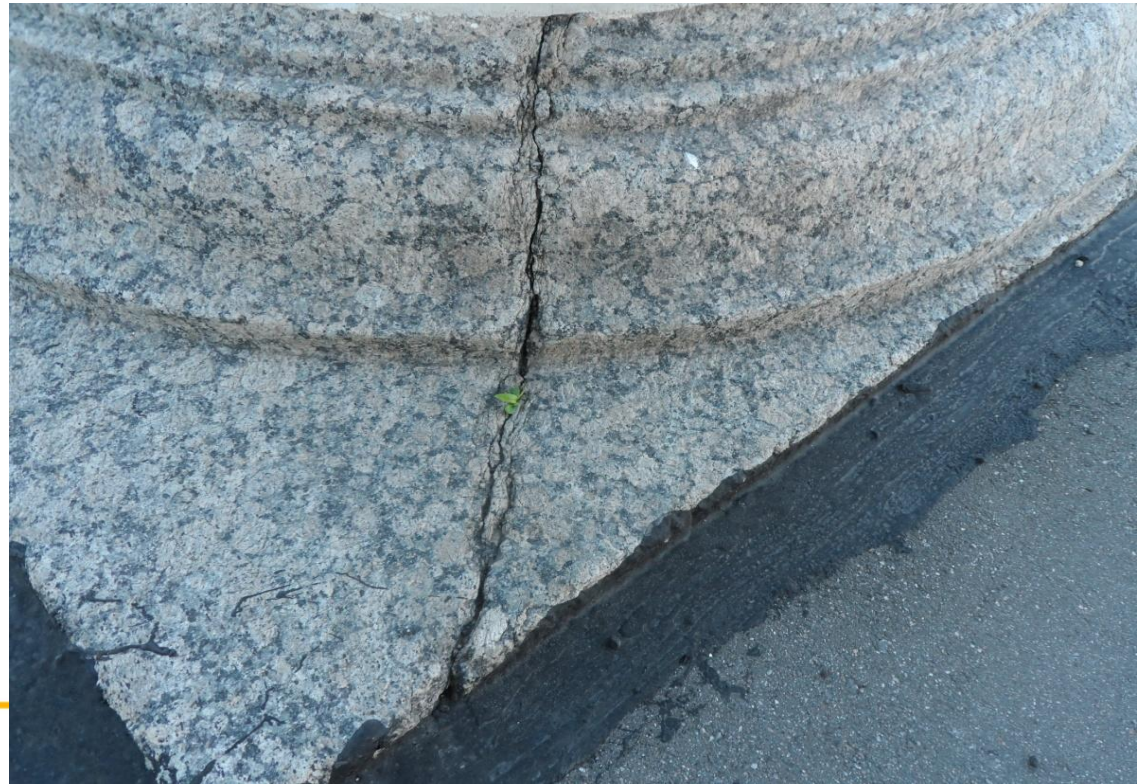
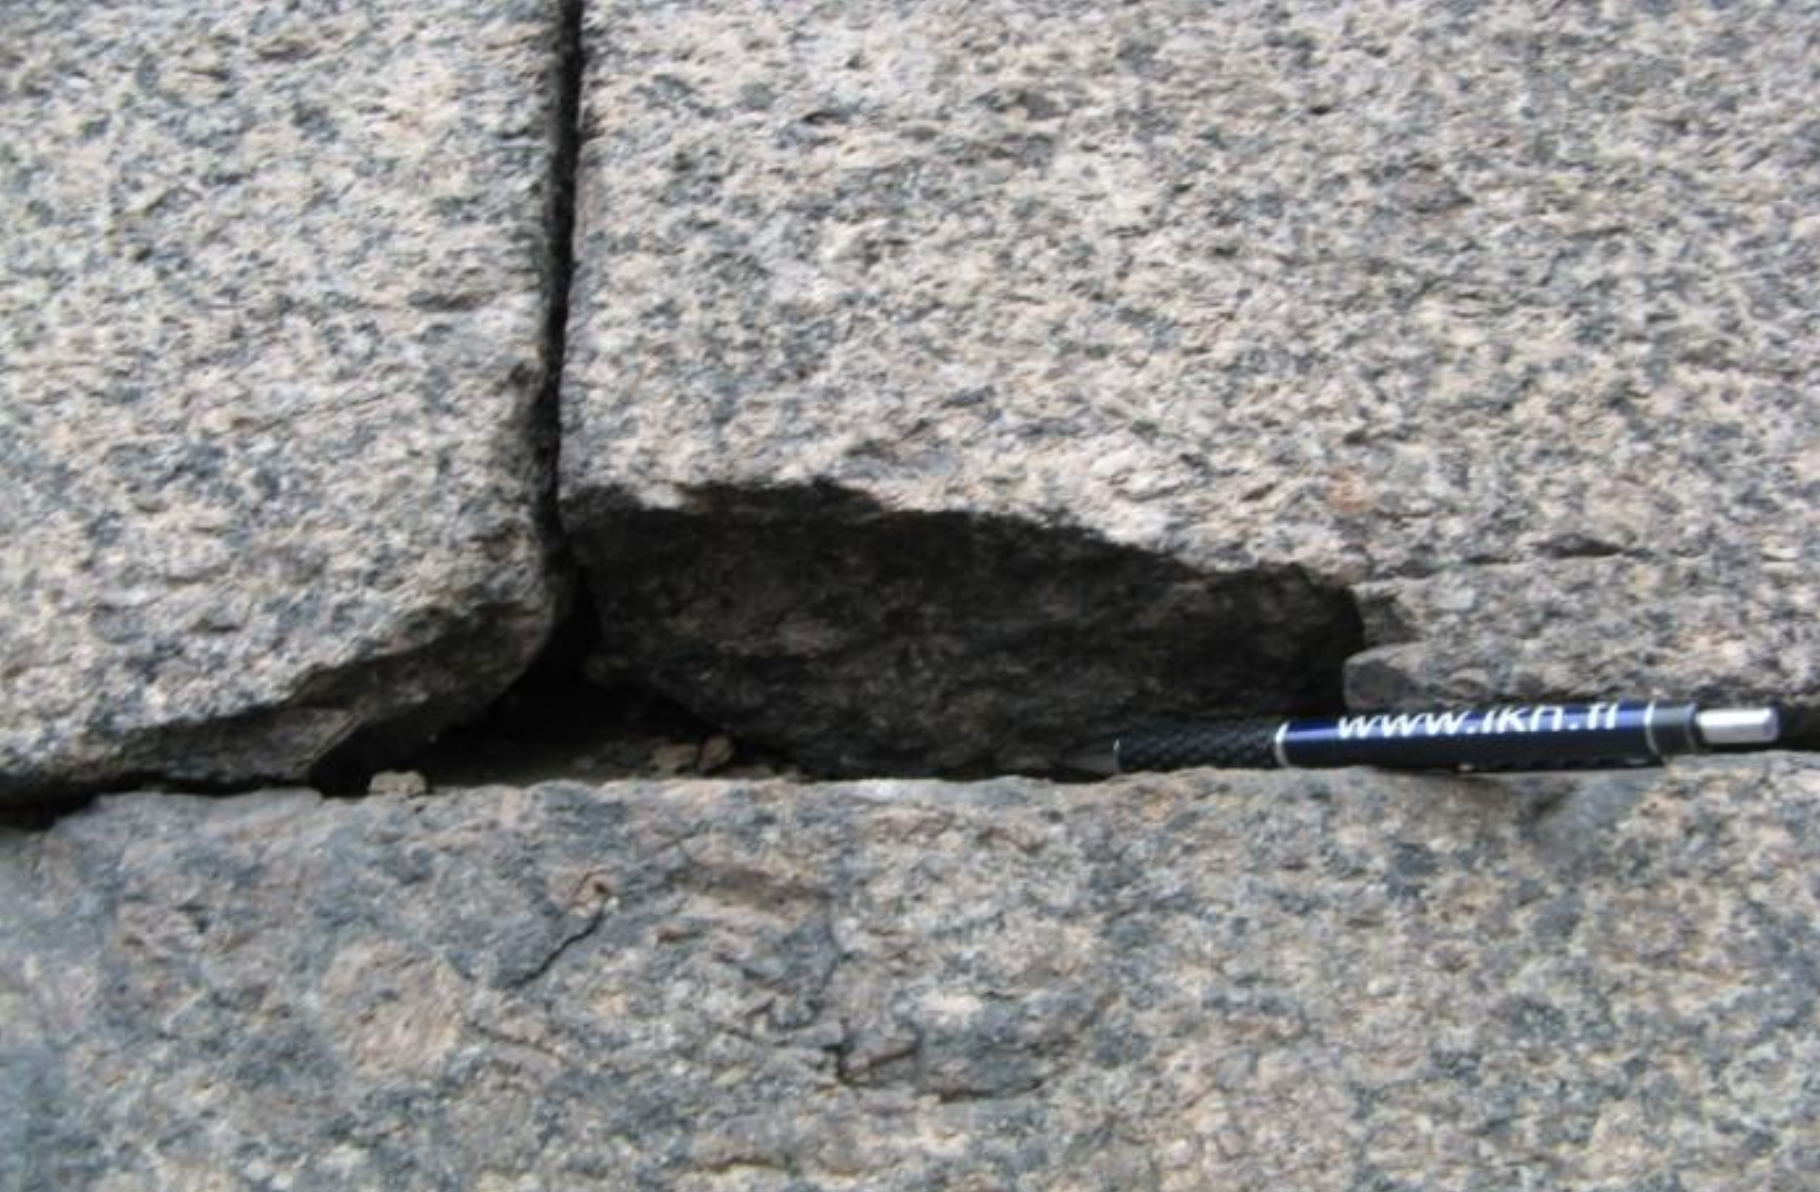
IE. Loss of rock fragments, chipping(O)

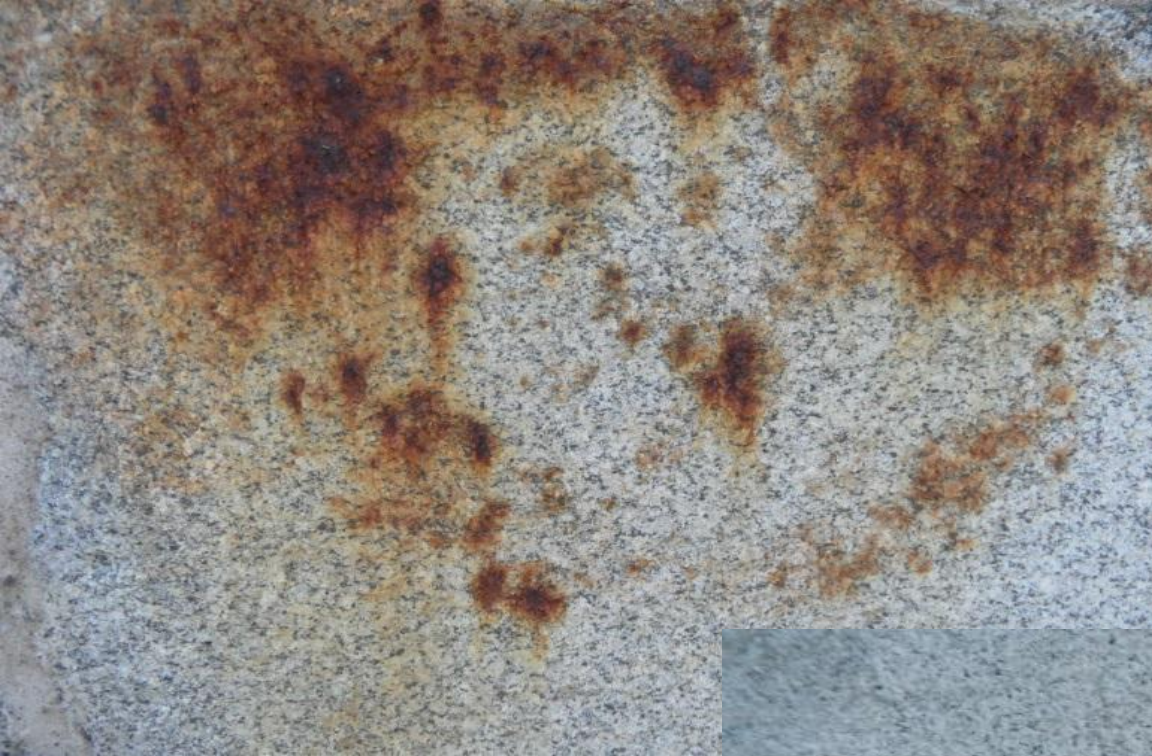
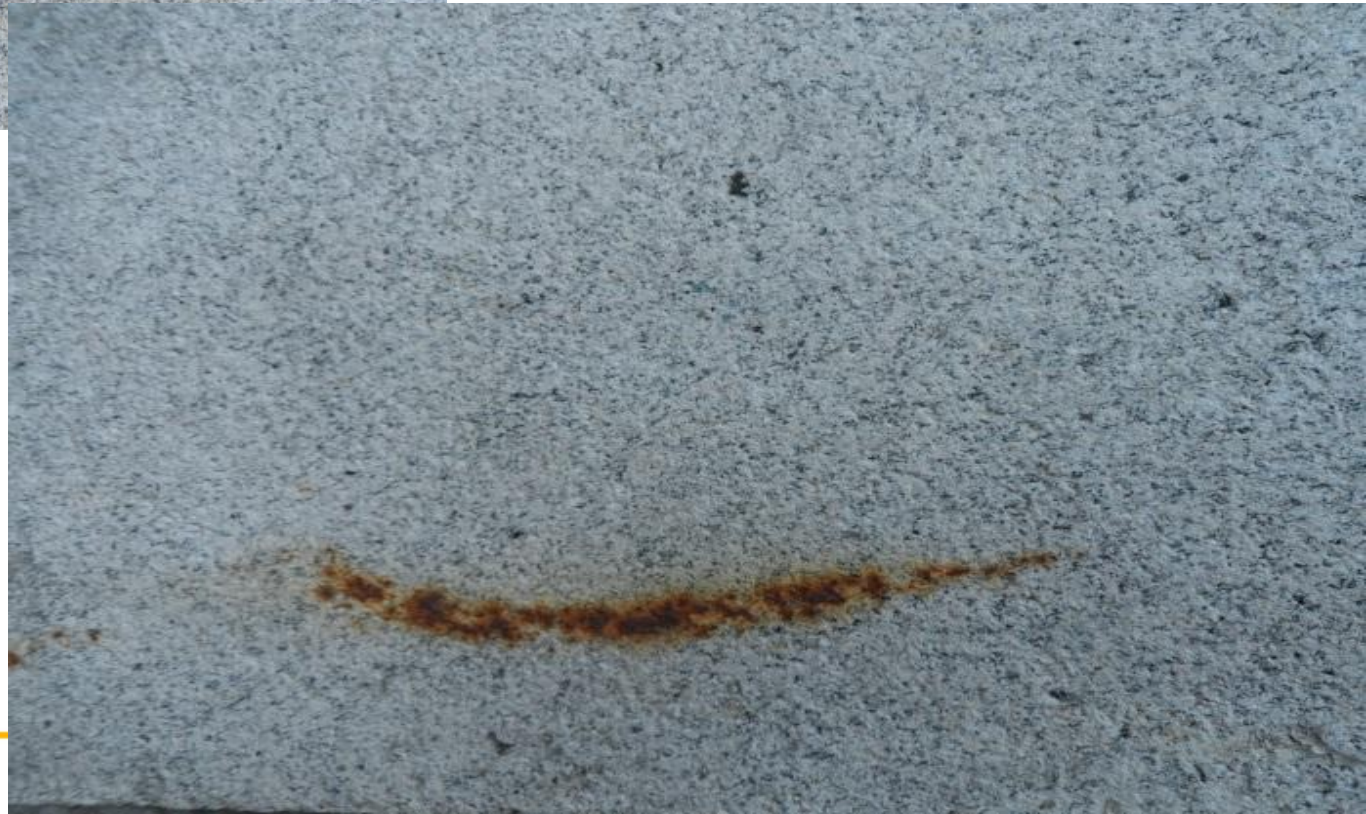
Chemical weathering

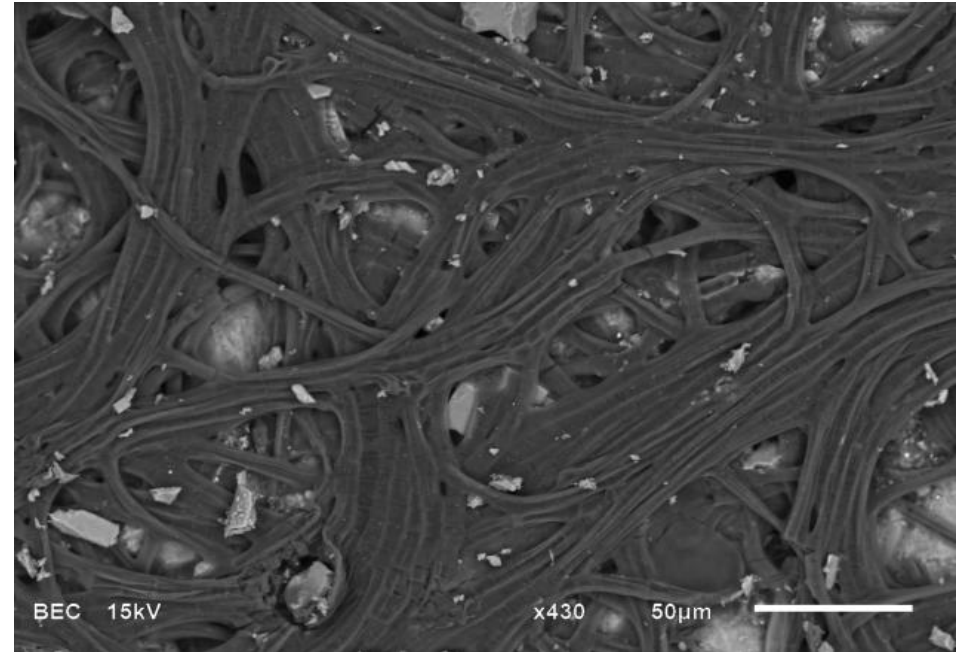
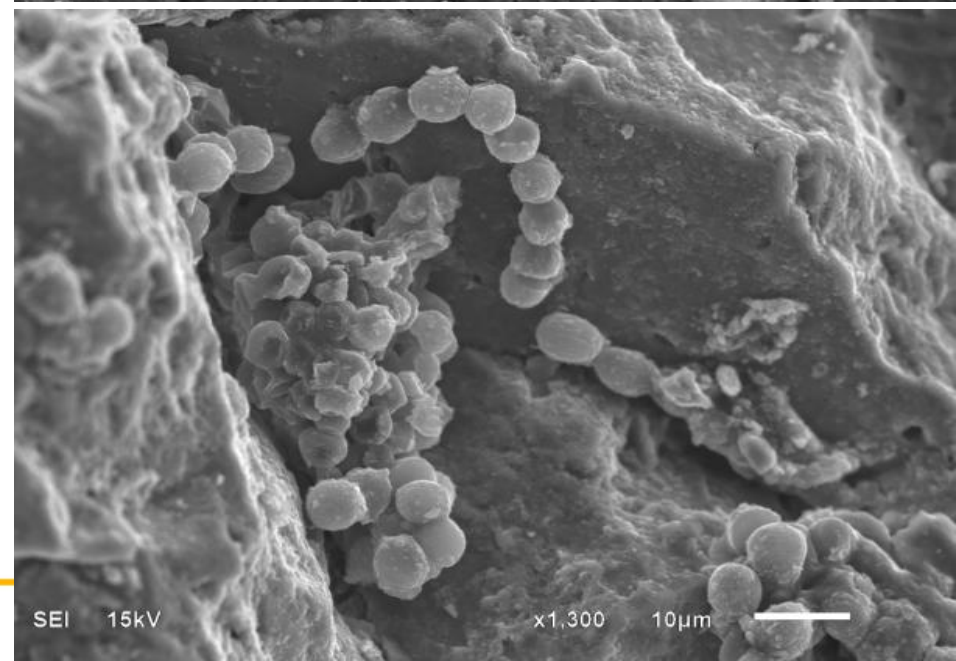
II A. Biofilms (Bi)

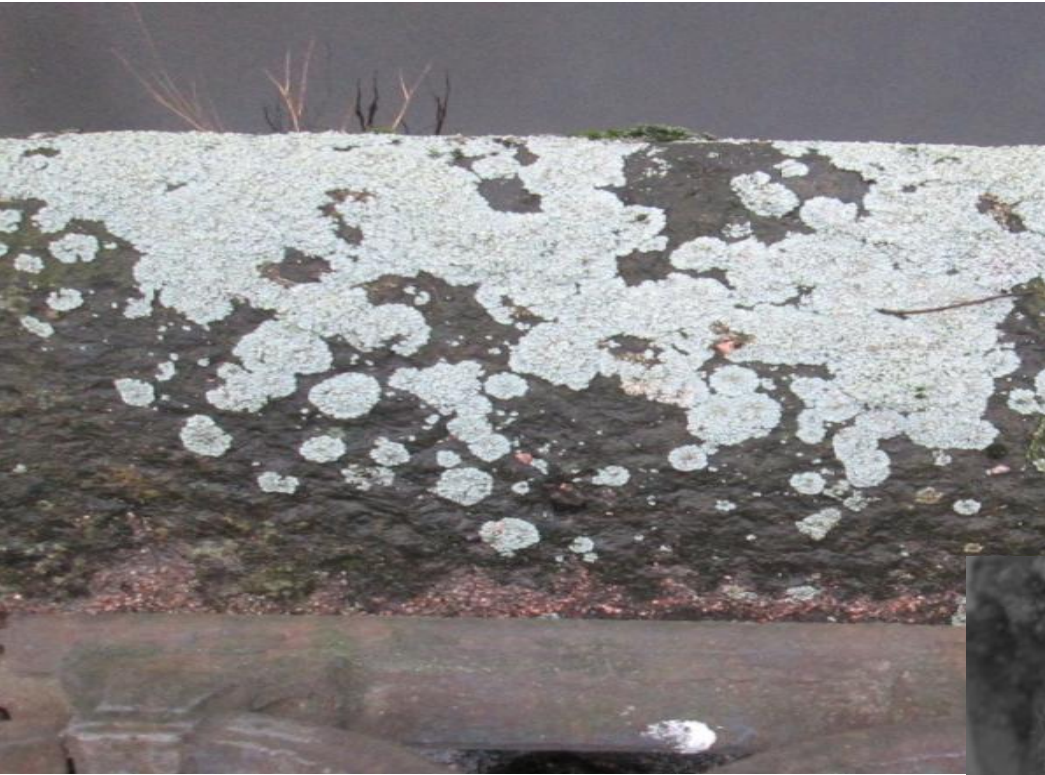
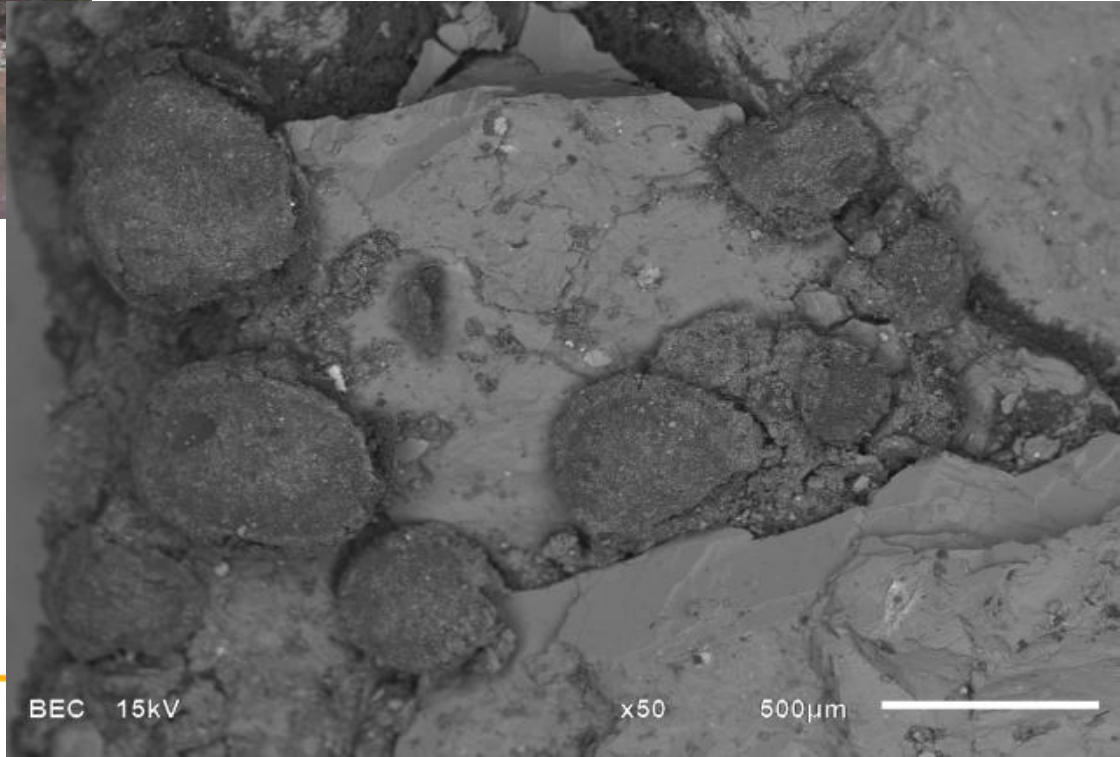
IIB. Lichens fouling (Bi)

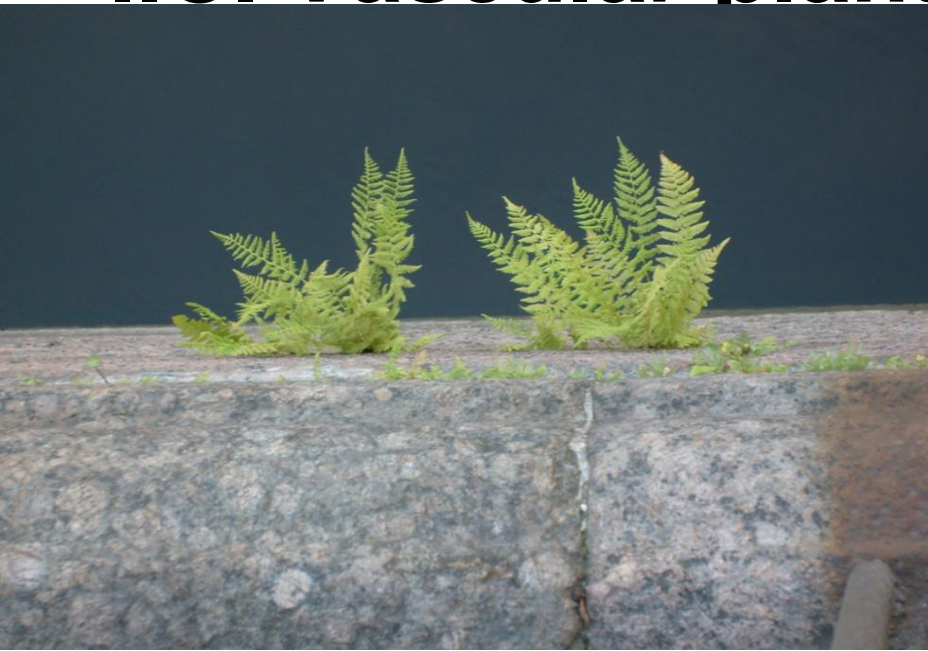
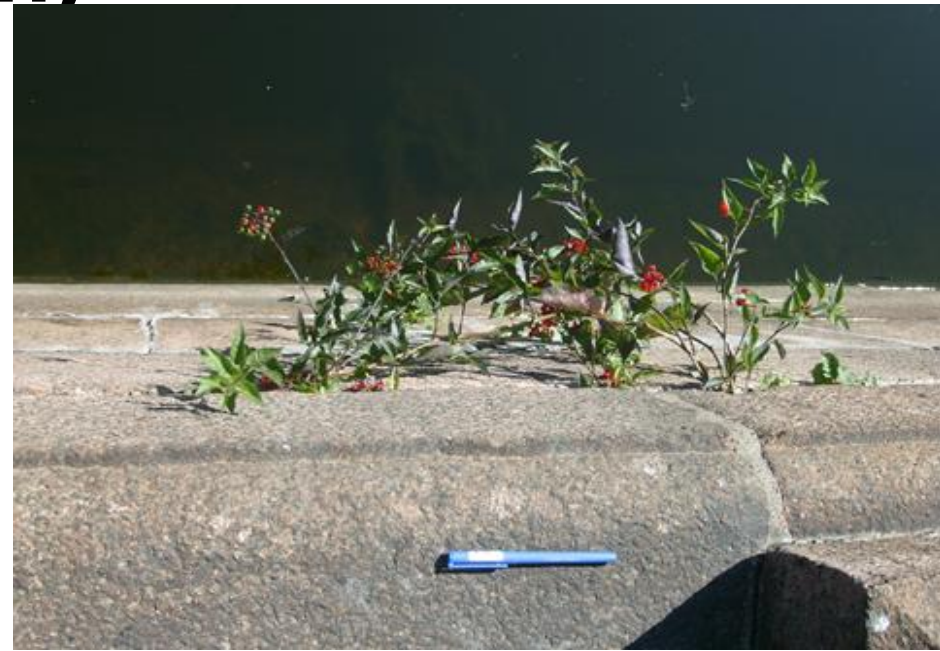
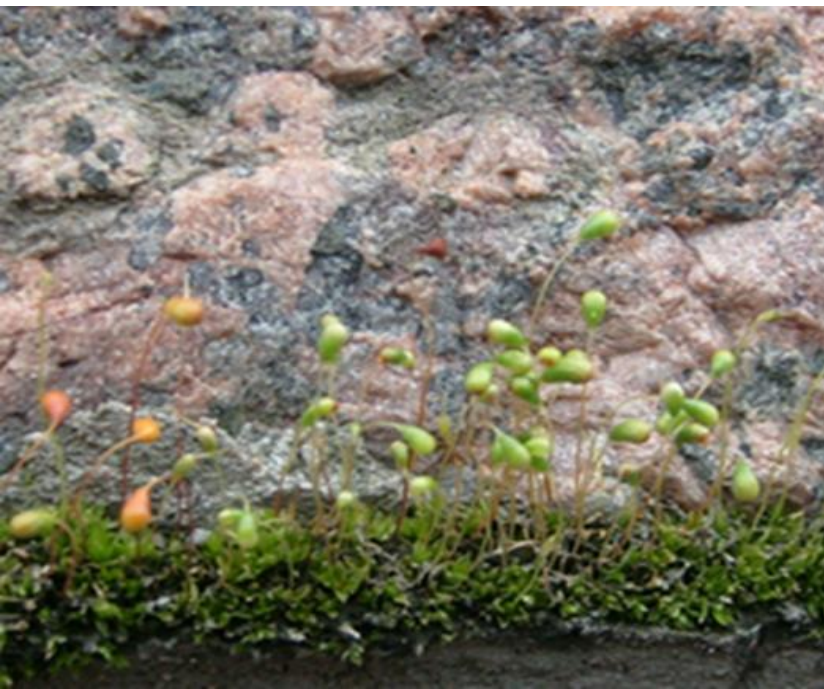
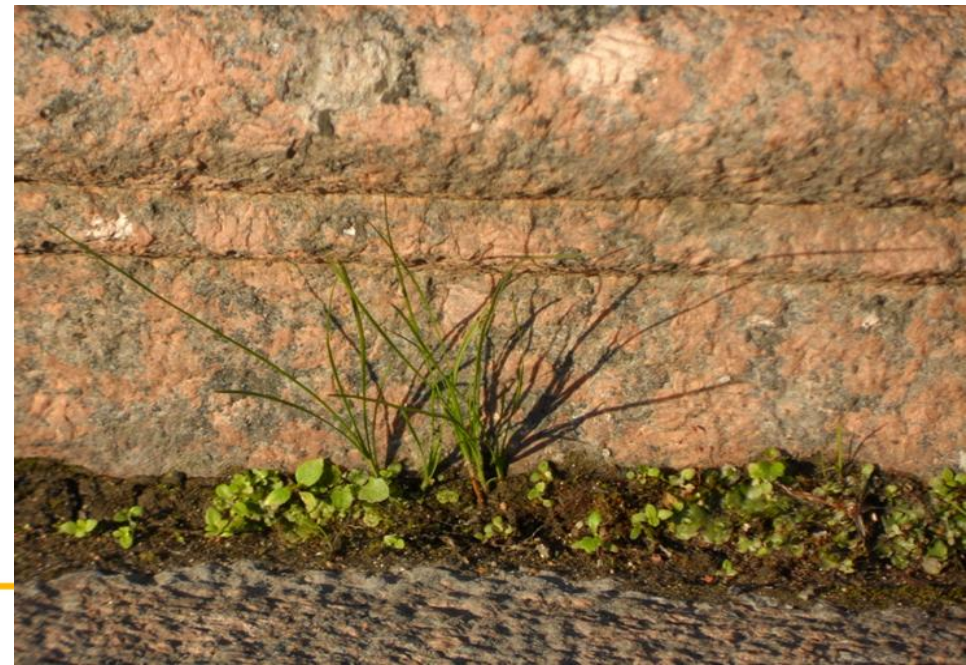
IIC. Vascular plants (Bh)

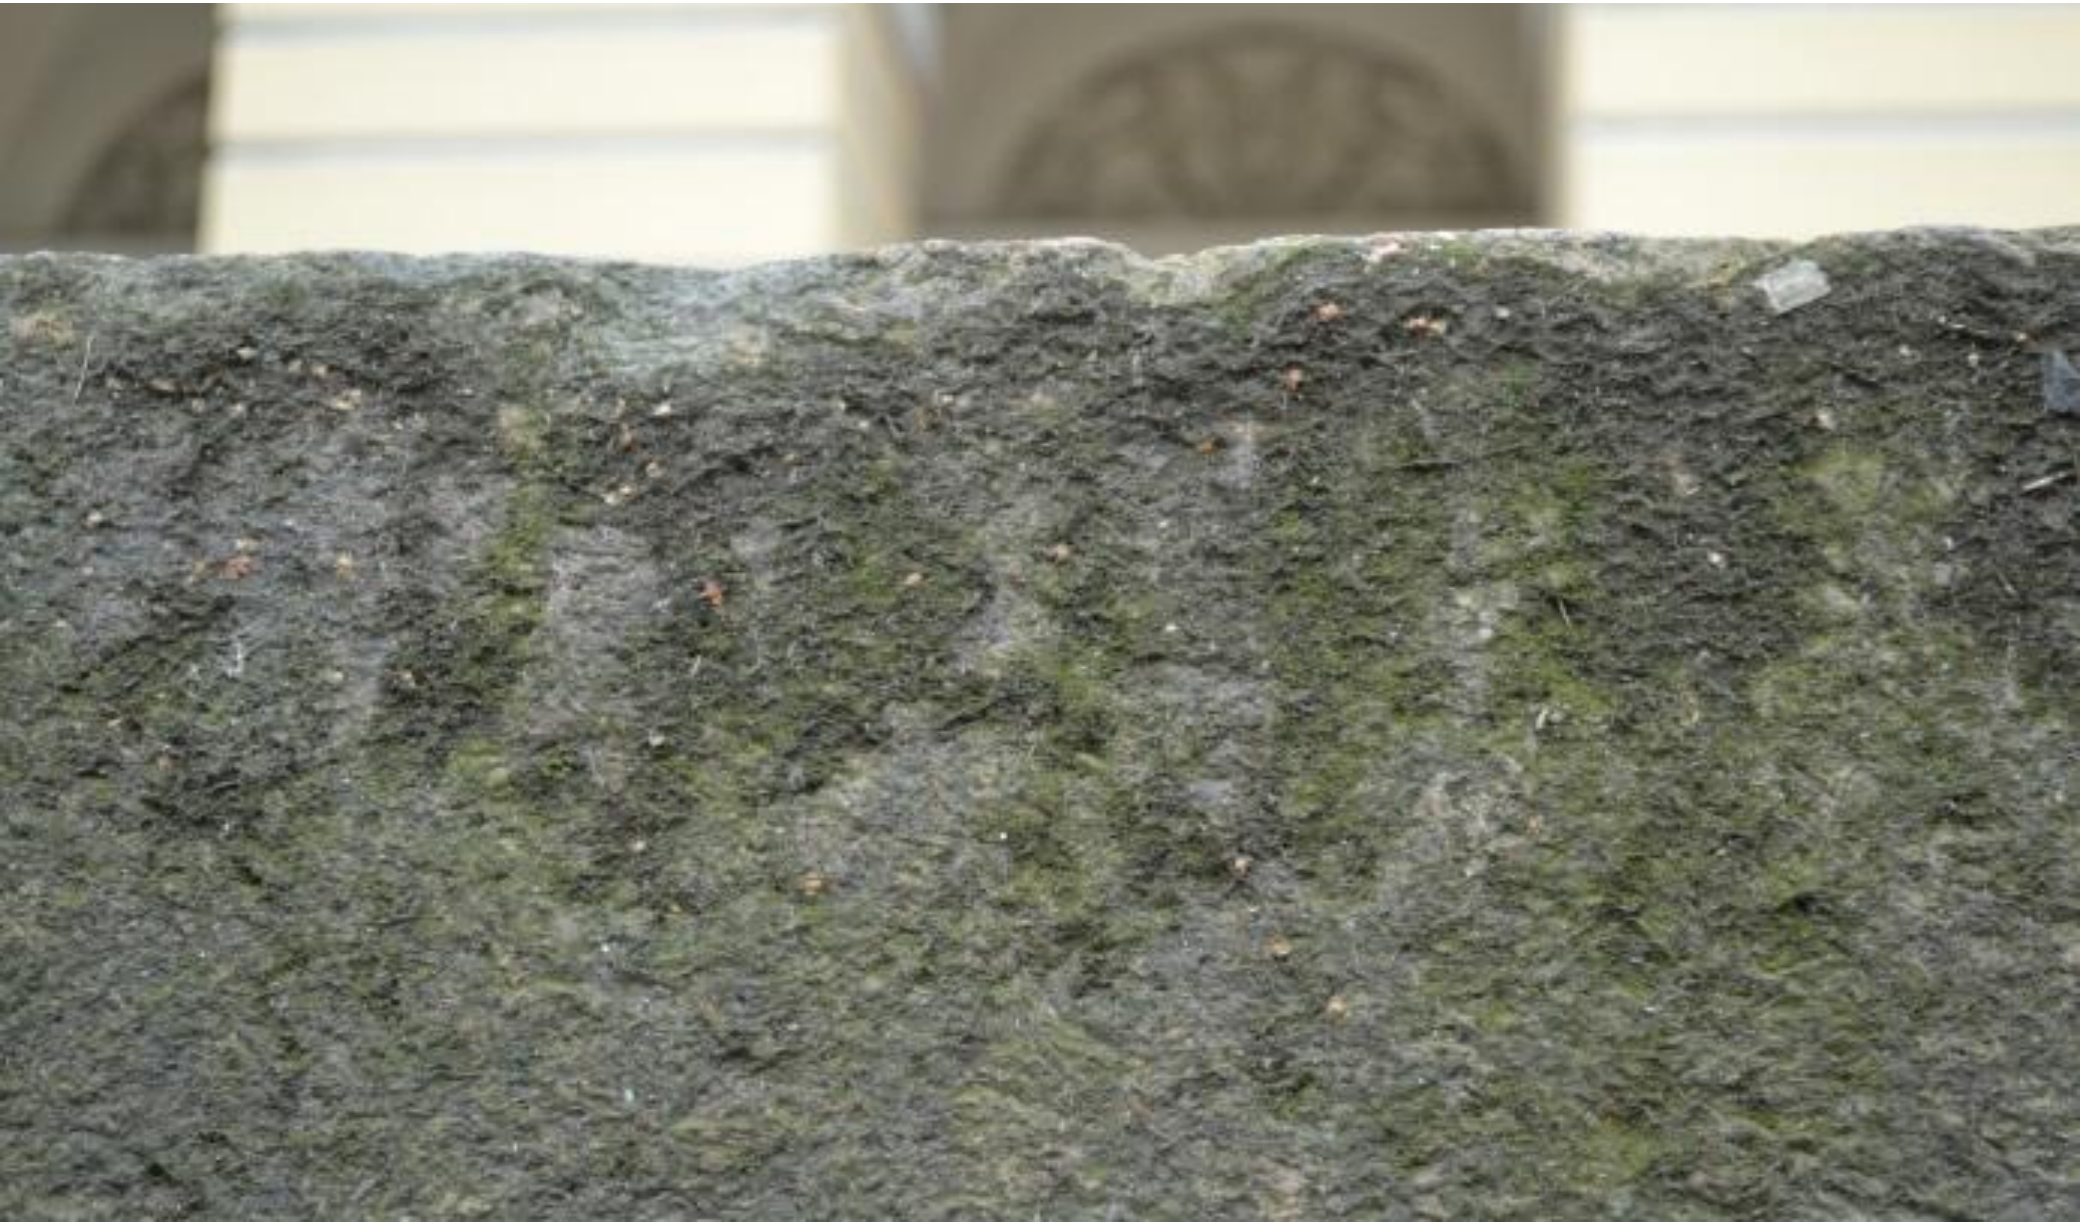
III A. Atmospheric pollution (I-C)
