Efficient use of natural stone in the Leningrad region and South-East Finland

SOUTH-EAST FINLAND - RUSSIA ENPI CBC PROGRAMME

Granite in SPb and Helsinki architecture

Stability of a stone in the city environment

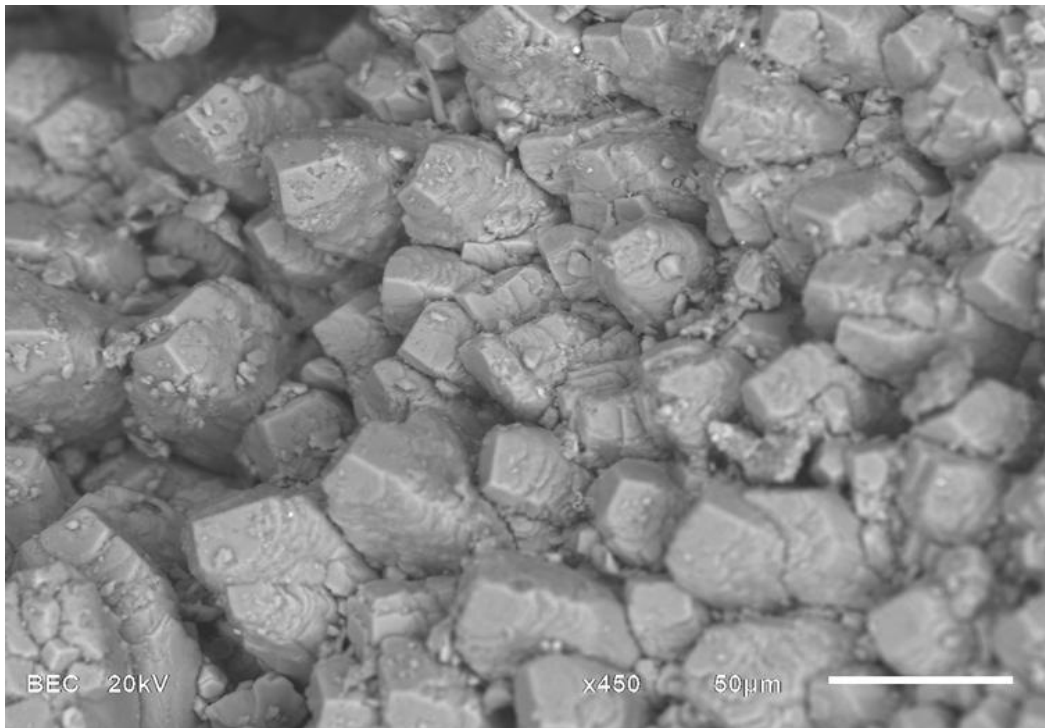
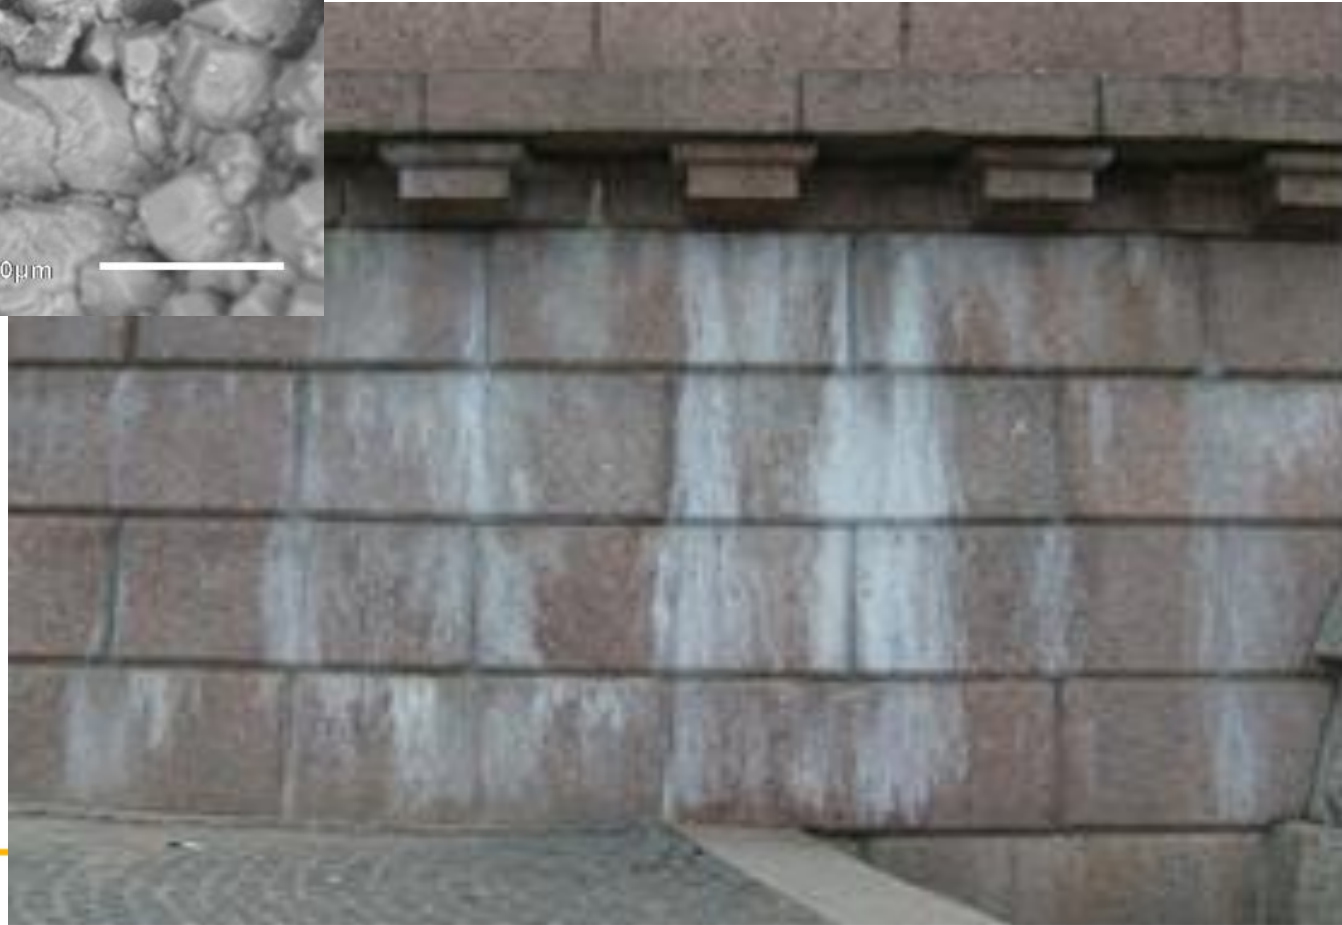
III C. Efflorescences (E-C)

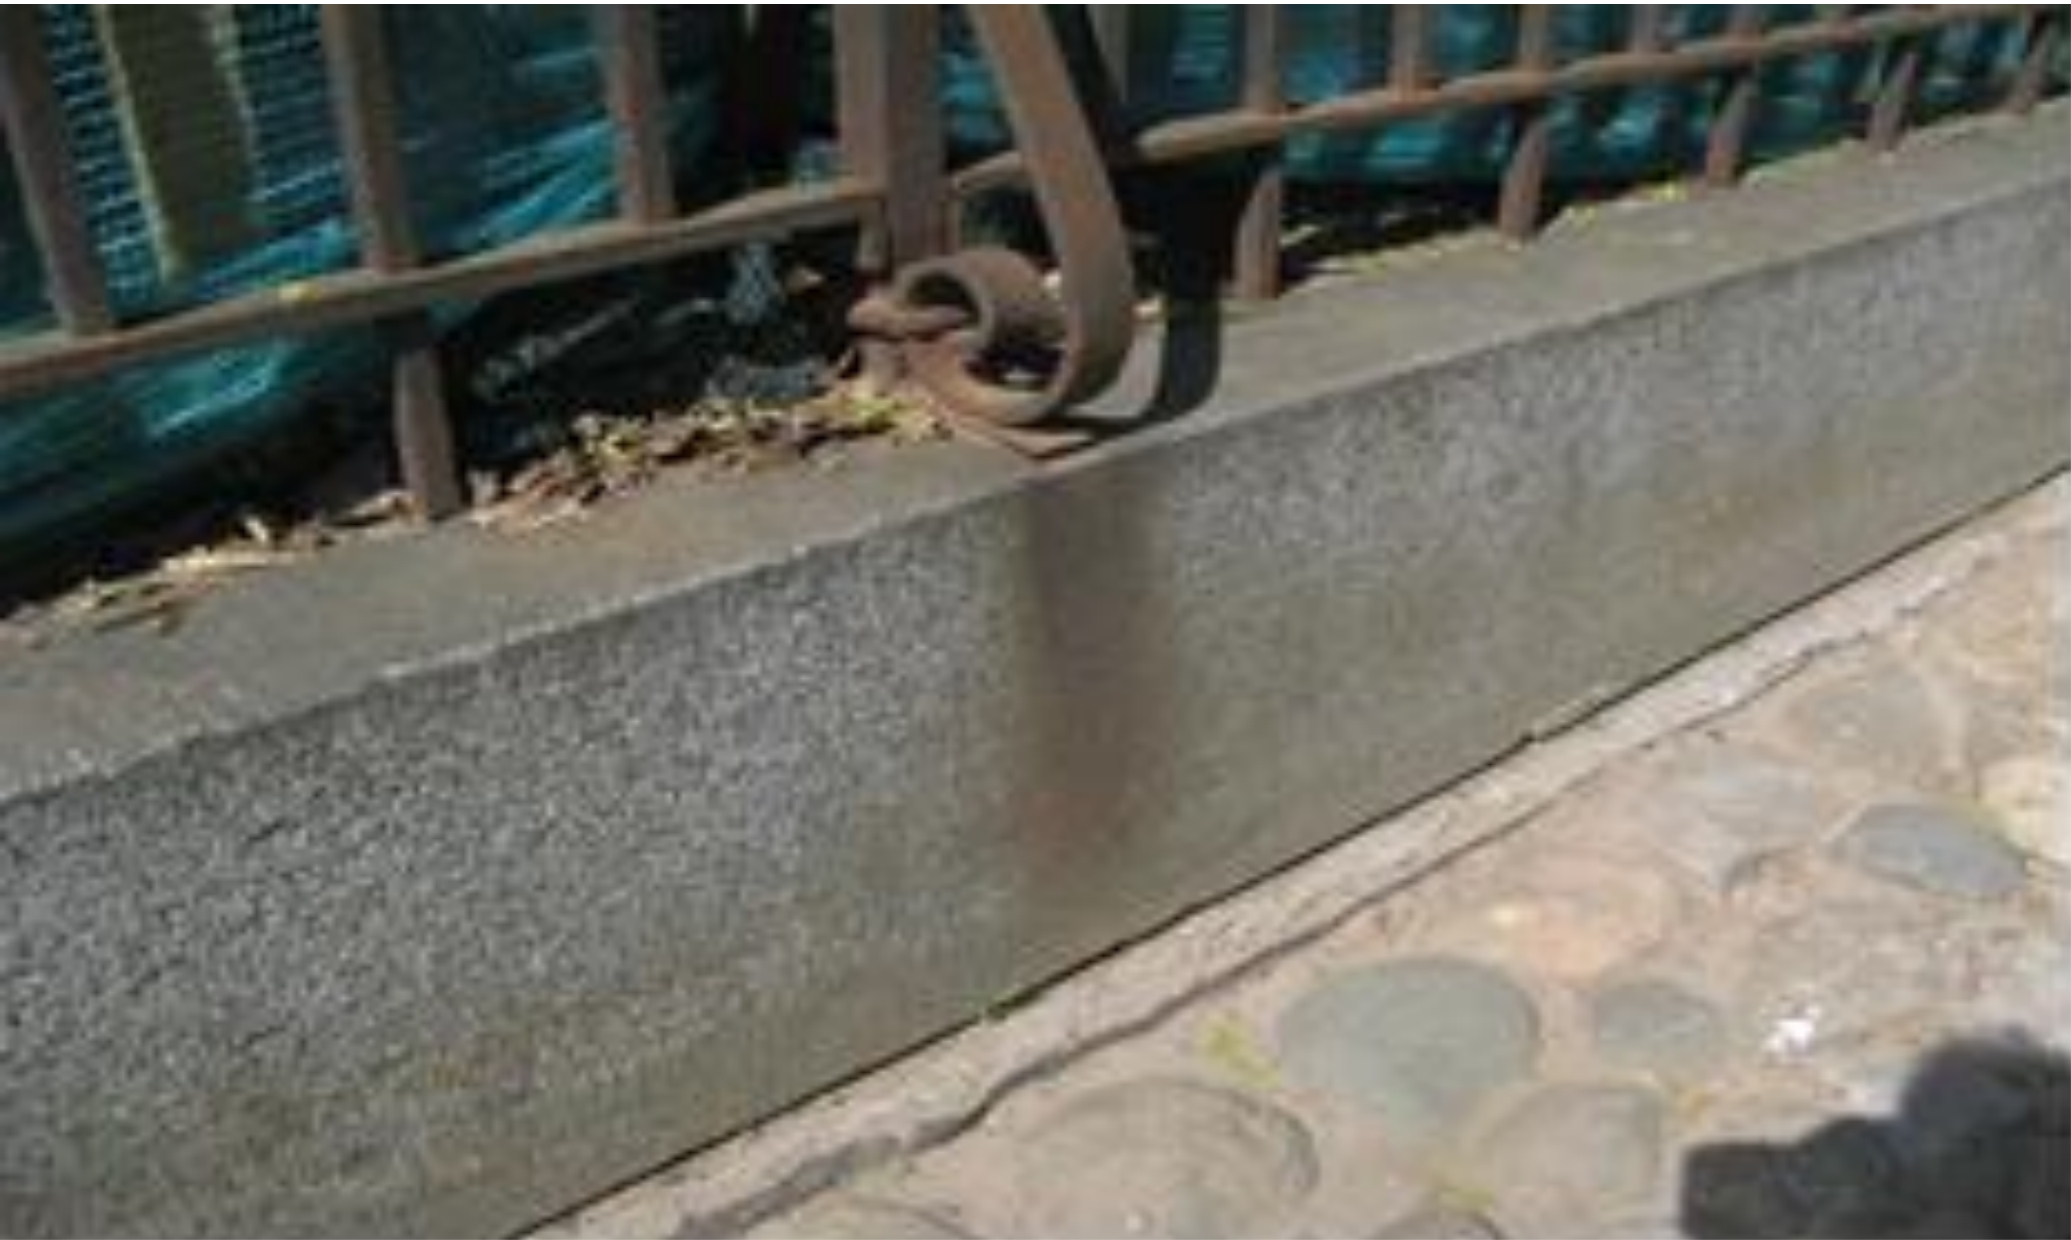
III D. Stains from metal corrosion constructions (D-C)

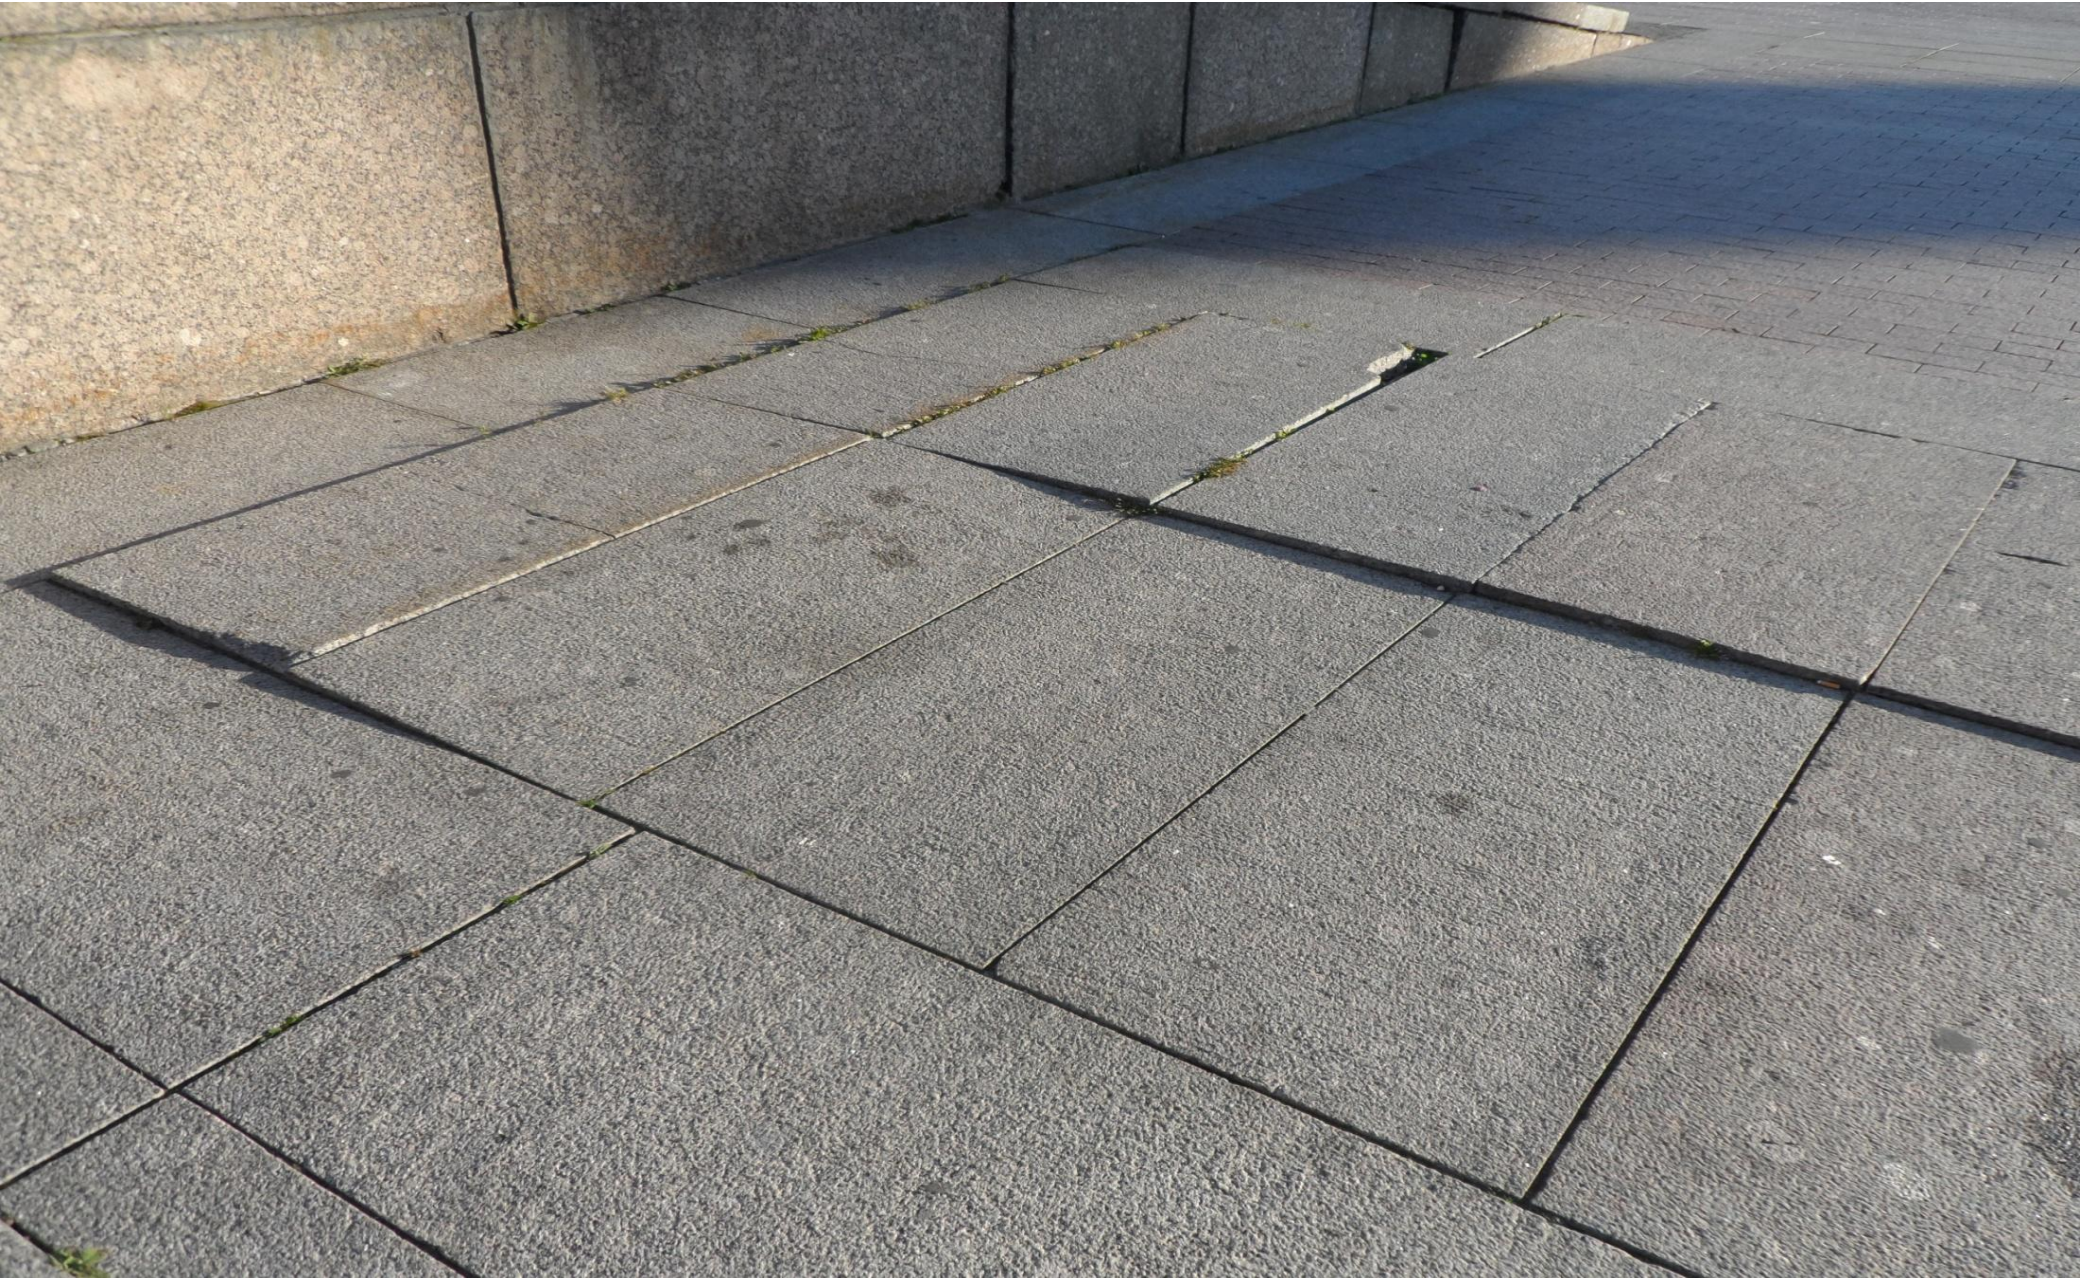
III.E. Deformation

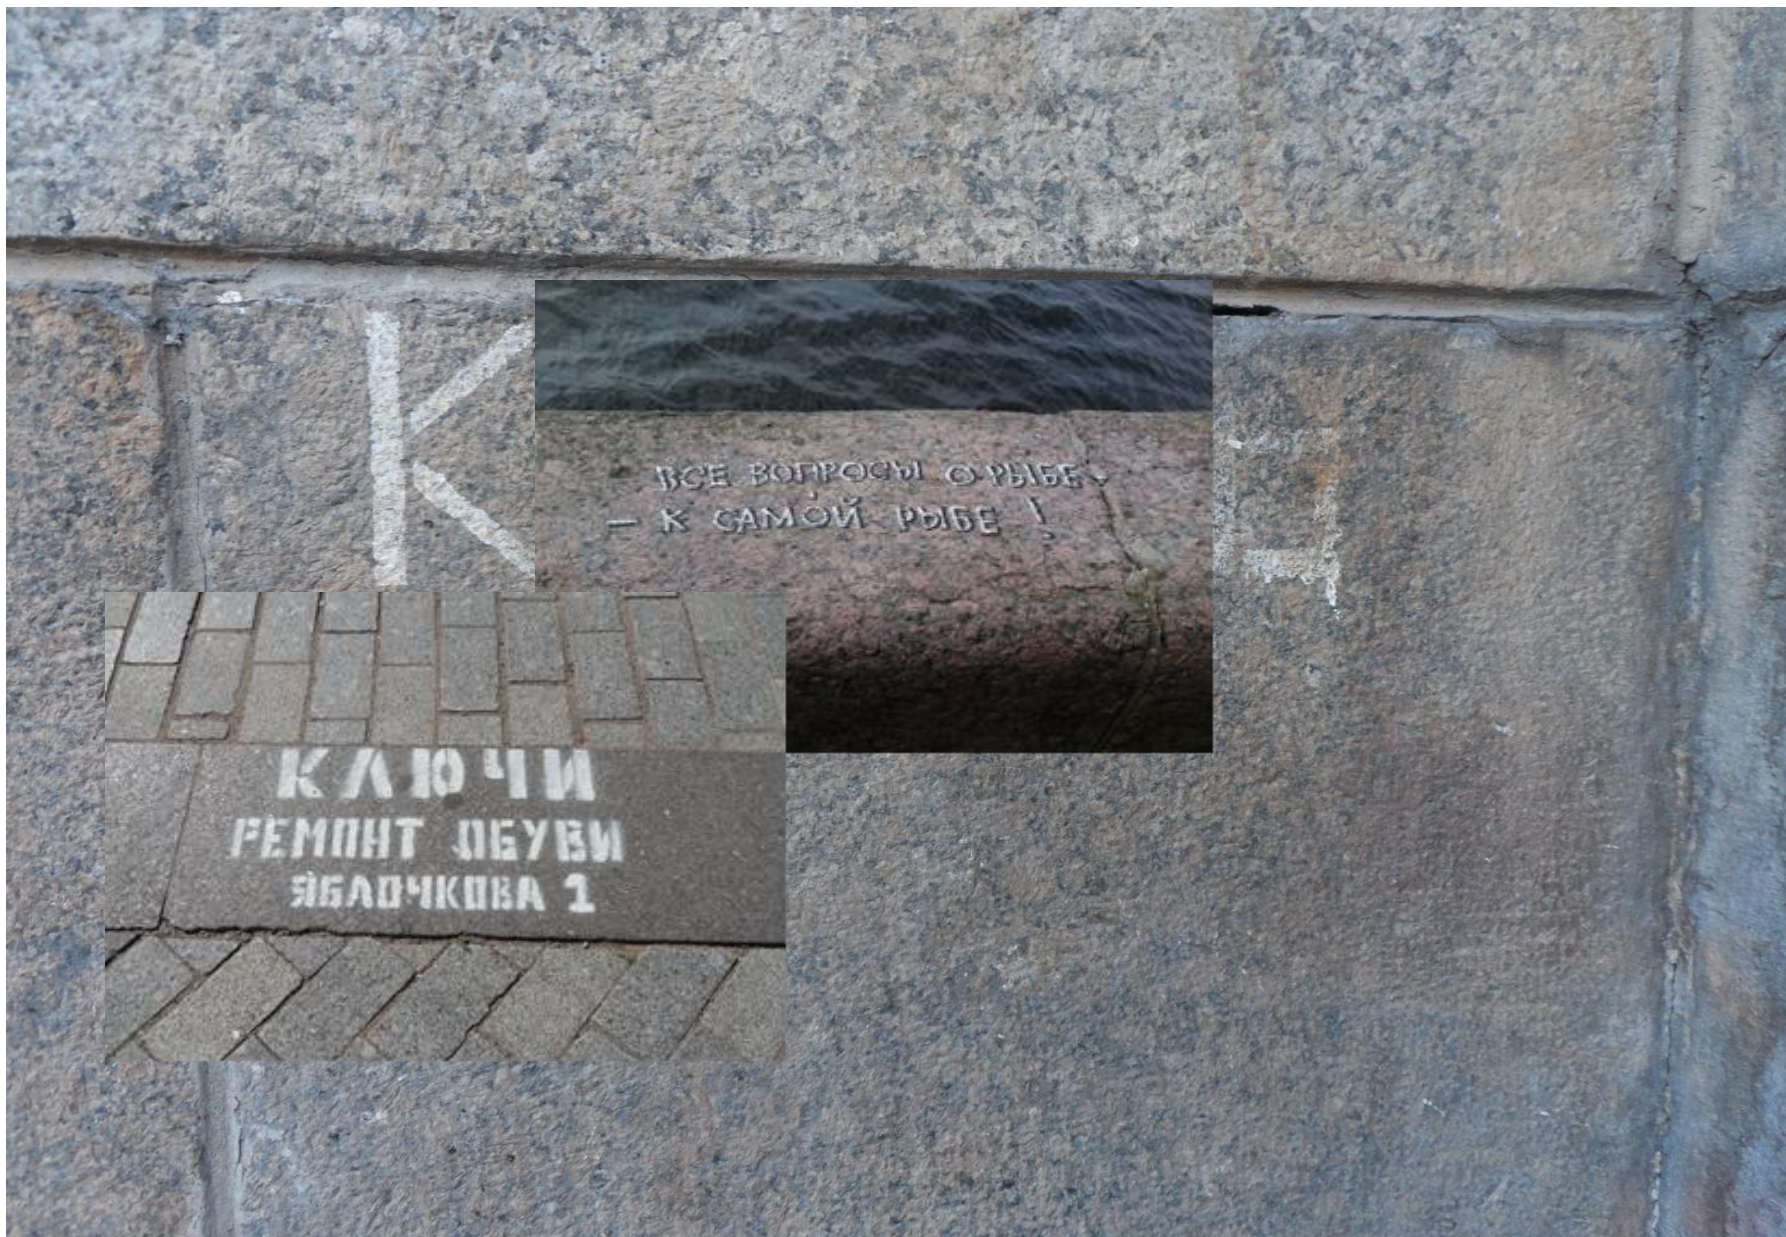
III. Graffiti, paint (aO, aR, aI)

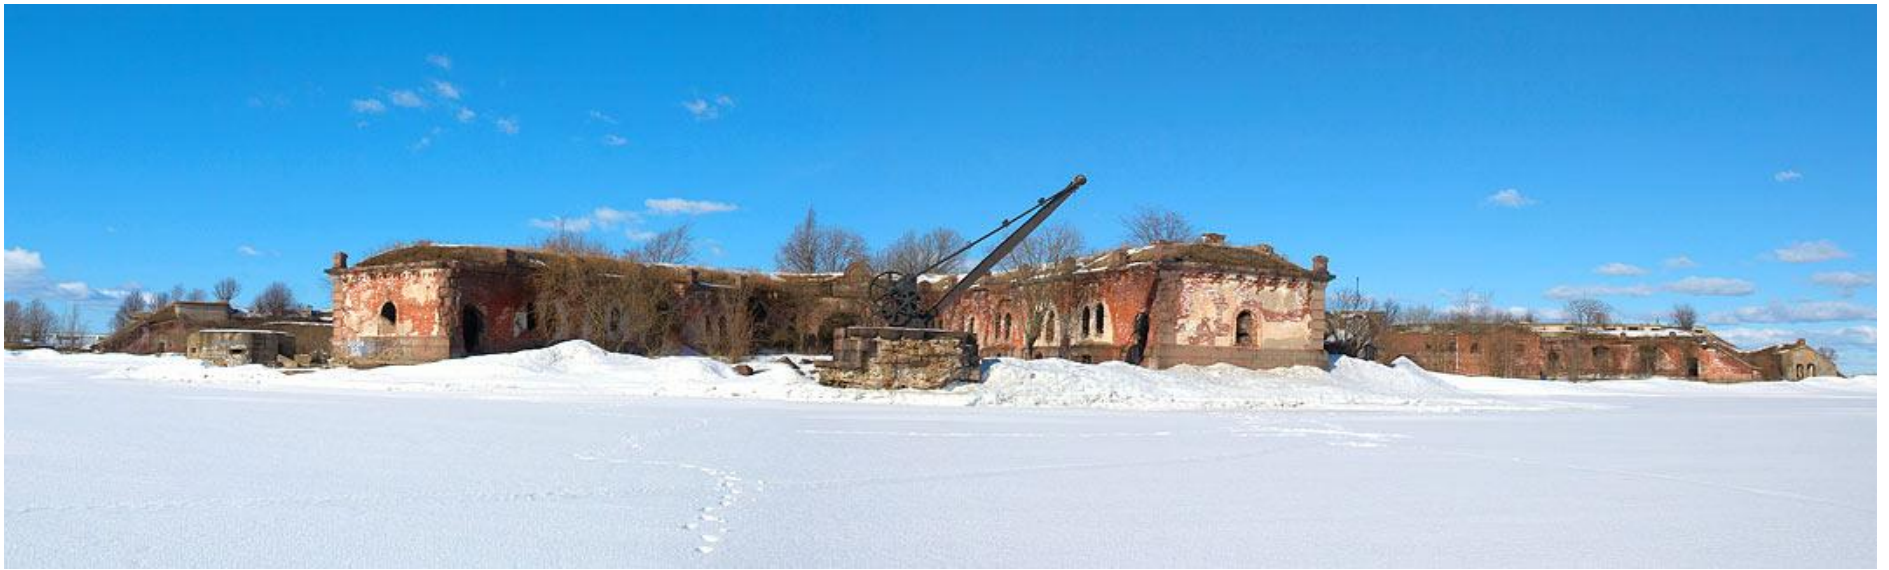
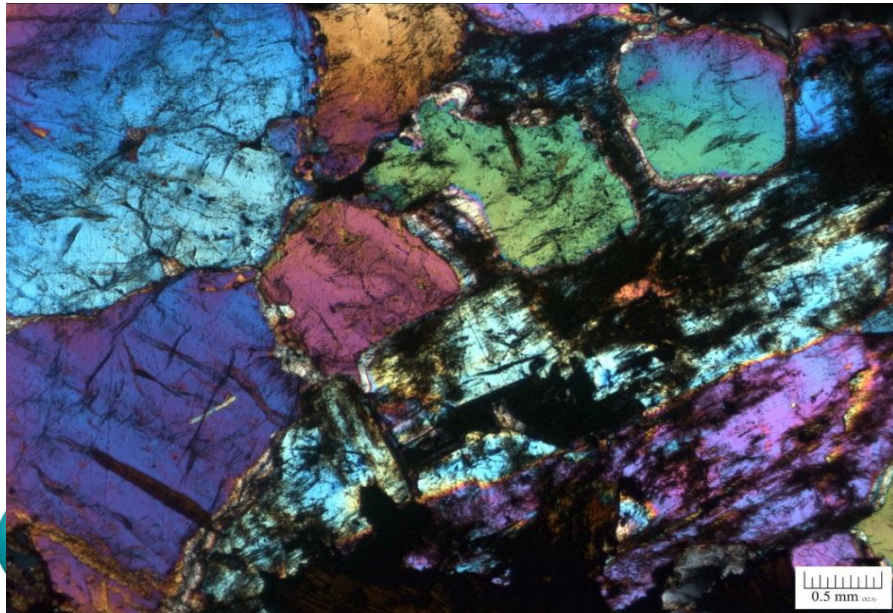
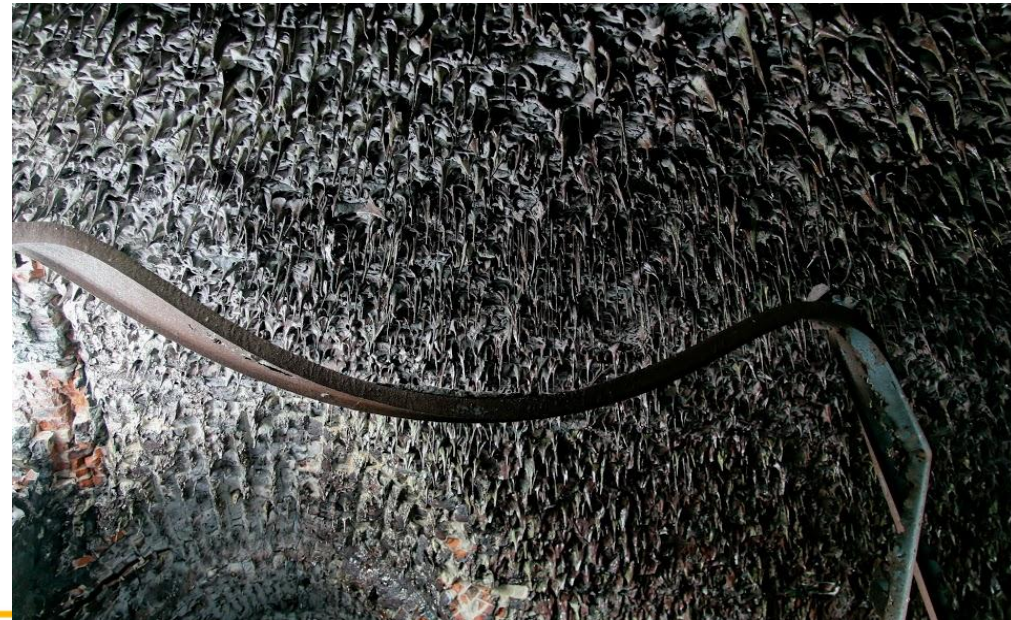
III G. Catastrophic destruction
