**SOUTH-EAST FINLAND - RUSSIA ENPI CBC PROGRAMME 2007-2013**  
**Efficient use of natural stone in the Leningrad region and South-East Finland**

## Site Inspections

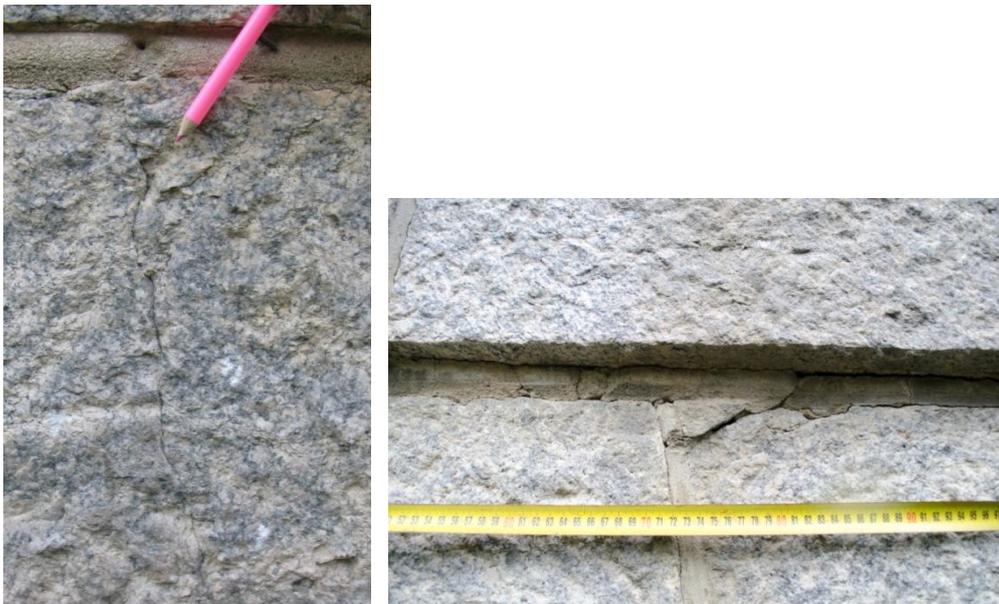
Cracks along 2 blocks, visible from the map of deterioration in Figure 7, are instead caused by structural movements as well as cracks along a window corner on the same façade. (Figure 10)

Figure 10 Cracks given by structural deformation. Fracture in the middle of a block, successively measured with UPV, on the left (photo by Nike Luodes GTK). Crack in correspondence of the upper corner of a block over a window, on the right (photo by Joonas Toivanen GTK).

Not high deformations of the structures that would represent a risk for stability of the building have been recognized but some fractures had been caused by structural movements as visible from Figure 10. Impact against the structure has been relevant in deforming the stair structure as visible from Figure 9 and Figure 11 where a block of the stair has been dislocated.

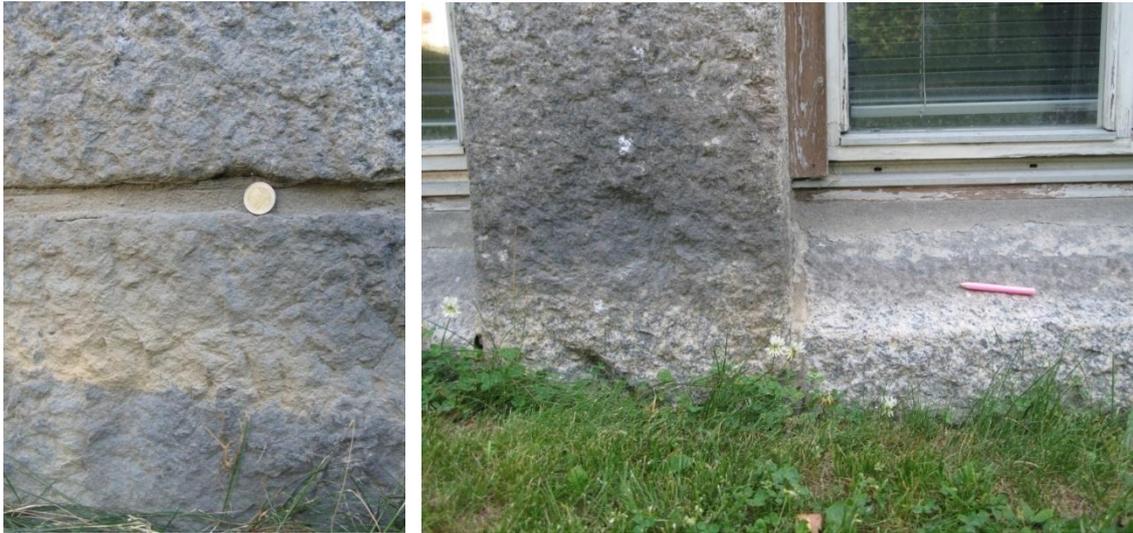
On the lower part of the basement in contact with the soil is visible an area with loosen atmospheric dust deposition (light brown). On the basement are visible also areas where deposition has turned into black crust as near the corners and in more protected areas as behind the rain pipes, on the window sills and on the wall between the windows (Figure 13).

Figure 13. Atmospheric particle deposition and fixation

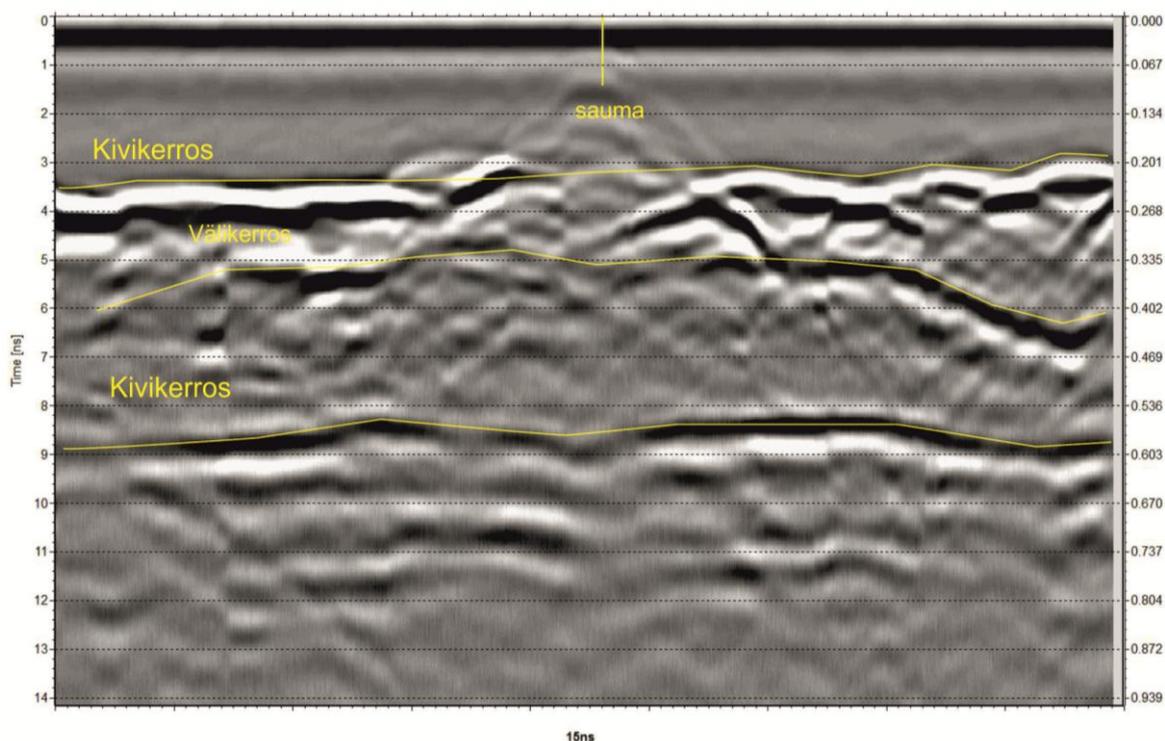
The parapet of the stair is composed by a three layer wall: a stone block of approximately 200mm in the inner side of the parapet, a part filled with loosen material and air and an external wall with block thick 200-300mm as visible from the radardgrams of Figure 30. The top of the radargram represent the surface of the wall over which the antennae has been placed.

Figure 30. Processed radargram of Line F2, showing in yellow the wall layers. Kivikerros meaning Stone layer and välkerros meaning a middle layer that is in between the two stone blocks. The radargram has been taken according to Figure 31

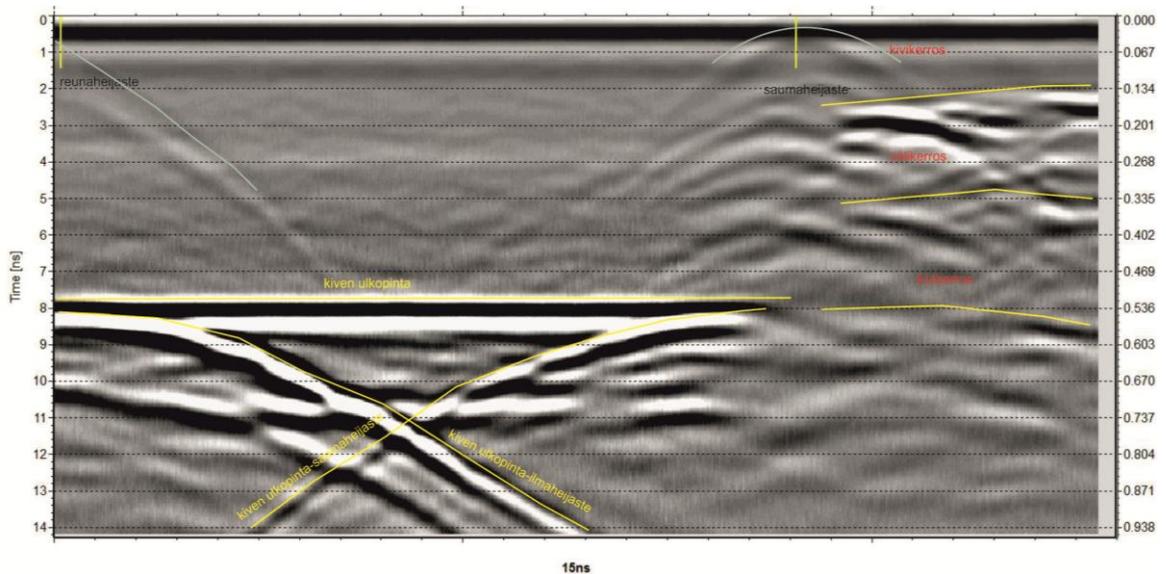
Figure33. Processed radargram of line F4.

From Figure 33 it is visible the initial massive corner block, thick approx.500 mm, and after it, three layer wall structure as the previous wall. The same layered structure has been found also in the basement performing a long measurement on the basement of the West façade.

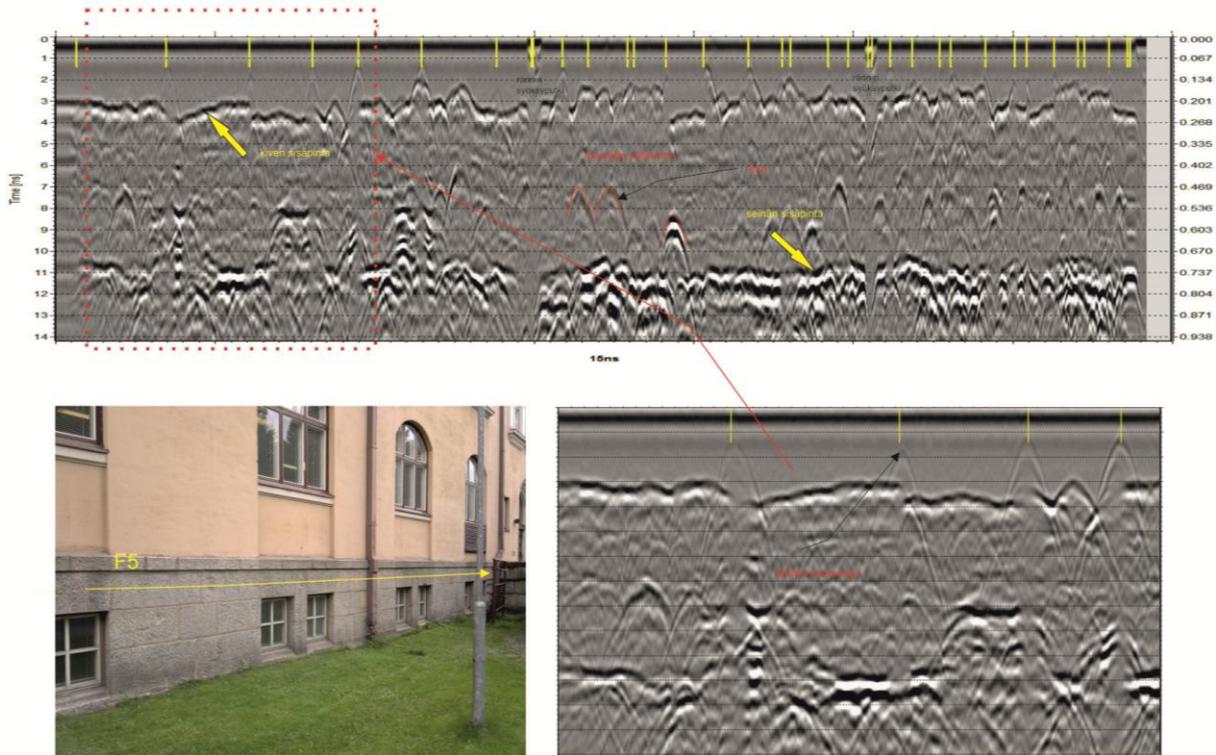
Figure 34. Processed radargram showing the “Kiven sisapinta” back side of the stone basement, “muurattu välikerros”, laid and compacted filling material in the hollow, “seinän sisäpinta” inside surface of the whole wall-possibly 73cm thick. In the lower frame is enlarged a detail of the full radargram

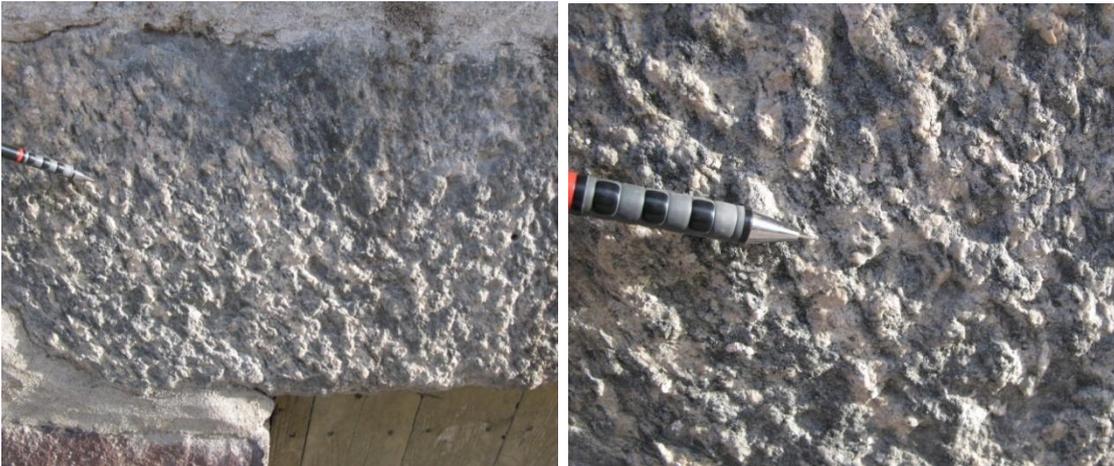
The original surface was either split or chiselled. On the stones used in the extension done in 1874 could be noticed that the harder minerals have been weathered off less than the softer minerals, as visible from Figure 11, leaving a more rough surface compared to the fresh material.

Figure 11. Routhing of the surface on the blocks of the basement facing Hallinkatu done in 1874.

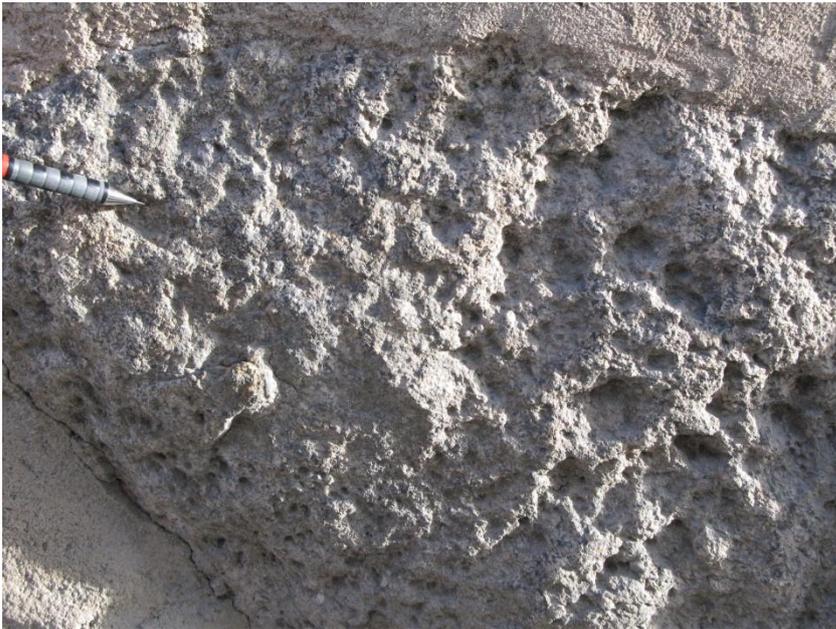
Some of the old basement blocks have shown higher degree of surface degradation as the block shown in Figure 13 from the enlargement done in 1874 facing Hallikatu. It is possible that the blocks used had already been originally weathered, since the material has been not quarried but picked as erratic blocks. The material is also a kind that has higher tendency to deterioration and that last less than a sound granite the local environmental condition, moreover, if mechanical cleaning operations have been used, the surface could have been abraded also by those.

Figure 13. Block on the side constructed in 1874 facing Hallikatu, the material is showing deepening and cavities

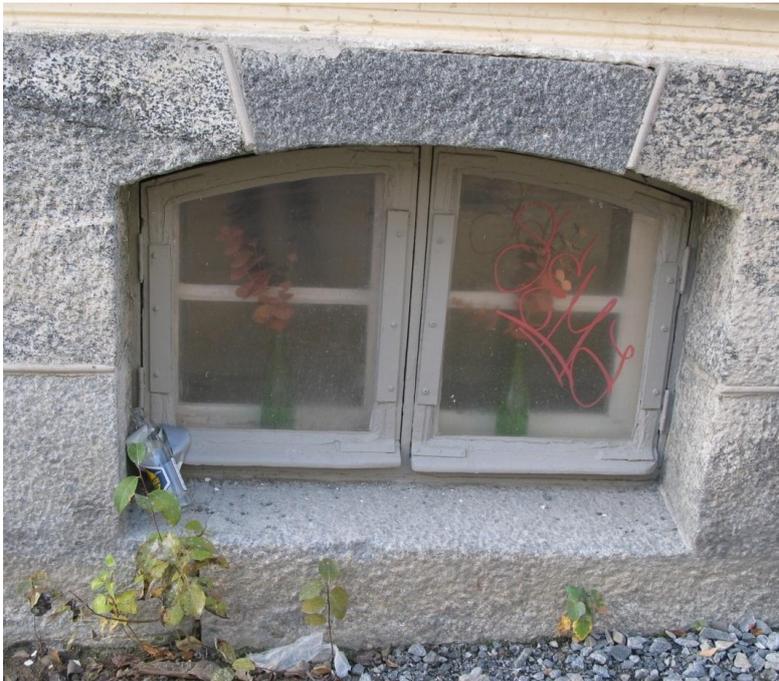
One deformation has been noticed over a window on the basement facing Puijonkatu. The central block has been dislocated probably because of the vibrations caused by the works of reconstruction of the main square and repaving of the roads (Figure 18)

Figure 18. Windows on the side facing Puijonkatu over which a block has been dislocated.

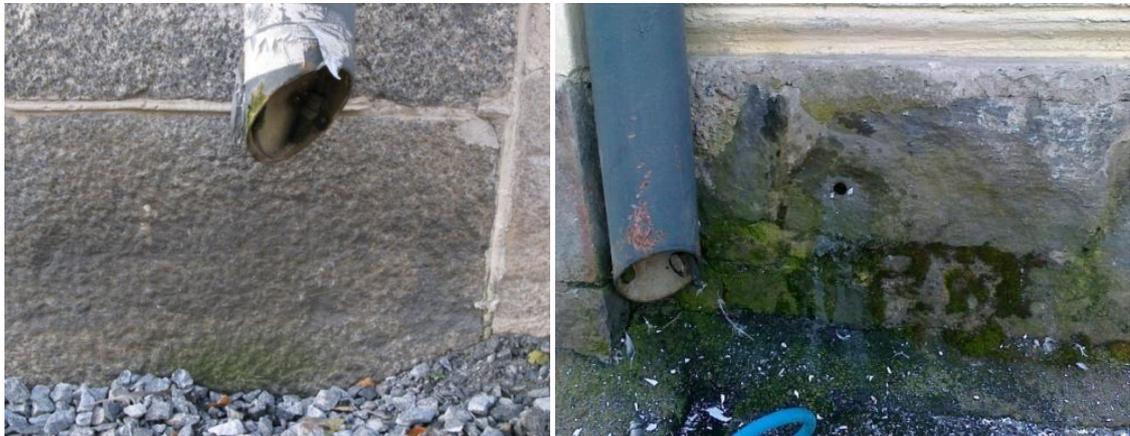
Figure 20. Example of the biofilms formed over the stones in correspondence of the drain pipes. On the left the facade facing Puijonkatu and on the right that facing Kauppakatu.

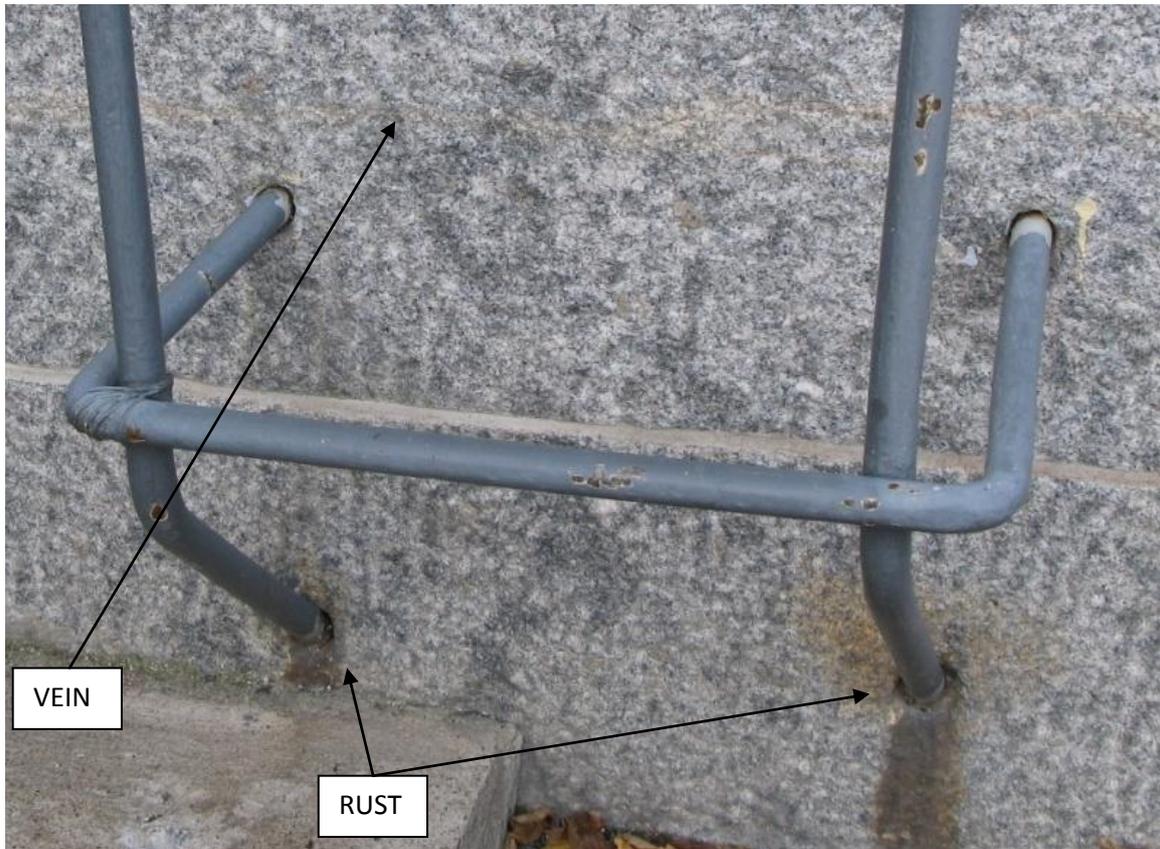
Figure 24. Vein showing oxidation of minerals on the inner yard basement on the wing on Hallikatu, facing south, built in 1914. In the figure is also visible rusting given by interaction with the metal stairs.

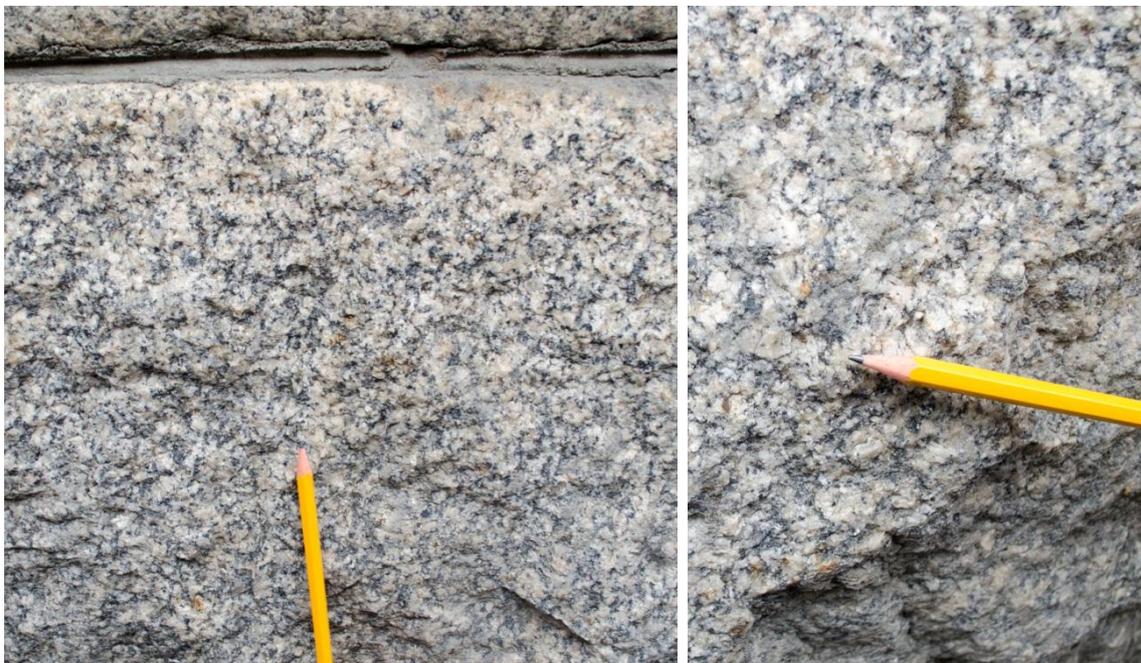
Figure 10. Example of oxidation of elements in the material itself. (photo Joonas Toivanen)

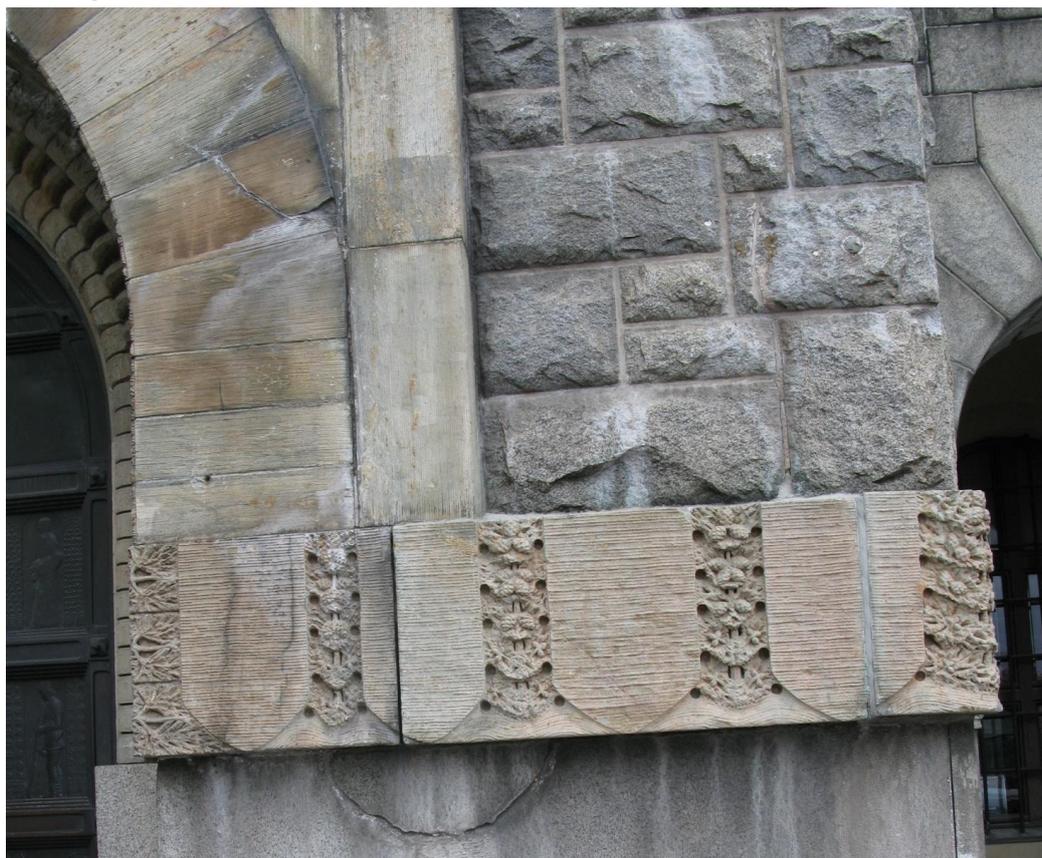
Figure 14. Presence of two cracks probably due to mechanical actions or to structural deformation has been noticed on the main entrance arc. (Photo: N.luodes)

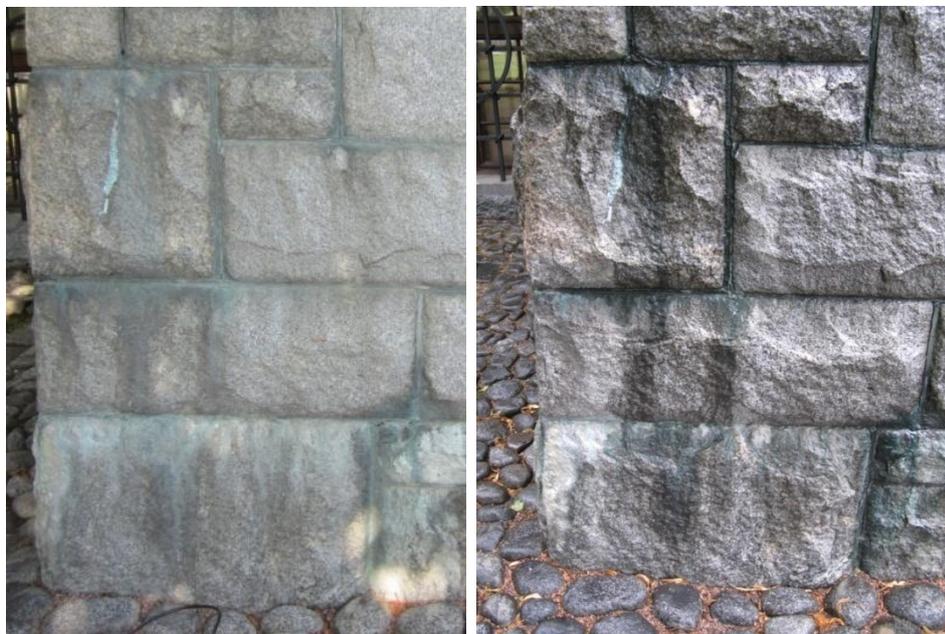
Figure18. Deposition of copper forming a thick crust on the bottom most elements. The picture is taken from an element of the building facing South. On the left is shown the basement in dry conditions, on the right in a rainy day. (Photo: N.Luodes)

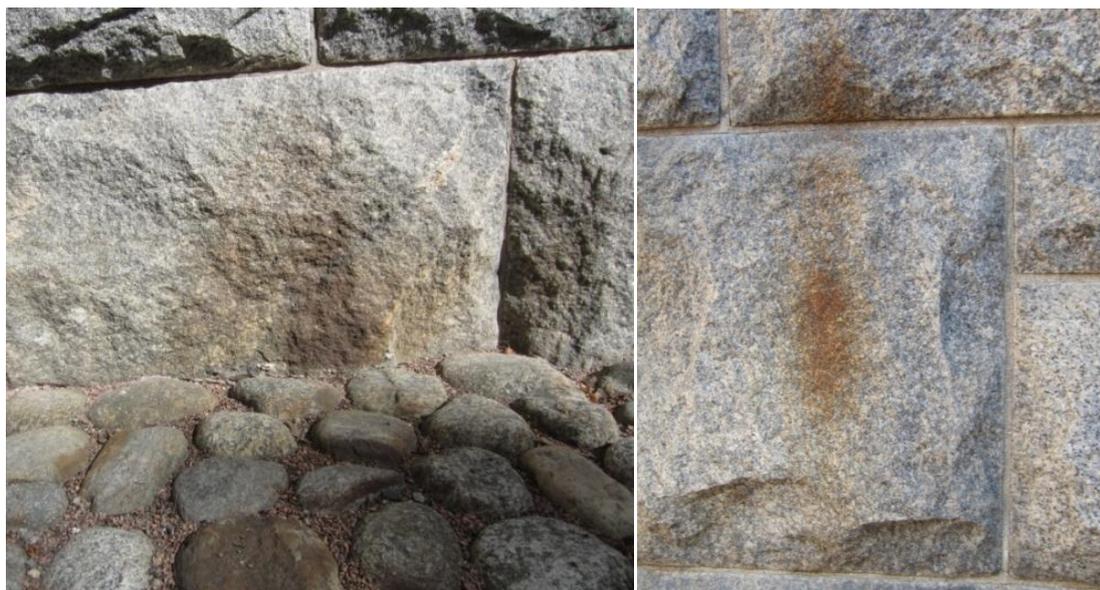
Deposition of iron given by anthropogenic activity is shown in Figure 19.

Figure19. Spots of rust on the facade facing the garden on the west. (Photo: N.Luodes)

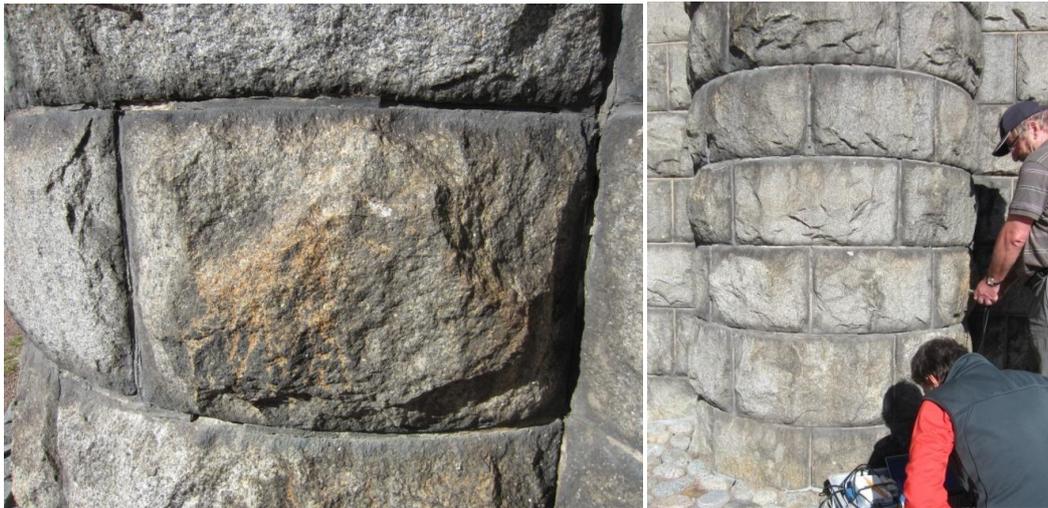
Figure 20. Presence of iron oxides over the surface of the blocks on the basement facing the car park on the West. (Photo: N.Luodes)

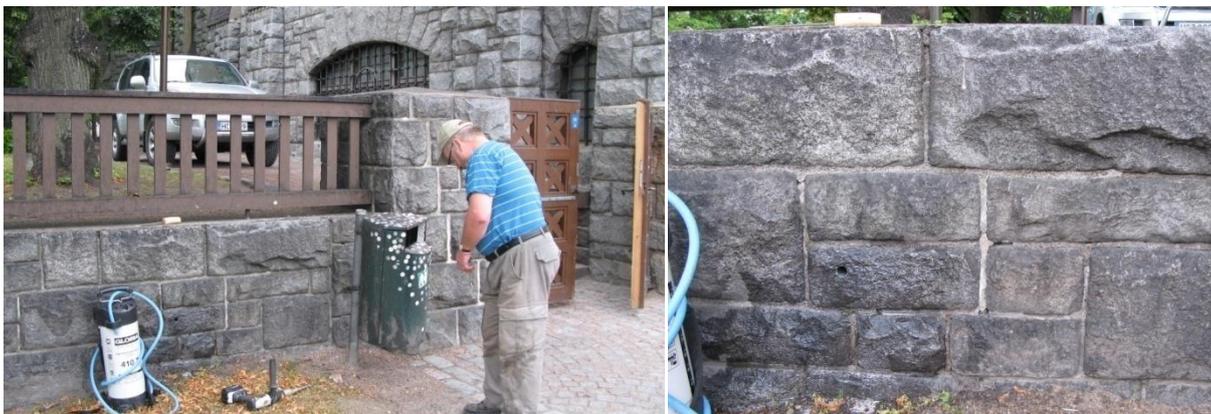
Figure 25. Kansallismuseo 2 collected from a dirty part of the garden wall where black crust and dust deposition are visible.

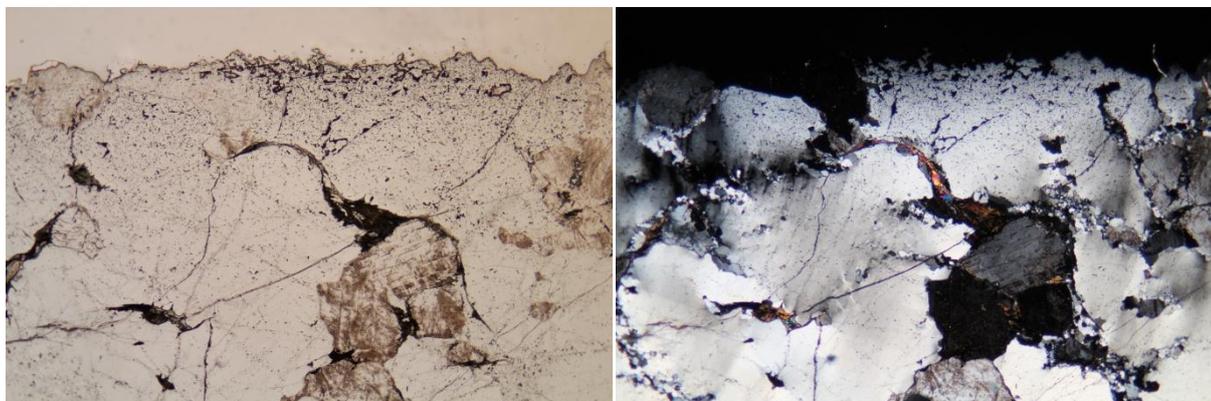
Figure 35. Starting of mineral disintegration on the top part of the sample.

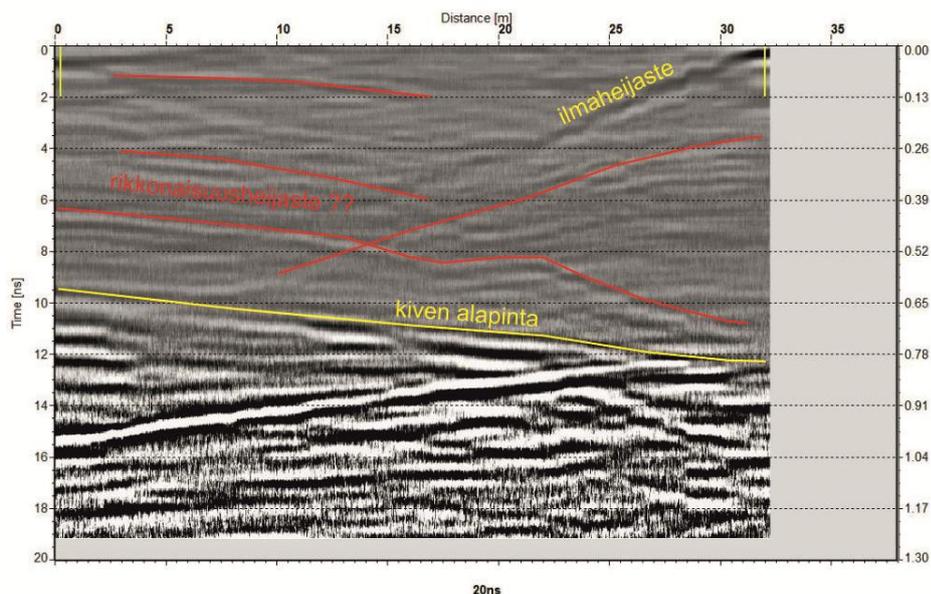
Figure 57. Interpretation of measures run along Line 15. Kiven alapinta: back side of the block, ilmaheijaste: air reflection, rikkonaisuusheijaste: fractures. (Radardgram: Heikki Sutinen)

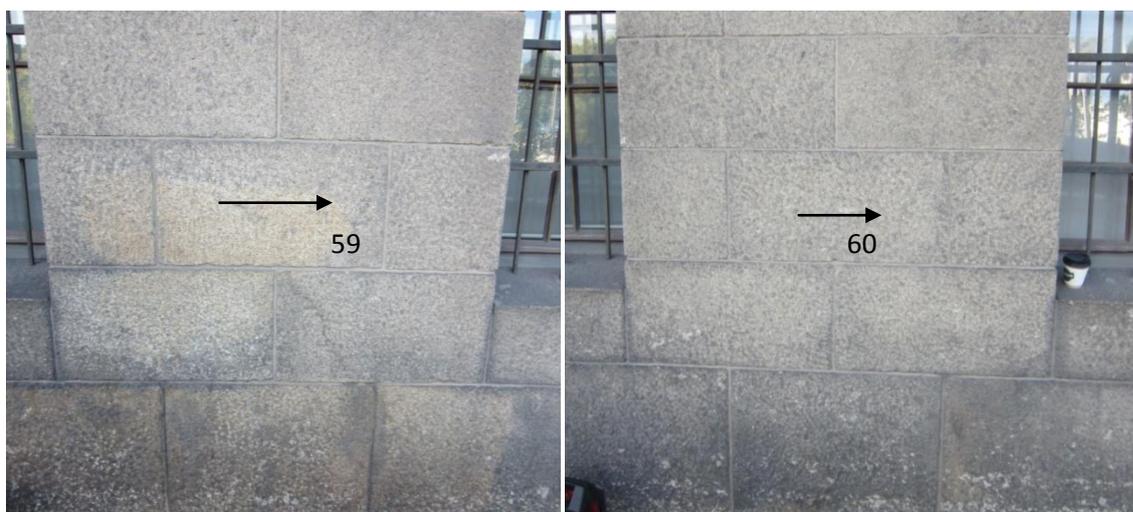
Figure 80. Blocks tested on Mannerheimintie, facing East. The block n 60 tested had been showing flaking deterioration.

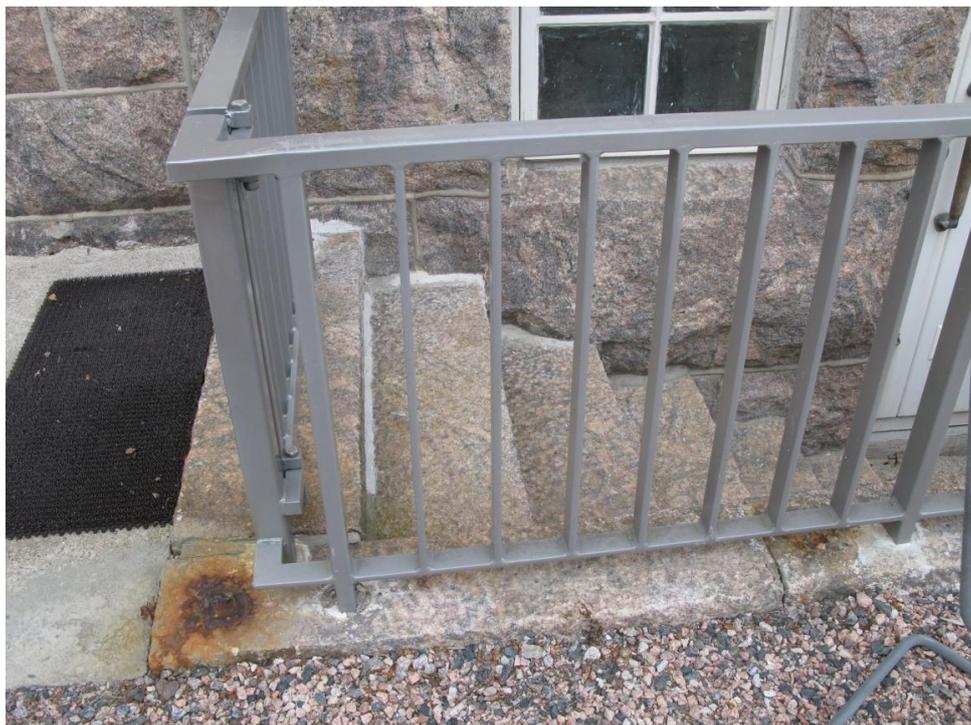
Figure 6. Metal/rustiness deposition over the blocks, probably in correspondence of previous metal fence. (Photo: N.Luodes, GTK)

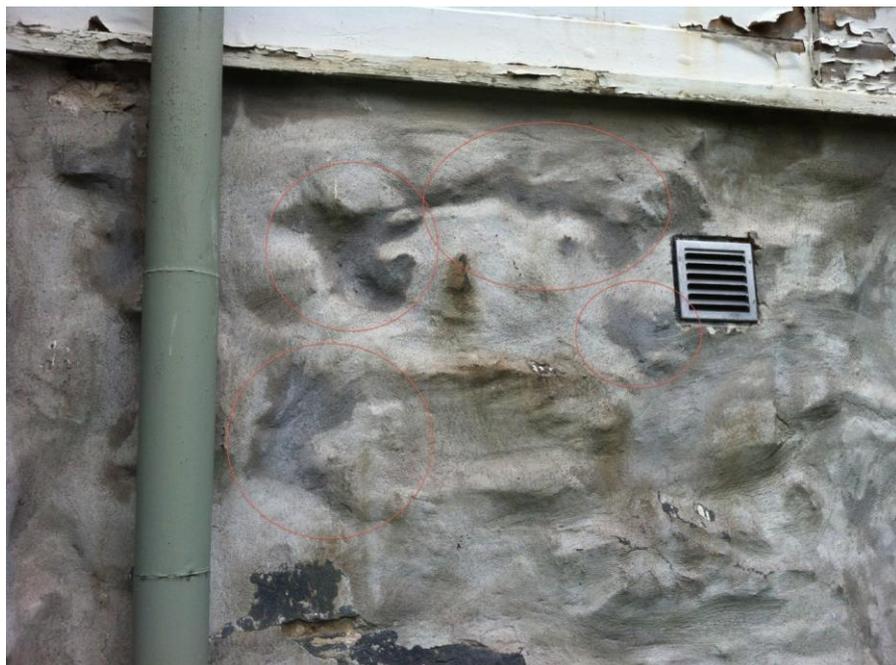
Figure 20. Humidity visible during visual inspection shows up also by thermal analysis as warmer areas between the rocks (Photo. A Shkurin)

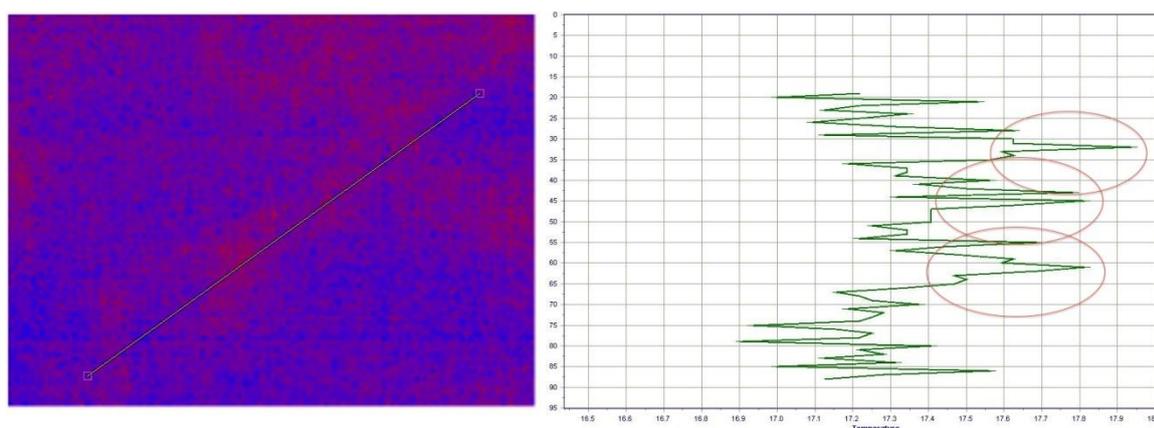
Figure 21. Higher temperatures are shown in correspondence of the mortar joints between the rocks of the basement, showing different behavior of the two structural components.

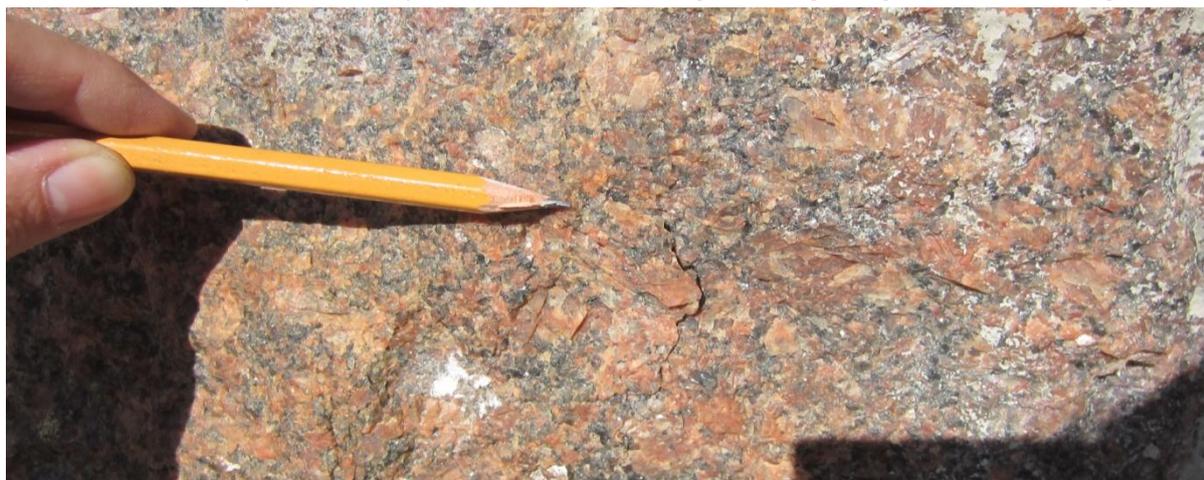
Figure 20 Granit block of dry dock showing a starting of chipping weathering.

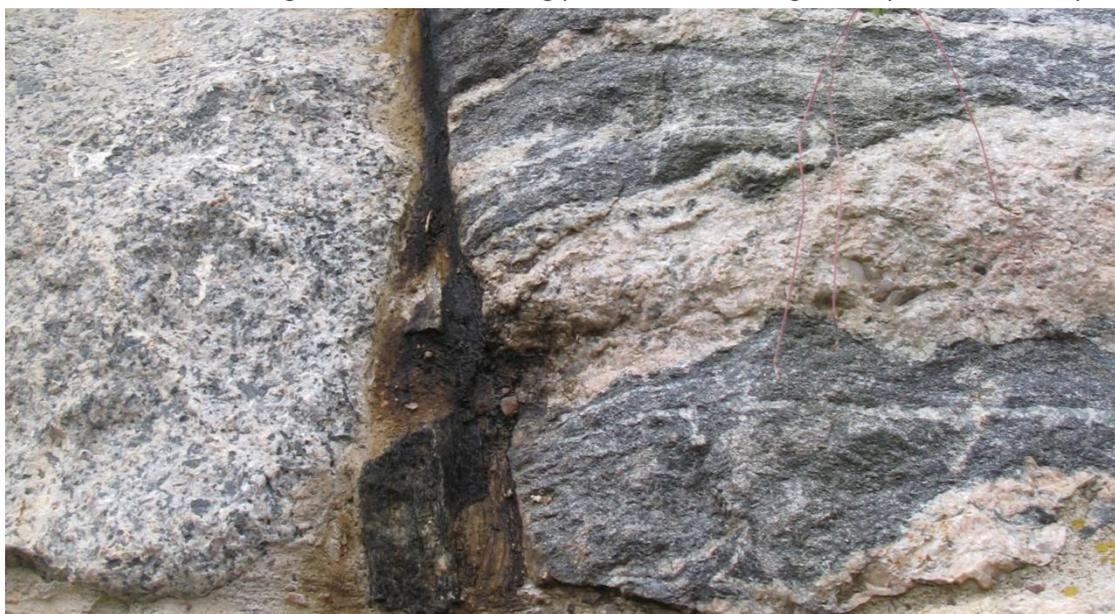
Figure 21 Example of granular disintegration by potassium feldspar in a gneissic rock (Photo: H.Pirinen)

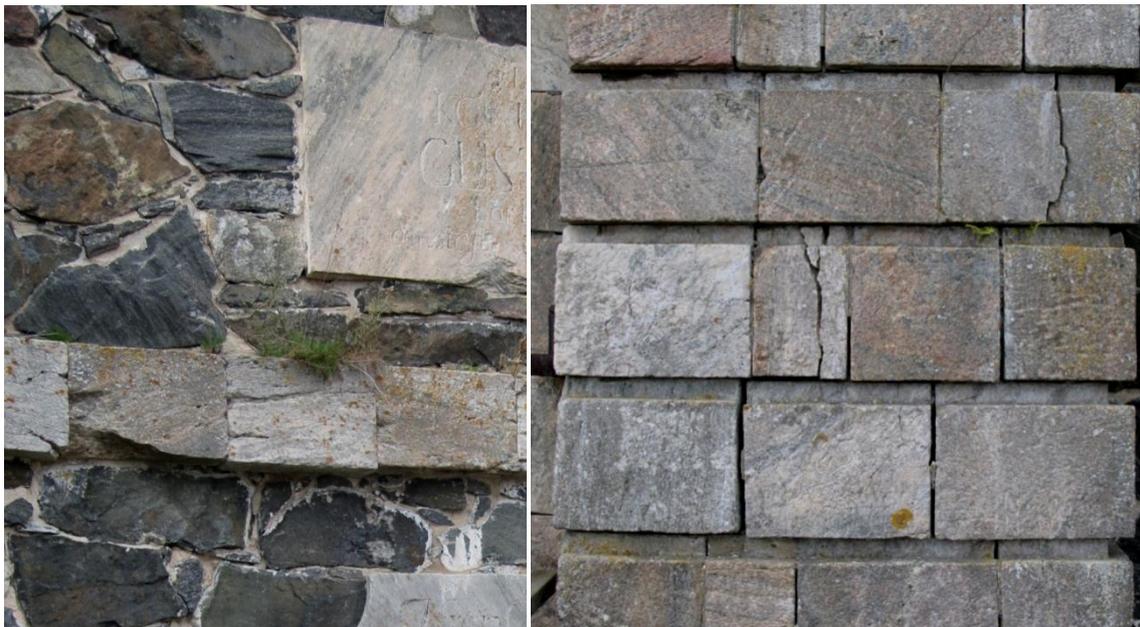
Figure 22. The king's port presents two kinds of materials used: the split blocks and the shaped limestone. The limestone bricks show fracturing along the layers caused by material deterioration. (Photo: P.Härmä, H.Pirinen)

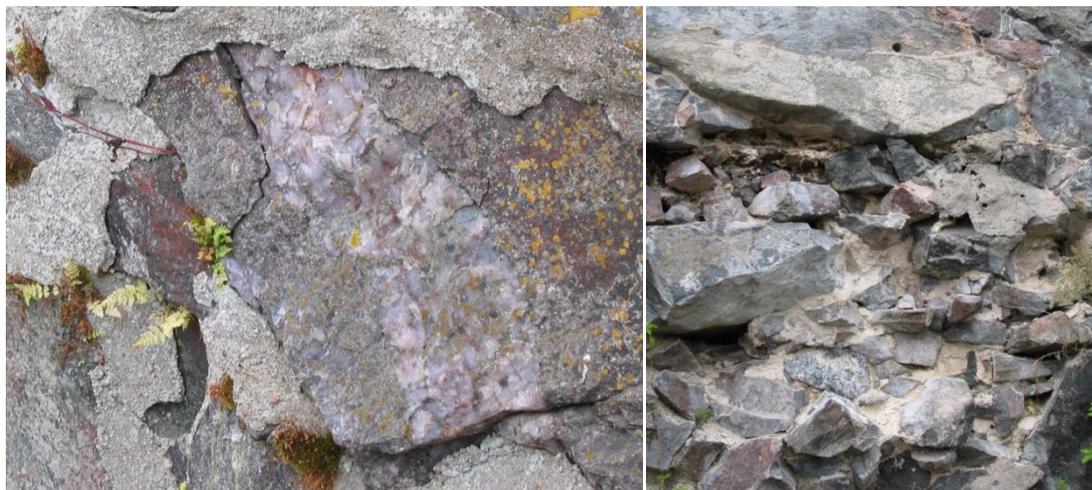
Figure 24 Crack on the corner of a stone on the left, and loss of outer part of a wall on the right.

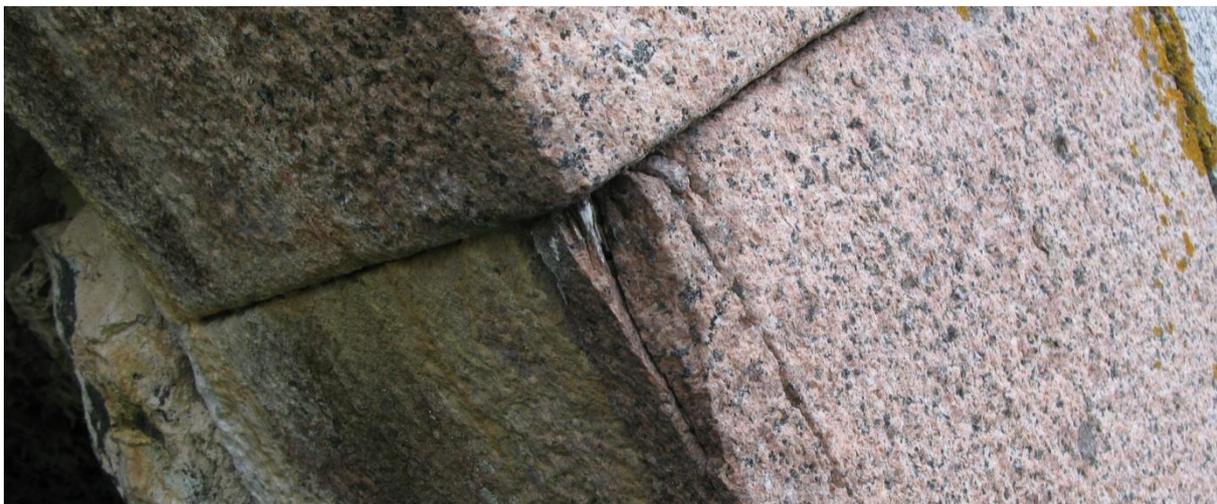
Figure 26 The granite block of the arc present a fracture that could had been cause by structural deformation, being in the compressed part of the arc.

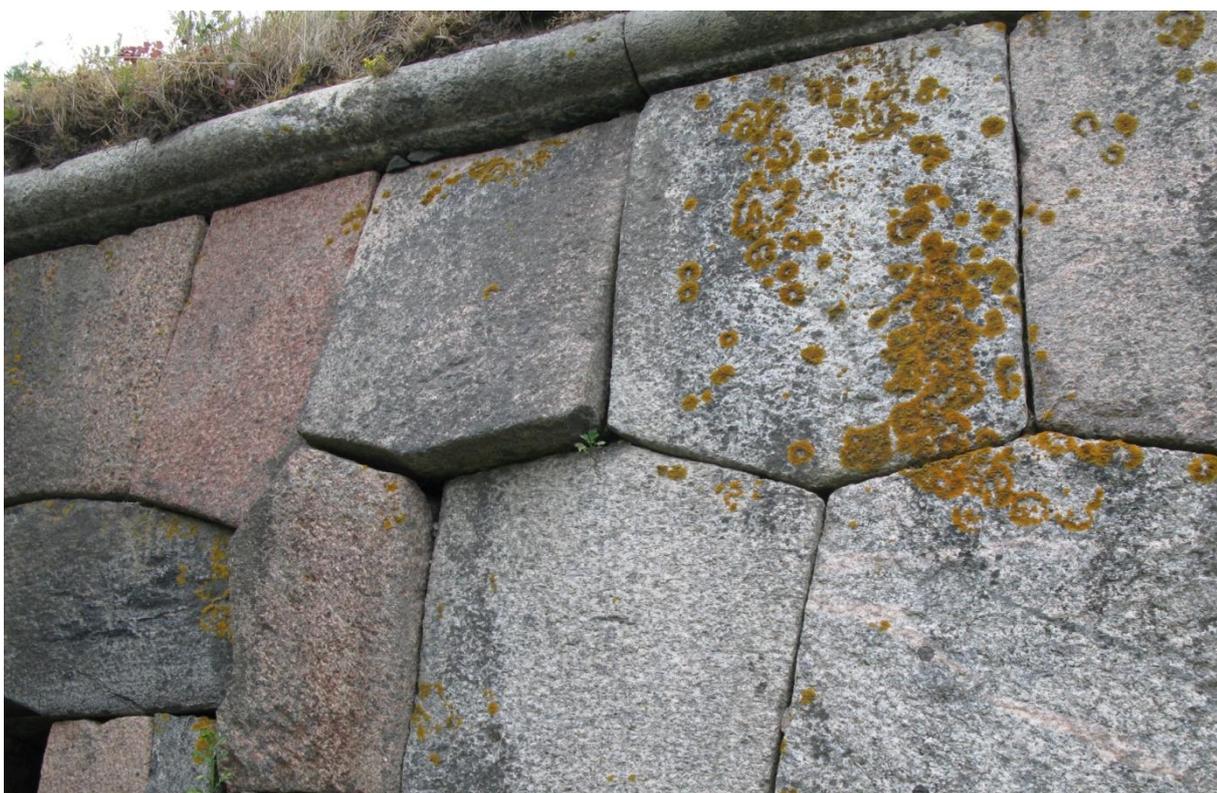
Figure 27 Dislocation of a block caused by the pressure of the terrain (Photo: N.Luodes)

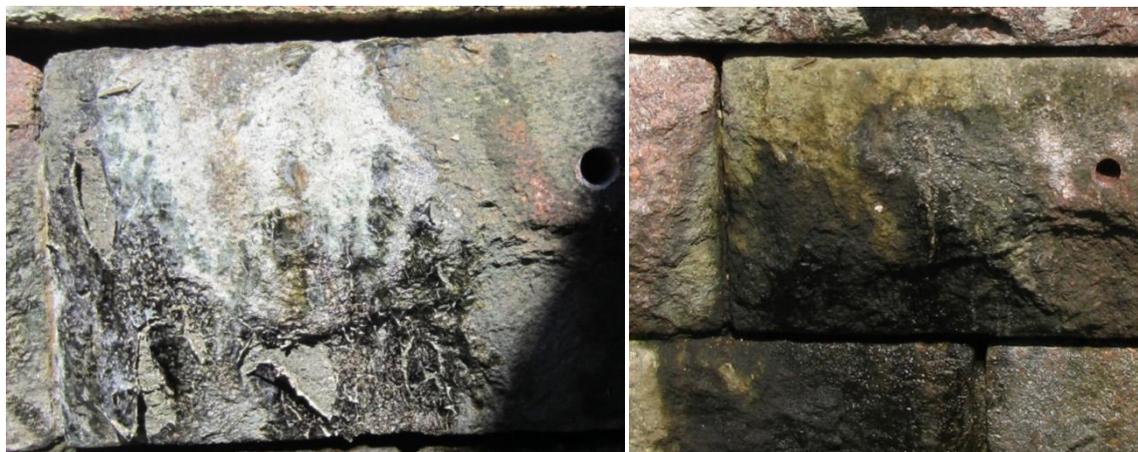
Figure 28 Block of the dry dock in dry and wet conditions presenting growing of biofilm/seaweed

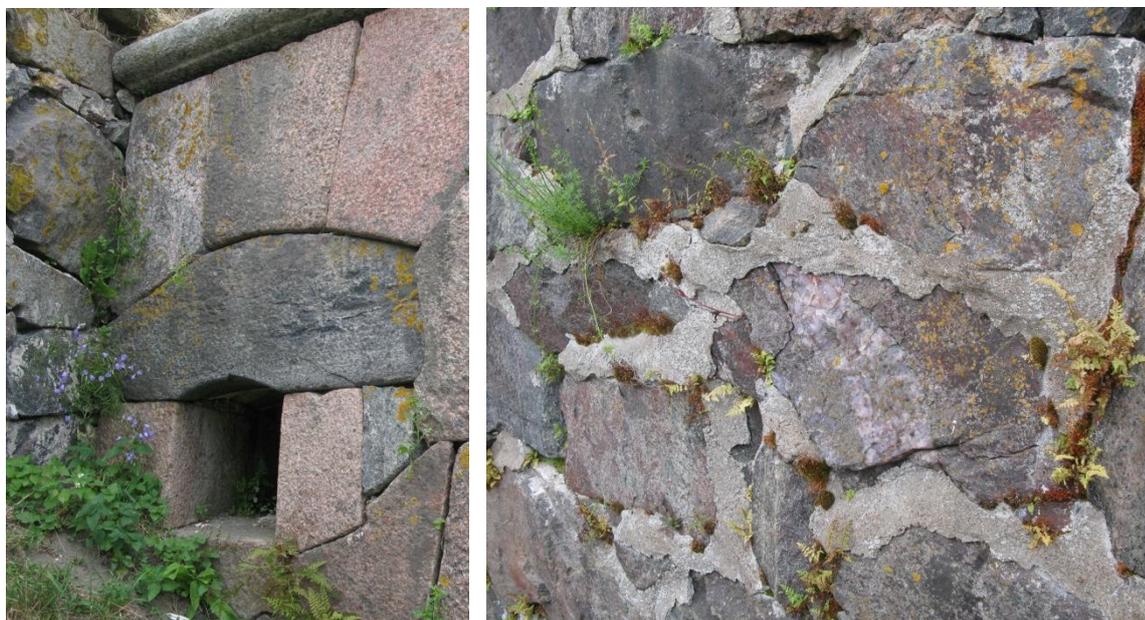
Figure 31 Mosses and higher plants growing on the wall in front of the Walhalla restaurant and on an upper wall facing the dry dock. (Photo: N. Luodes, H.Pirinen)

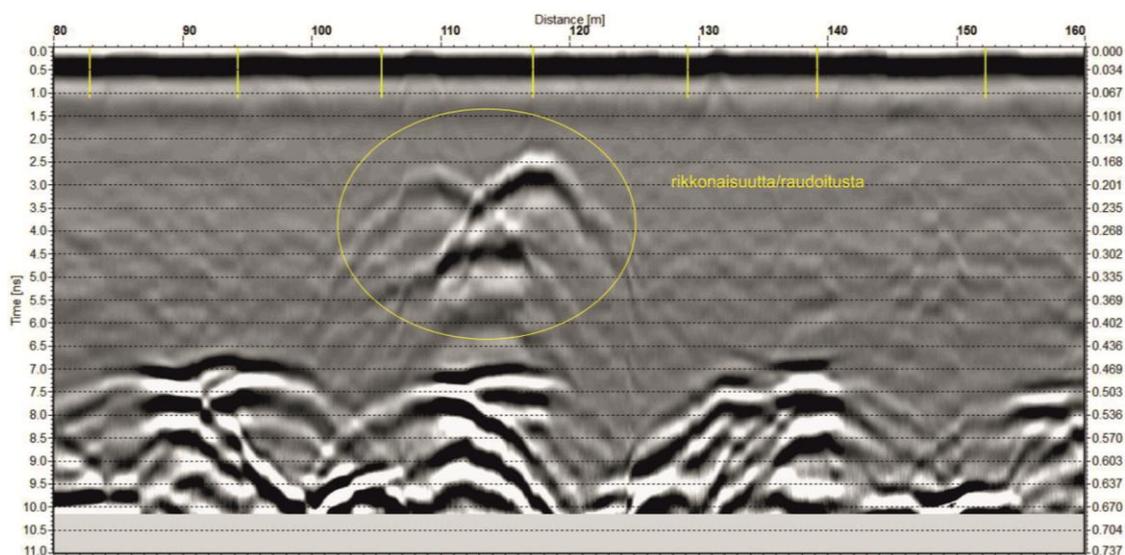
Figure 72 Block n.9 showing high reflection, probably due to a metal anchoring.
