Use of natural stone and stone construction

Ilkka Paajanen, Senior Lecturer, Architect, Saimaa University of Applied Sciences
Martti Muinonen, Senior Lecturer, Architect, Saimaa University of Applied Sciences

This report is a part of the project "Efficient use of natural stone in the Leningrad region and South-East Finland". The project is co-funded by the European Union, the Russian Federation and the Republic of Finland.

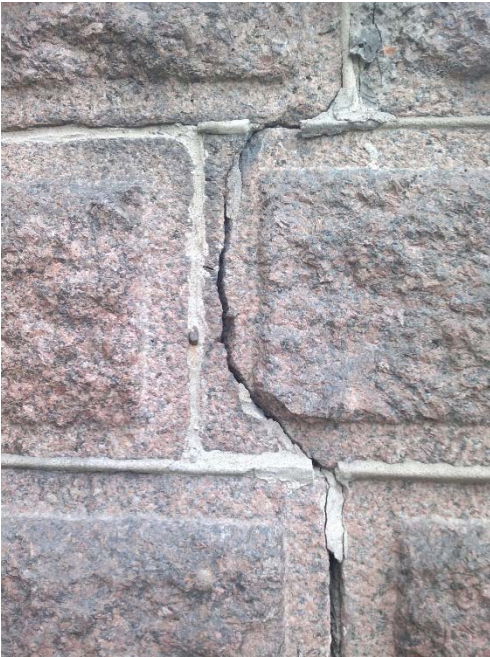
(Paajanen, 2014.)

Cracks are clearly visible to the naked eye, but they may be small hair cracks, various crack networks or major fractures. Cracks may also be caused by, for example, rusting iron supporting structure within the stone. Deformation includes various forms of bending or twisting of the stone, which is typical of marble structures. (ICOMOS 2010, 10 -15.)

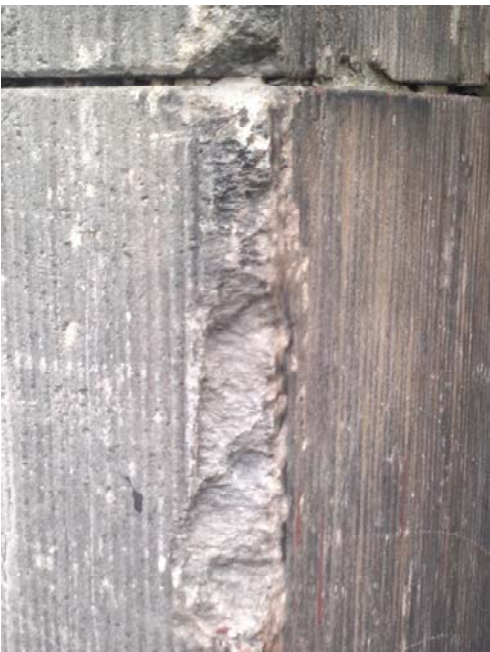
(Paajanen, 2014.)

Detachment includes various instances of detachment of the outer layer of the stone, local crater-like detachments caused by internal pressure, detachment due to the layered structure of the stone, detachment of single grains and various types of detachment even large-scale detachment caused by

external pressure. Detachment may be caused by salts, water and different mechanical strains. (ICOMOS 2010, 14 – 27.)

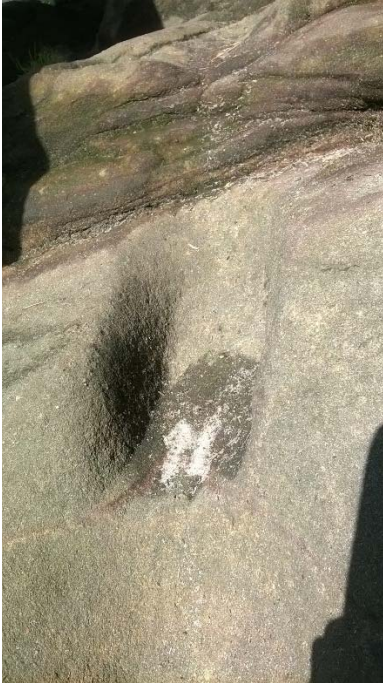
(Paajanen, 2014.)

Material loss may be caused by, for example, erosion and various mechanical damages. For example, a wrong kind of sealant may cause detachment in stone. Erosion can be caused by various chemical, physical or biological processes. Damage caused by erosion is typical of various types of sandstone. Mechanical damage is to a very large degree caused by people either by impact or by simply wearing down the stone (for example, on floors and thresholds). One group belonging to this class is "missing part", in other words clearly missing parts of structures, sculptures, etc. which they have possessed earlier (for example, an arm broken off from a statue). (ICOMOS 2010, 28 – 41.)

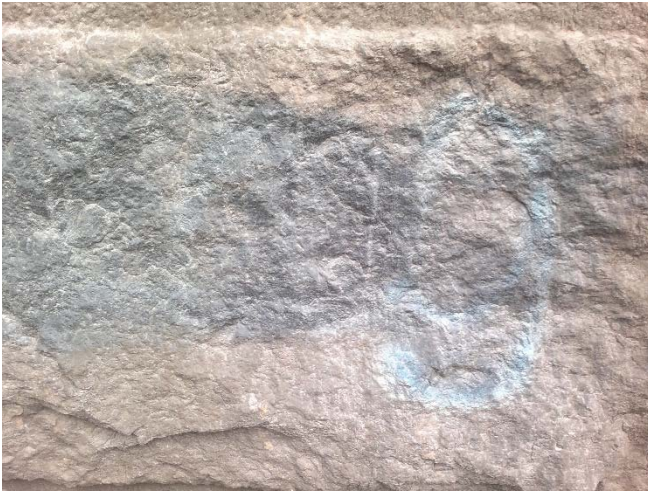
(Paajanen, 2014.)

Discoloration & deposit may include exogenic deposits of colour or discoloration of the stone's own colour, hue of the colour or colour chroma. Exogenic discoloration is encountered particularly much in urban environments on surfaces that are not rinsed clean by rainwater. Air pollution also causes discoloration of the surface. Especially salts, corrosion of metals, fungi and other bacteria as well as fires may cause discoloration. This group also includes various measures or phenomena creating a thin film on the surface of the stone (for example, graffiti protection) or (inadvertent or deliberate) polishing of the stone surface (for example, people leaning on a stone parapet and thus causing the polishing effect). Human-made graffiti are also classified to belong to this group. (ICOMOS 2010, 42 – 63.)

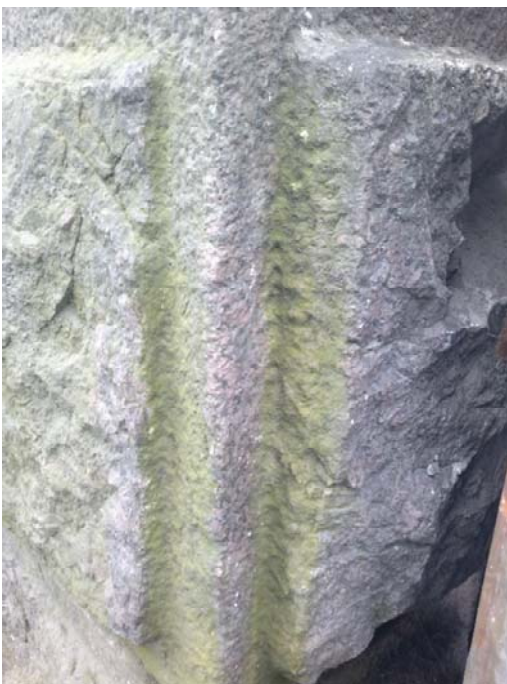
(Paajanen, 2014.)

Biological colonisation includes phenomena caused by plants growing on stone but also bacteria, fungi and other corresponding sources. Detrimental effects caused by these vary from changes to external appearance to detachment caused by larger plants. (ICOMOS 2010, 64 – 75.)

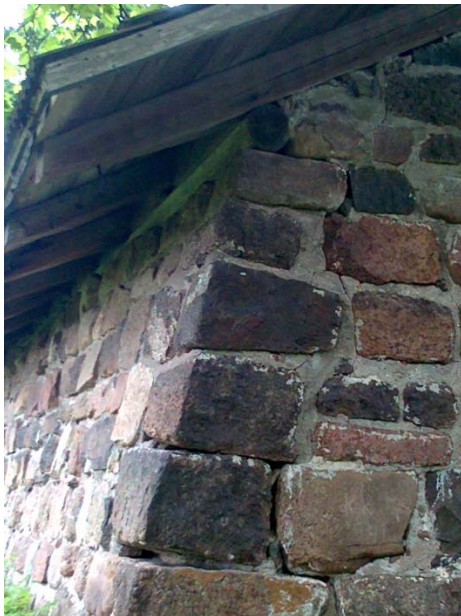
(Paajanen, 2013.)

Solid stone structures are based on the use of thick, heavy and massive stones often piled on top or next to each other. The stones may be attached together, seamed or not seamed, bonded or not bonded. In solid stone structures, the shape and surface treatment of the stones may be reasonably free. With regard to structural engineering, the stone structures are supported by their foundations or foundation soil and withstand compression. Structural-physical behaviour of solid stone structures is clear and uncomplicated. As a rule, solid stone structures can only be used in cold and external structures due to their thermal conductivity.

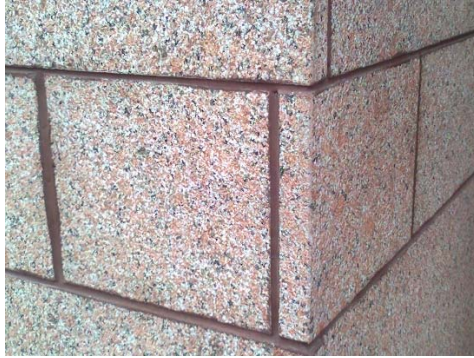
(Paajanen, 2013.)

Curtain or layered structures are based on use of thinner and smaller stones, often stone panels in layered structures. In this case, the stone panels are a separate structural layer, or a "weather wall" of the structure, often a curtain wall structure with ventilation opening. The stone panels will be attached with various mounting methods to the actual main structure bearing the load. As a rule, the mounting takes place with metal fixtures and mortar/glue mounting based on various systems. The seams of the stone panels are finished with elastic sealing compound. Consequently, curtain stone cladding is used in different circumstances than solid stone walls and the temperature and humidity conditions on the external and internal surfaces of the stone slab vary.

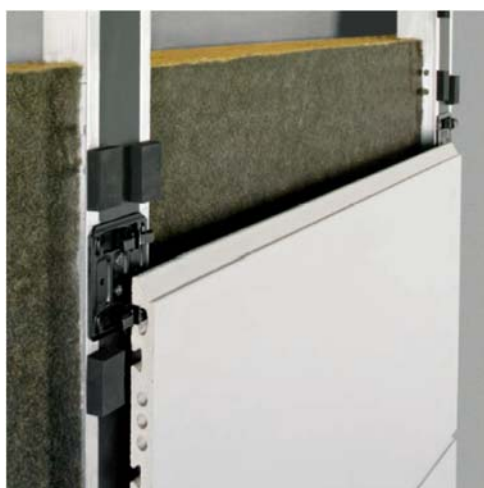
Pictured above the structural principle of a ventilated exterior ceramic wall with added insulation used in reconstruction. (ABL, 2014.)

Light and ventilated facade structure with exposed joints is also well-suited for reconstruction. If added exterior installation is used in reconstruction, it is safest to attach it in a traditional manner in the frame structure of the stone facade. Especially in Finland, the exterior surface of the added insulation must be weather-proof and moisture permeable.

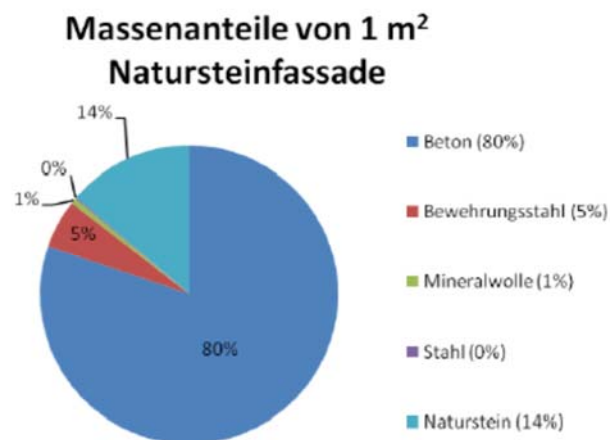
(DNW, 2014.)

The stone facade structure is traditional ventilated exterior wall structure supported by load-bearing concrete wall, the structure of which is presented below.

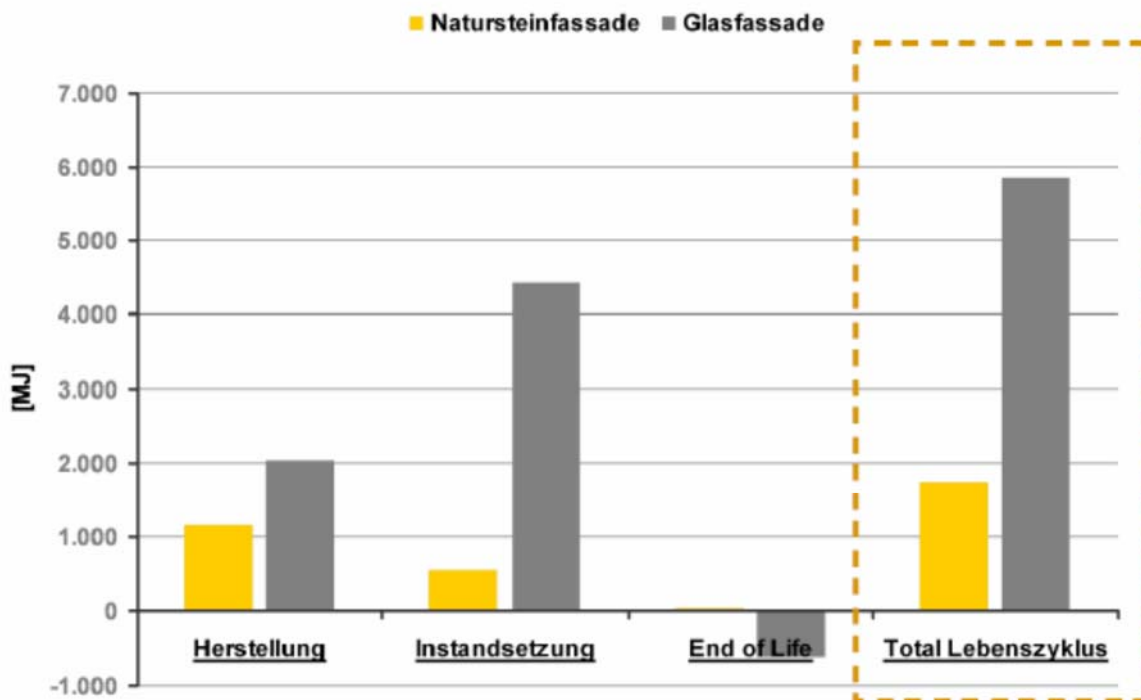
(DNW, 2014.)

With regard to consumption of primary energy, the results showed that the energy costs of the glass-aluminium facade were approximately three times higher than those of the stone facade. The environmental impact of the glass-aluminium facade exceeded those of the stone-concrete facade by approximately 360%. Naturally, the architectural style of the buildings was very different as well.
