Efficient use of natural stone in the Leningrad region and South-East Finland

SOUTH-EAST FINLAND - RUSSIA ENPI CBC PROGRAMME

Granite in SPb and Helsinki architecture

Stability of a stone in the city environment

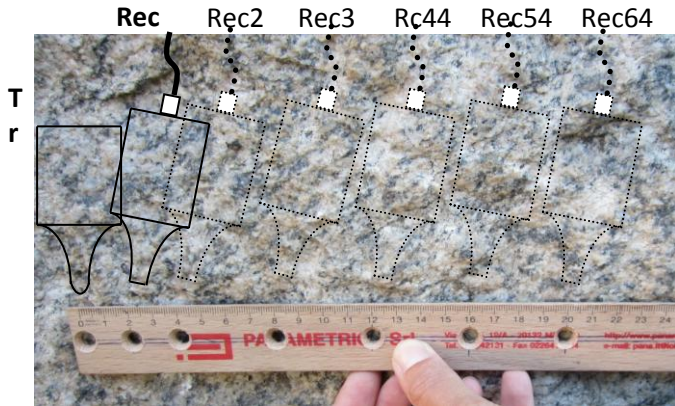
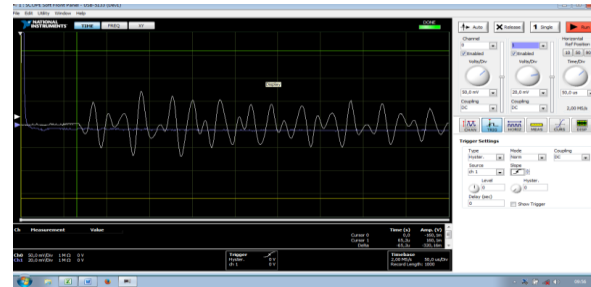
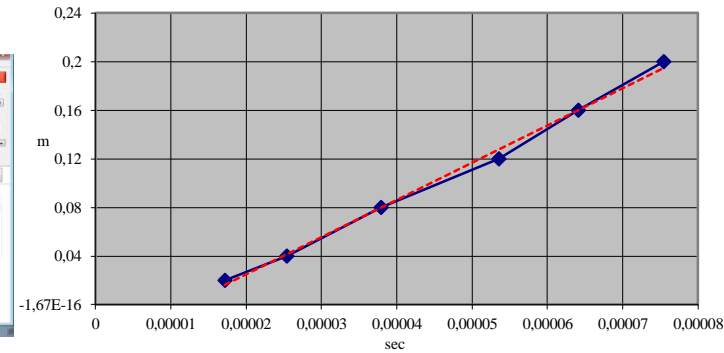
The evaluation of ultrasonic velocity in a stone material has been used in order to evaluate possible sign of weathering on site. The method according to EN 14579 (2005)

RESULTS: changes in speed caused by surface cracks and oxidation level. In the boulder blocks results affected by weathering

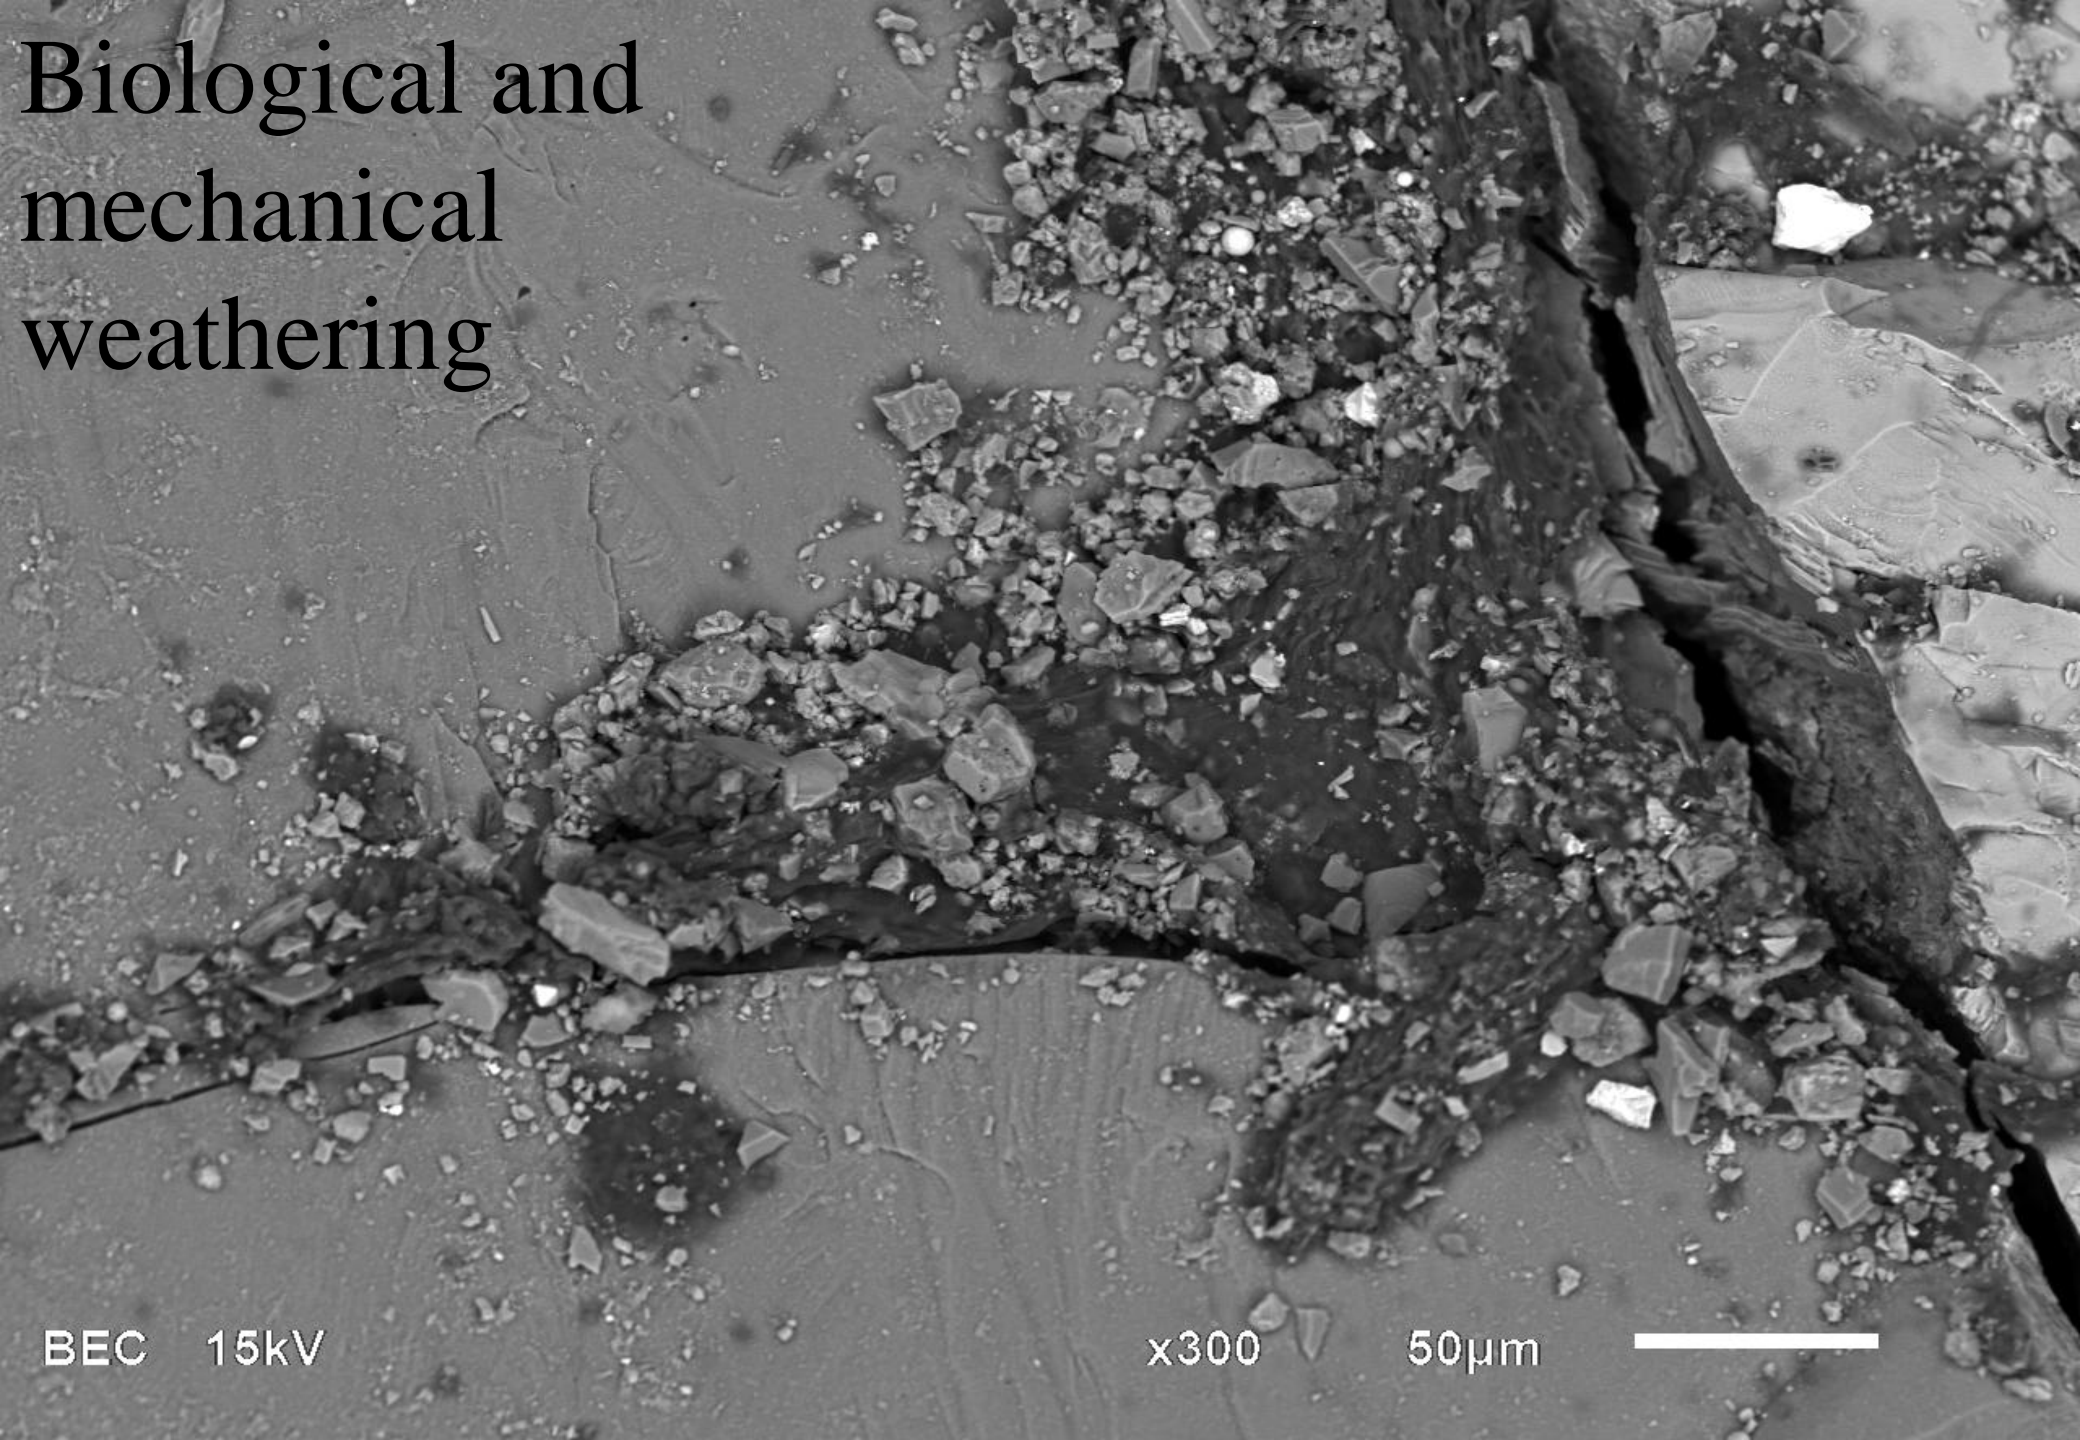
Biological and mechanical weathering
