**SOUTH-EAST FINLAND - RUSSIA ENPI CBC PROGRAMME 2007-2013**  
**Efficient use of natural stone in the Leningrad region and South-East Finland**

## Site Inspections

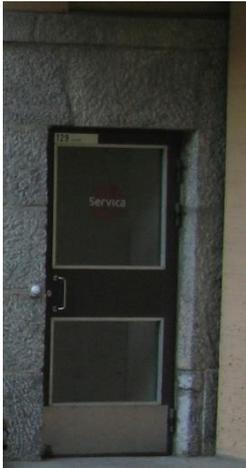
The structure has been renewed as visible from comparison with old photos with the addition of a porch in the façade facing the yard reaching about 3m height. The façade facing the park on the West presents a light concrete structure, functioning as storage and an entrance had been created from a window opening splitting on site the stone blocks as visible from Figure 4.

Figure 4. Particular of the door created from a window. (photo N.Luodes, GTK)

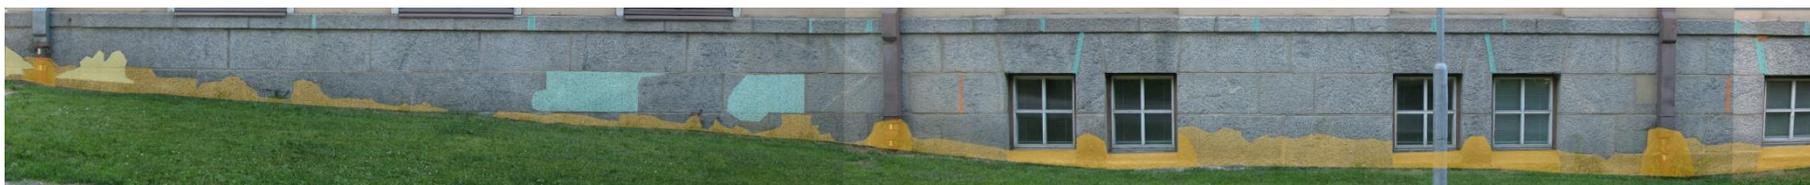
Figure 7 . Example of Map of the damages

Color coding:

Light blue-changes of color both from anthropogenic origin and natural weathering;

Dark orange lines: cracks

Overall the wall present only limited elements of deterioration but some of them are diffused along the whole basements, as atmospheric particles deposition and fixation.

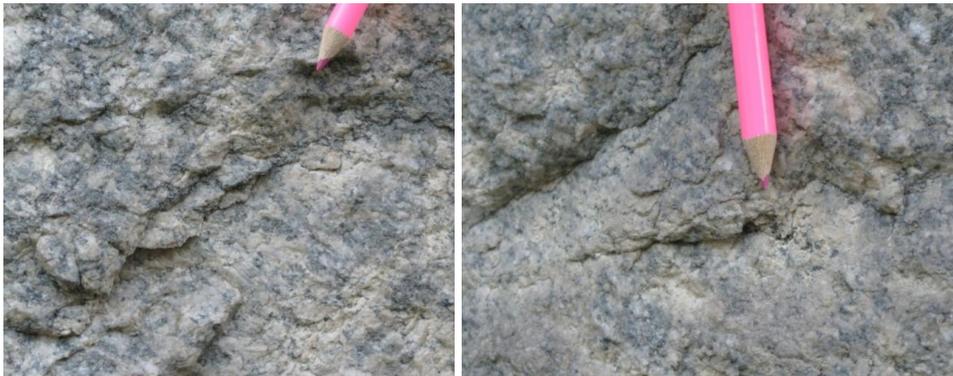
Hollows are not recognized but chipping it is noticed, as form of de-cohesion of some parts of the surface, more than single crystals or mineral grains. An example is shown in Figure 8.

Figure 8 Decohesion of some element of the surface, chips or pieces of about 5mm have tendency to detach when the surface is touched.

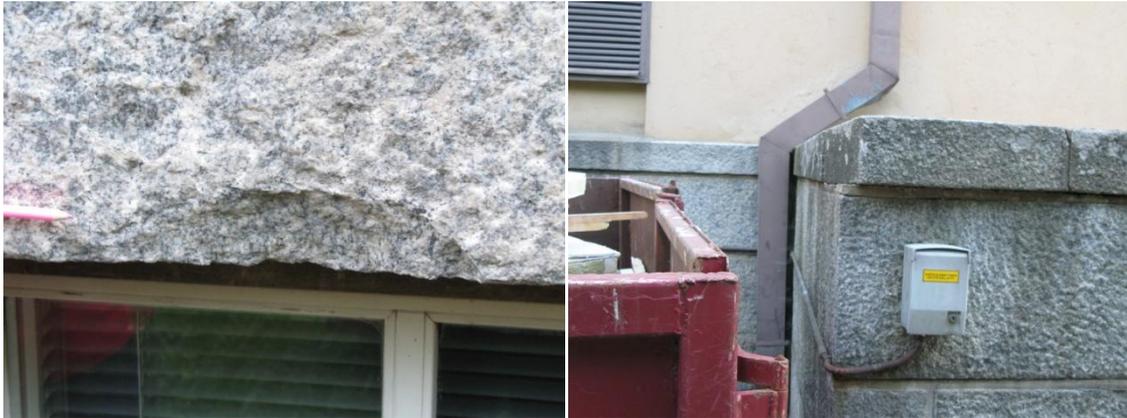
The stone elements of the façade show some cracks attributed to anthropogenic actions derived by possible impacts against the structure over a window on the left of the entrance stair and over the corner of the stair (Figure 9).

Figure 9. Missing part over a window, stair parapet's block moved by an impact action.(Nike Luodes, GTK)

Not high deformations of the structures that would represent a risk for stability of the building have been recognized but some fractures had been caused by structural movements as visible from Figure 10. Impact against the structure has been relevant in deforming the stair structure as visible from Figure 9 and Figure 11 where a block of the stair has been dislocated.

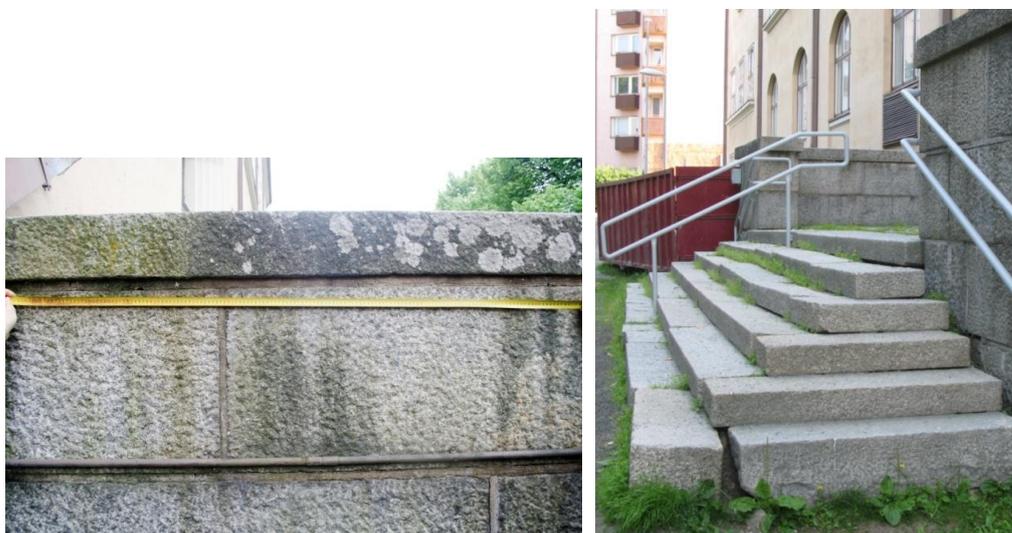
Lichens can be seen mainly on the stair's wall facing North on its inner-outer and upper surface (Figure 11). Samples had been taken in correspondence of the lichens on this wall (Section 1.4.1).

Figure 11. On the left: Stair's wall facing North showing presence of lichens and biofilm. On the stairs, on the right, is visible presence of higher plants (and dislocation of steps by anthropogenic origin)

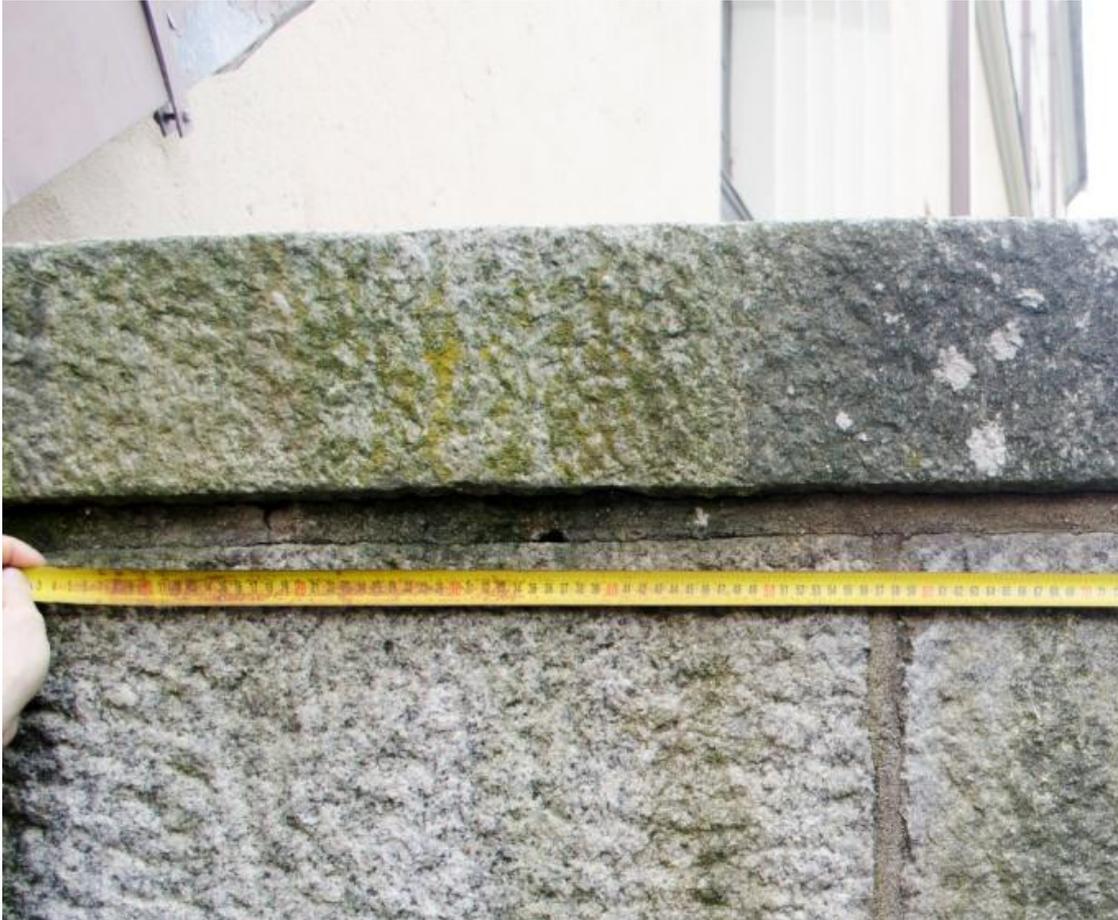
On the wall facing north on the stairs can be a diffused biofilm even if its composition has not been studied (Figure 12 is an enlargement of Figure 11).

Figure 12. Biofilm and biological colonization on stairs parapet facing North.

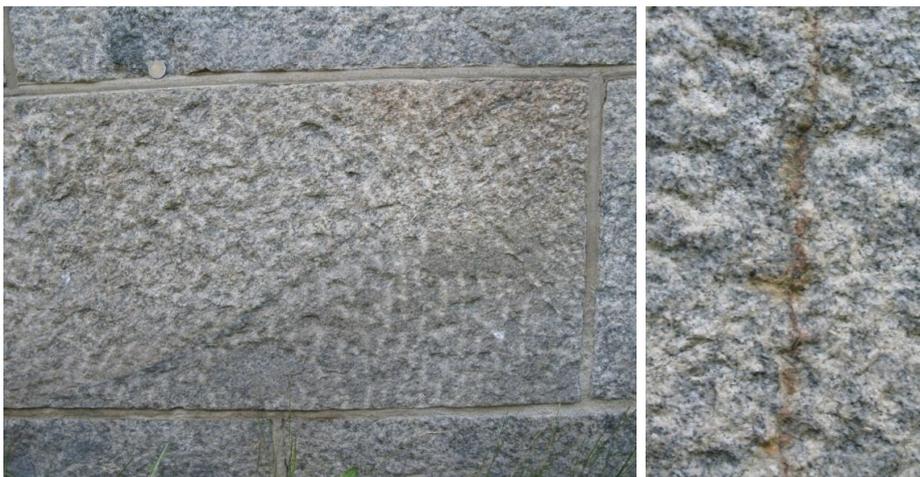
Changes of color determined by weathering of the material are visible on some blocks. Especially one shows rusting of minerals along a fracture of the material given by some sulphuric iron minerals (Figure 14), probably pyrrhotite. While changes of color attributed to anthropogenic origin in correspondence of joints filled with mortar are mainly visible on the stone sill between the basement and the upper wall (Figure15).

Figure 14 Changes of colour given by original weathering of the block on the left, and by weathering of sulphuric iron minerals on the building site, on the right.

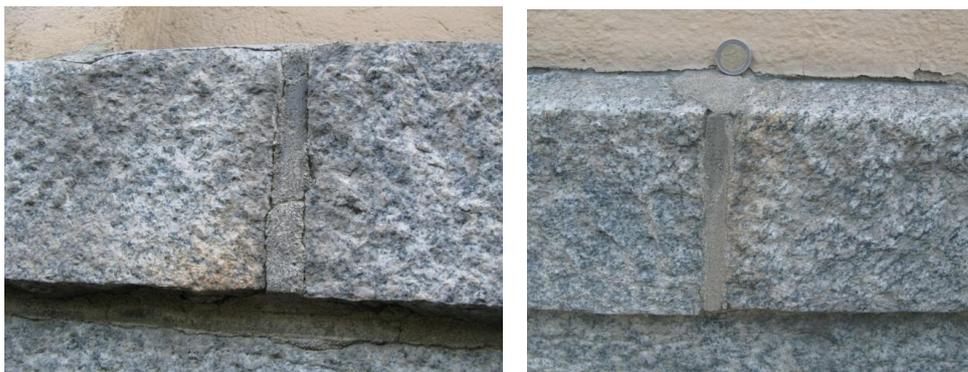
Figure 15. Changes of colour determined by migration of the salts of the mortar.

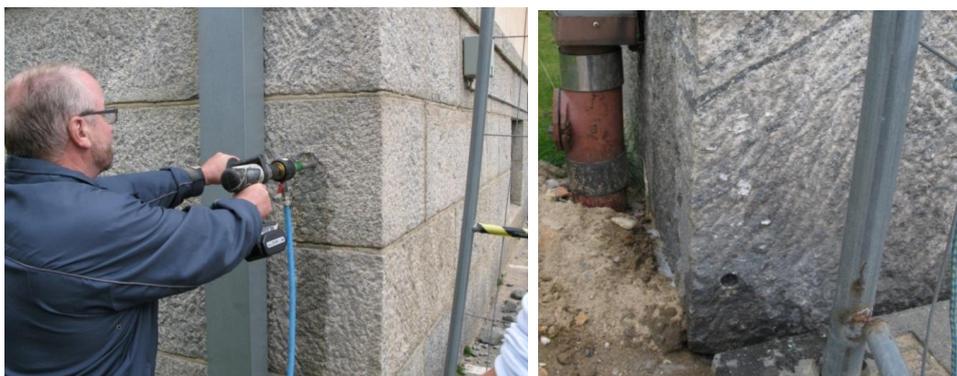
Figure 18. Drilling of sample Niiralan school 1 (on the left) - on the West façade on the corner with Valkeisenlampi- Not weathered material. Drilling of sample Niiralan school 2 (on the right)- it is on the South façade on the corner with the park. The surface is affected by atmospheric particle fixation. Material sampled on 17.8.2012. (Photo Heikki Pirinen)

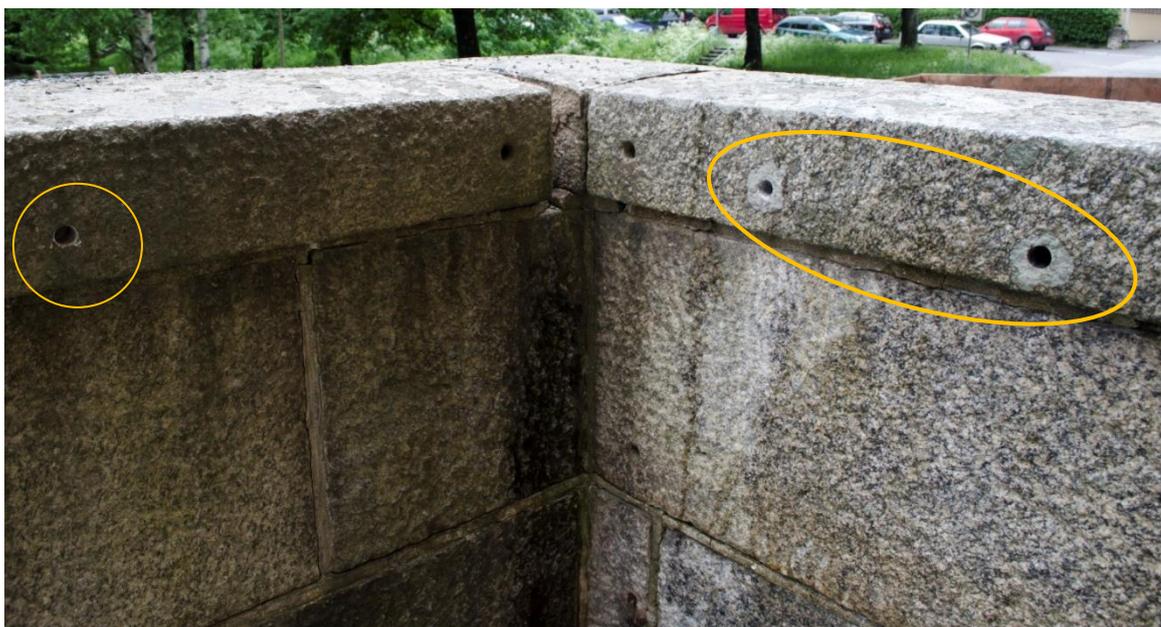
Figure 19. Drilling of sample Niiralan school 3 (on the right) and 4 (on the left) on the inner walls of the stairs parapet. On the surface of sample 3 was growing lichen, on that of sample 4 there was presence of dust fixation. Material sampled on 17.8.2012 and 2013. Photo Joonas Toivanen, GTK

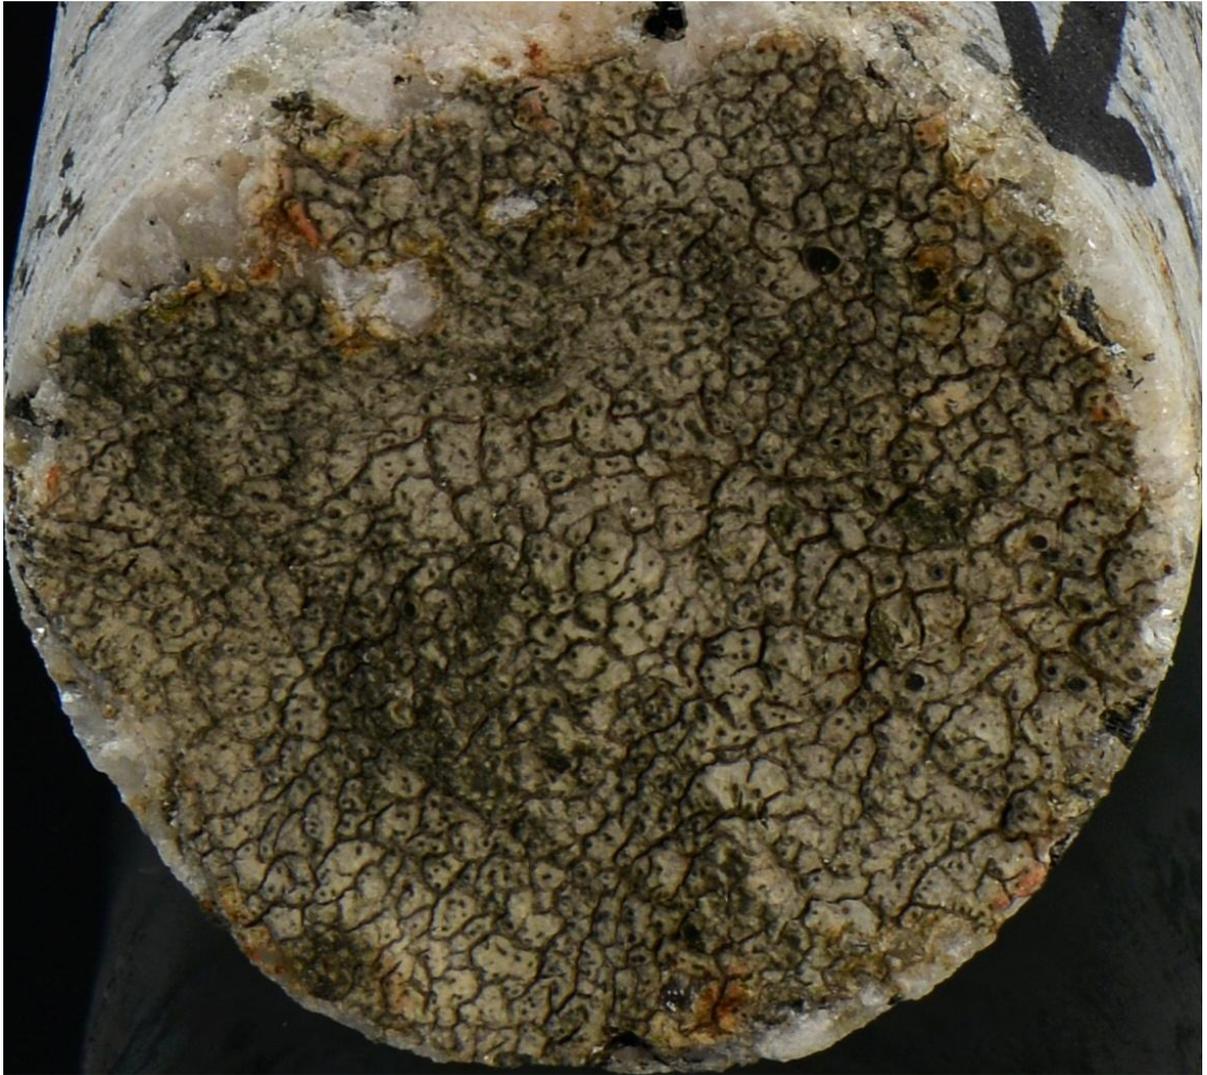
Figure 24 Detail of the surface of sample HAPŞ2012-25.3 cut over lichen on the stair parapet. The sample diameter in its section is 20mm. (Photo by Jouko Ranua GTK)

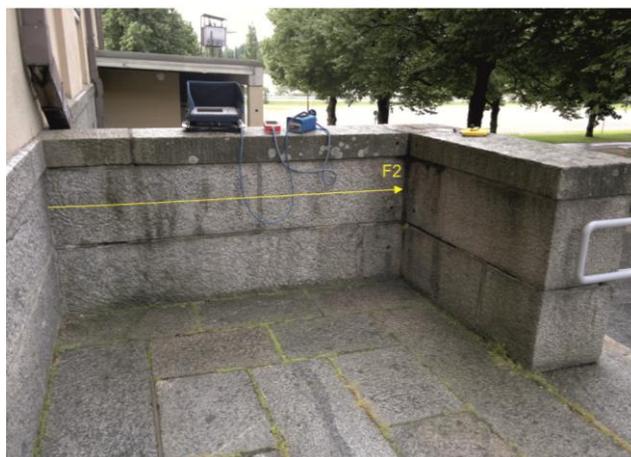
The parapet of the stair is composed by a three layer wall: a stone block of approximately 200mm in the inner side of the parapet, a part filled with loosen material and air and an external wall with block thick 200-300mm as visible from the radardgrams of Figure 30. The top of the radargram represent the surface of the wall over which the antennae has been placed.

Figure 31. Inner parapet wall on the stairs, showing the line F2 where GPR measurement using an antenna of 1600 MHz has been performed.

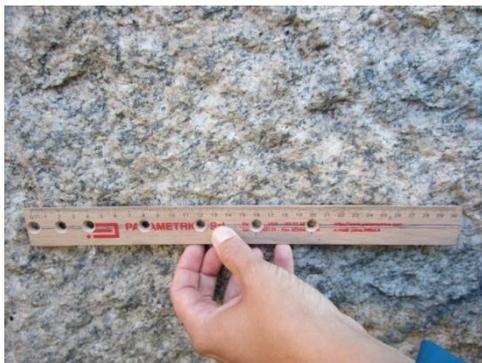
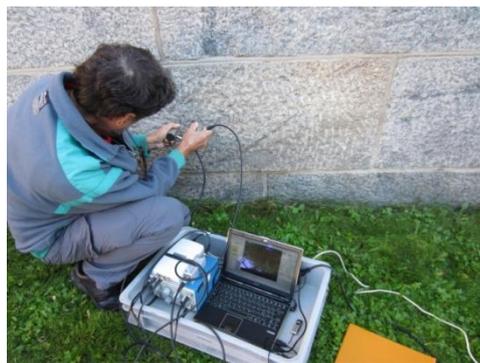
Block 6<sup>th</sup> (figure 37) presented a change in colour of the stone, more yellow than other blocks. Even though the weathering sign is diffused to the whole block and some parts of neighbour block it is reasonable to think that it is due to an original increased weathered area in the quarry. Velocity= 2549,01 m/s

Figure 37 Block 6<sup>th</sup> on the basement, placing of the rule to mark the measuring points and performing the measurements.

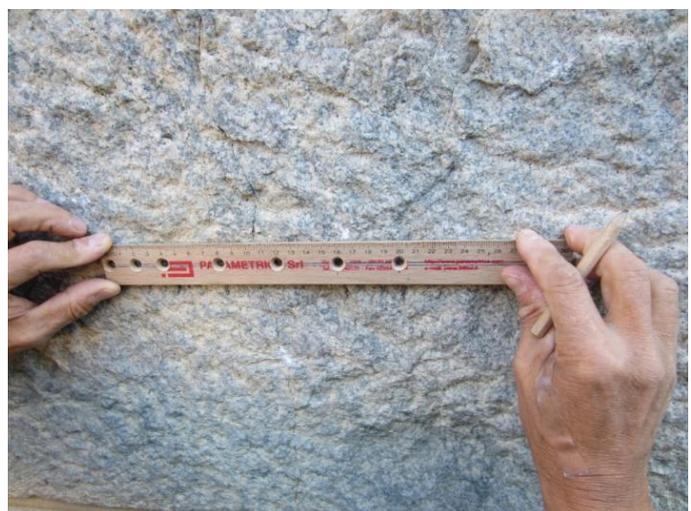
Block 10<sup>th</sup> presents a fracture and its average velocity= 2178,48 m/s. Reading after the third point was not possible due to the interference of the crack, so the velocity had been measured only from interpolation of the first three points.

Figure 38. On the right, block 10 on the basement of the school.

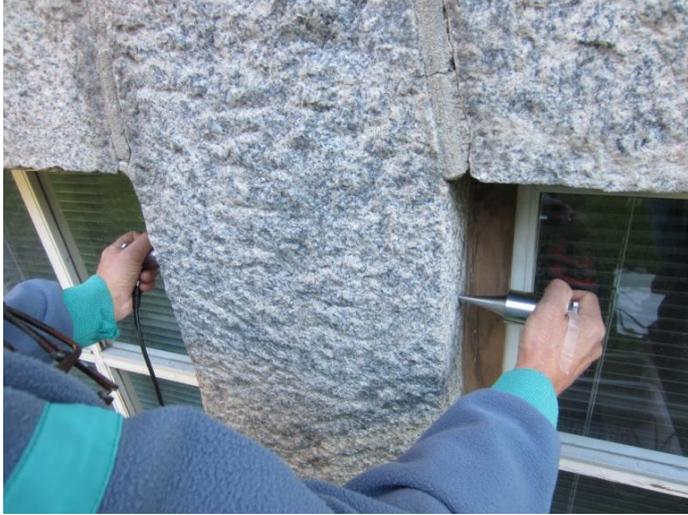
Figure 39. Measuring block 11<sup>th</sup>

Block 11<sup>th</sup> (Figure 39) presents fixed dust deposition-black crust. The UPV measurements had been performed as indirect measurements over the black crust and its velocity= $2619,074\text{m/s}$ , and as direct measurements on the column between two windows, with velocity= $4456,27\text{m/s}$  in the measuring points crossing a vein of biotite, while velocity= $3998,24\text{ m/s}$  in the measuring points located on an homogenous area of the stone.

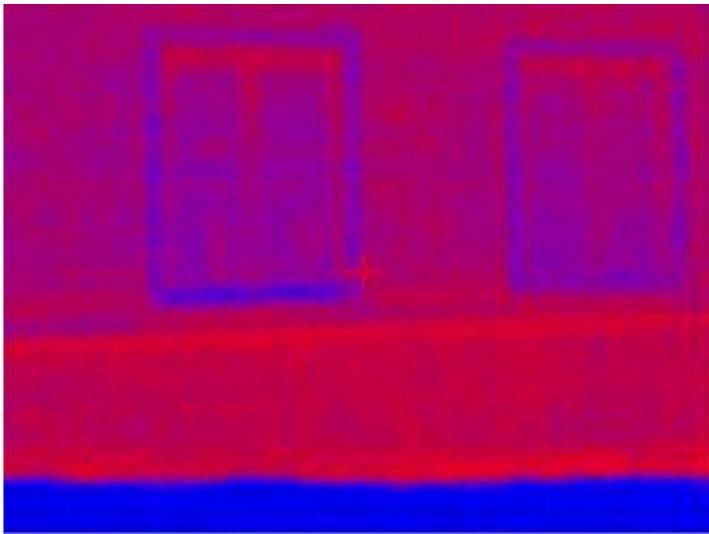
The façade overall show that the basement has higher temperature compared to the upper wall and this could be caused both by different thermal properties of the stone compared to bricks wall: the brick wall would be dissipating faster the heat gathered during insulating hours in the day time compared to the basement, and could also be cause by different insulation characteristics of the walls, since in the basement have probably not been used insulating materials, benefiting of the thickness of the layered structure. Figure 43 show this thermal difference.

Figure 43 Thermal image of a segment of the façade facing West. (Thermal photo by Aleksei Shkurin)

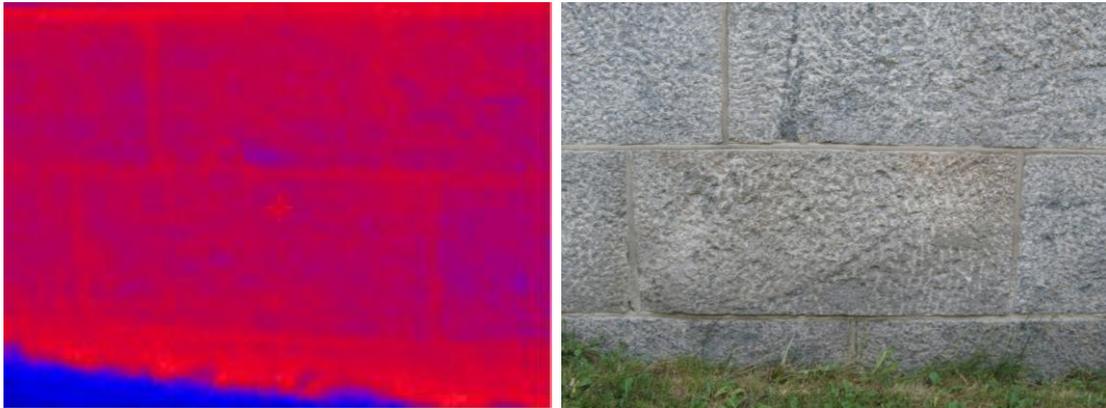
Figure 44. Thermal image and photo of the block that presents change of color given by original weathering- block 6. (Thermal photo by Aleksei Shkurin, Photo by Nike Luodes, GTK)

It is not visible a connection between changes of color given by different weathering and changes of surface temperature of the block. A black vein is visible as warmer compared to hollow areas of the same block.

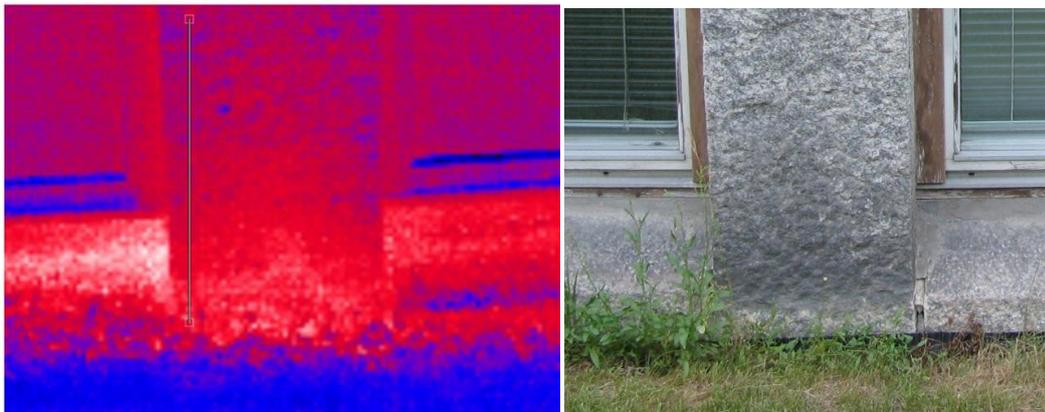
Figure 45. Thermal image and photo of the black crust between the windows. (Thermal photo by Aleksei Shkurin, Photo by Nike Luodes, GTK)

Higher temperature has been noticed over the black crust, probably caused by different thermal properties of covered and uncovered material or be influence of windows shape on air circulation.

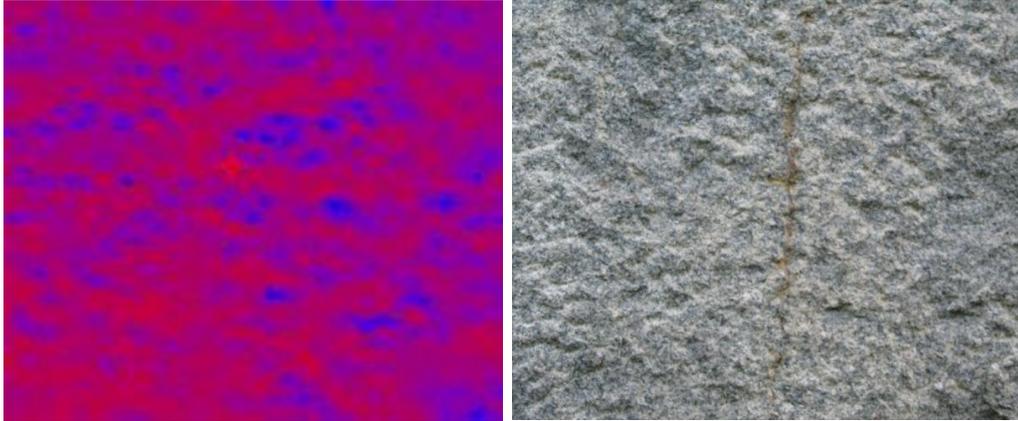
Figure 46. Thermal image and photo of the block presenting an oxidized mineral vein. (Thermal photo by Aleksei Shkurin, Photo by Nike Luodes, GTK)

It is not visible a strong change in thermal properties to allow the individuation of the vein, even though a change in mineral composition and structure could also imply a change in thermal behaviour of the material.

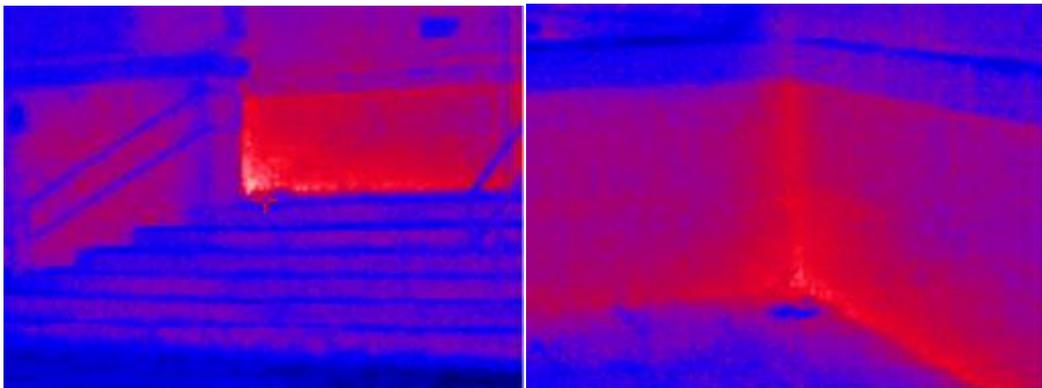
One of the hottest spot found on the building has been in correspondence of the corner over the stairs between the parapet and the brick wall of the building visible in Figure 47. The average temperature of the basement surface was around 13 °C while the average temperature of the basement near the stairs was around 16 °C especially in the corners, where the temperature was around 17 °C.

Figure 47. Thermal image of the stair and of the inner the corner between the brick wall and the parapet. (Thermal photo by Aleksei Shkurin)

The reason could be given by the fact that the area is protected from circulation of the air that otherwise would dissipate faster the heat emitted by the wall.

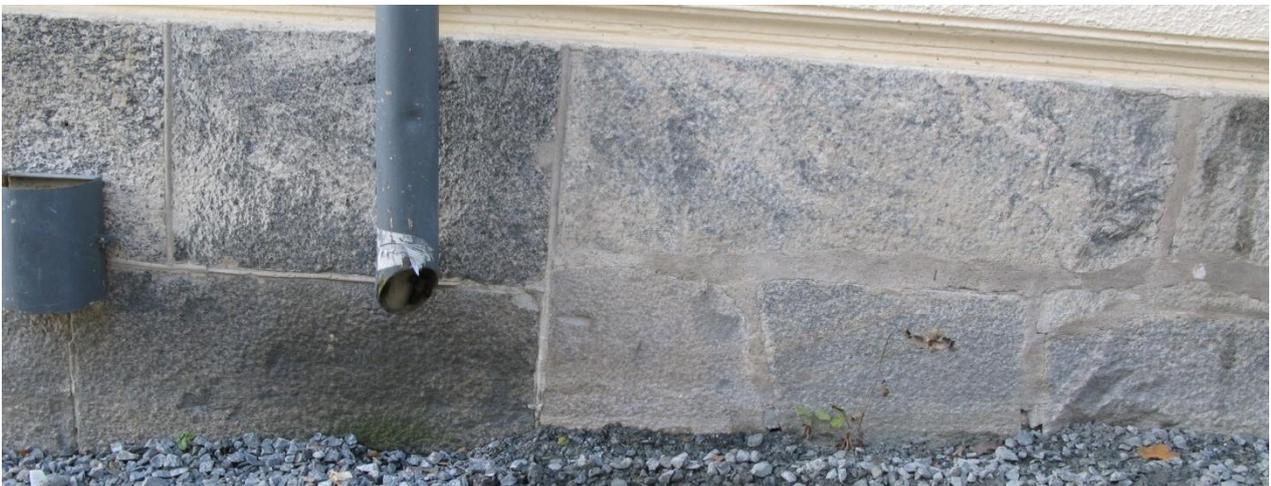
Figure 4. Puijonkatu- basement from the part possibly built in 1875 (on the right) and that constructed in 1885 (on the left) – enlargement n.2 and 3

On Figure 4 is visible that the old part constructed in 1875 (on the right) is much different from those constructed in the same years on the other sides (figure 3 and 2) and as material choice and finishing is more similar to the enlargement constructed in 1885. Different construction styles visible in Figure 4 are probably determined by the different uses of the basement (cold basement vs worm basement) but the material is the same.

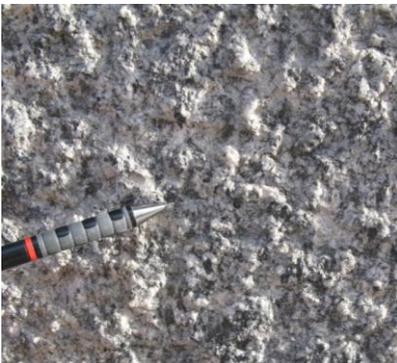
Also the surface of the blocks used in the latest enlargement in the courtyard have shown similar trend, as visible from Figure 12, where the chiseling marks are not visible anymore. The level of weathering has been lower than the one that affected the older part of the building and can be assumed that the weathering action has happened on site but probably has been due to cleaning operations, that gave a different impact on material that already presented different level of deterioration.

Figure 12. Block used on the inner yard and showing roughening of the surface.

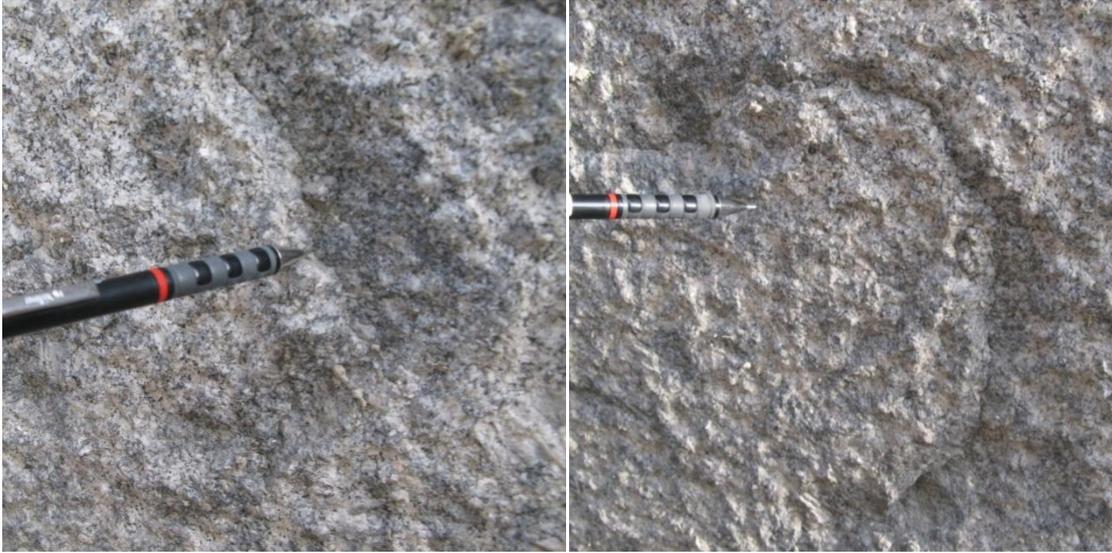
Hollows are recognized on the entire basement and in different forms depending on the stone kind. The newest part of the basement built as Ashlar masonry, used a granitic gneiss that showed in all the parts where has been used (inner yard, left and right wing) cavities of large dimensions that appeared to be detached according to splitting faces, as visible from Figure 14 and 15.

Figure 14. Two examples of formation of deepenings from the basement facing Hallikatu.

Both of the example shown in Figure 14 and 15 are on walls oriented to West, but same behaviour has been noticed also towards others orientations.

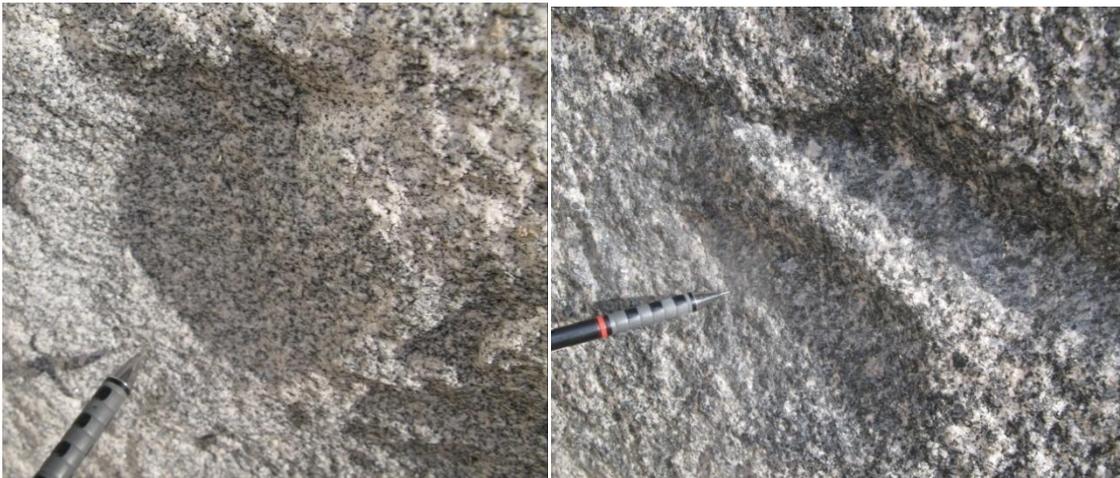
Figure 15. Two examples of formation of deepenings from the basement facing West in the courtyard.

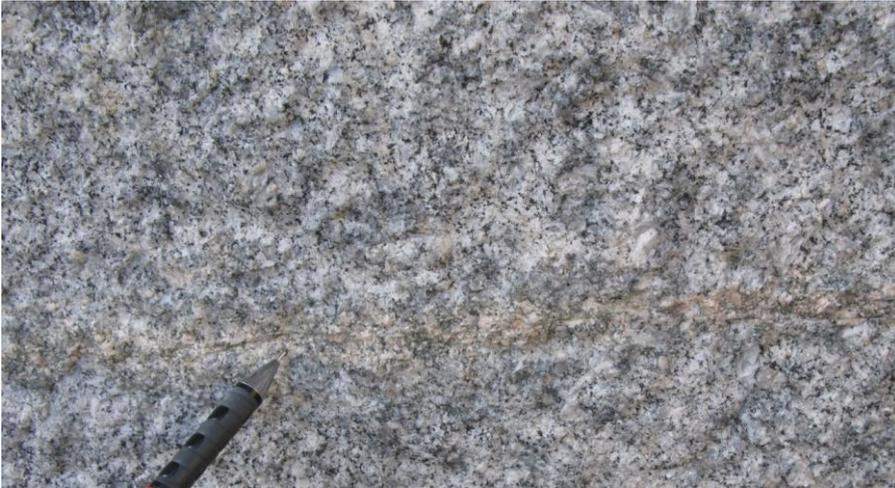
Fractured material has been noticed on some blocks used in the inner yard. The fractures are original of the deposit and have probably opened later on site, thanks also to the oxidation of some minerals, as visible from Figure 16.

Figure 16. Fracture original from the deposit where the block has been extracted and that has opened on site. Photo of a block used on the basement facing East in the inner yard.

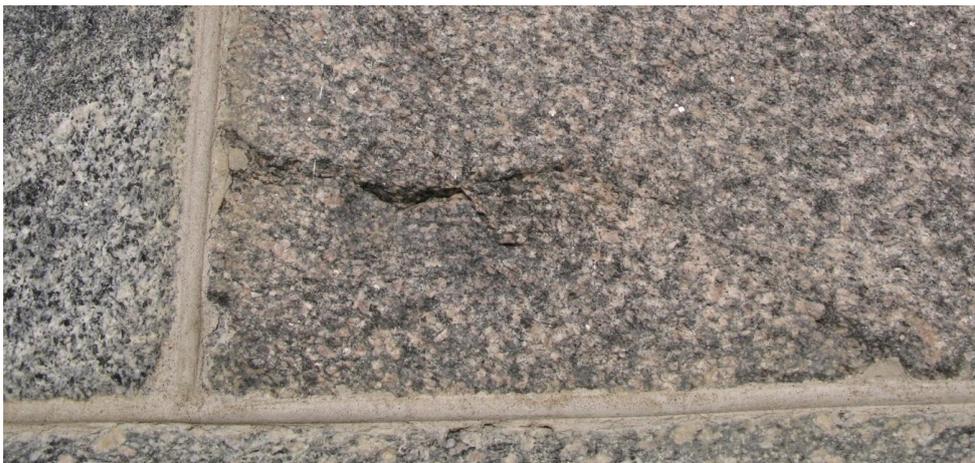
A crack probably given by anthropogenic actions is the one shown in Figure 17, in this case the stone has probably been subjected to an impact. The corner is also showing a natural plane over which a fracture has opened.

Figure 17. Fracture and scaling, probably given by a combination of actions: an impact and own tendency to fracture on a natural cleavage.

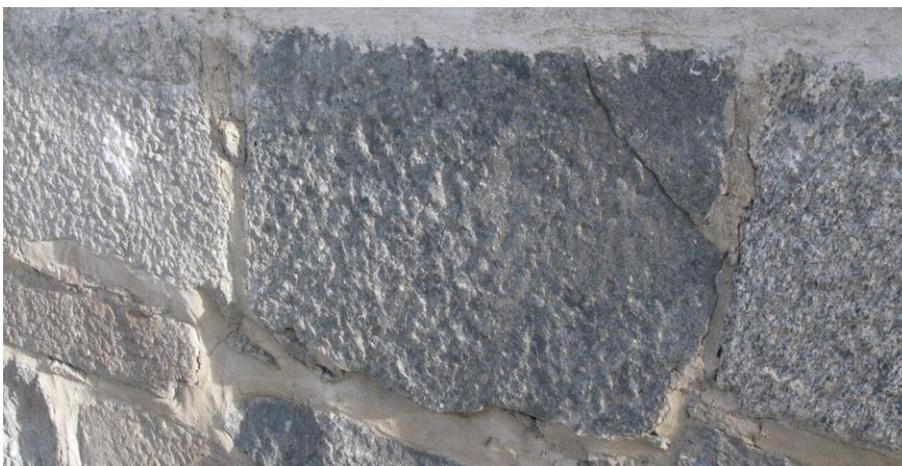
Another fracture visible is on a block on the basement facing Hallikatu and built in 1874, shown in Figure 19. The corner has cracked, probably to vibrations or movement of the structure.

Figure 19. Corner cracked on a block in the old basement built in 1874 facing Hallikatu.

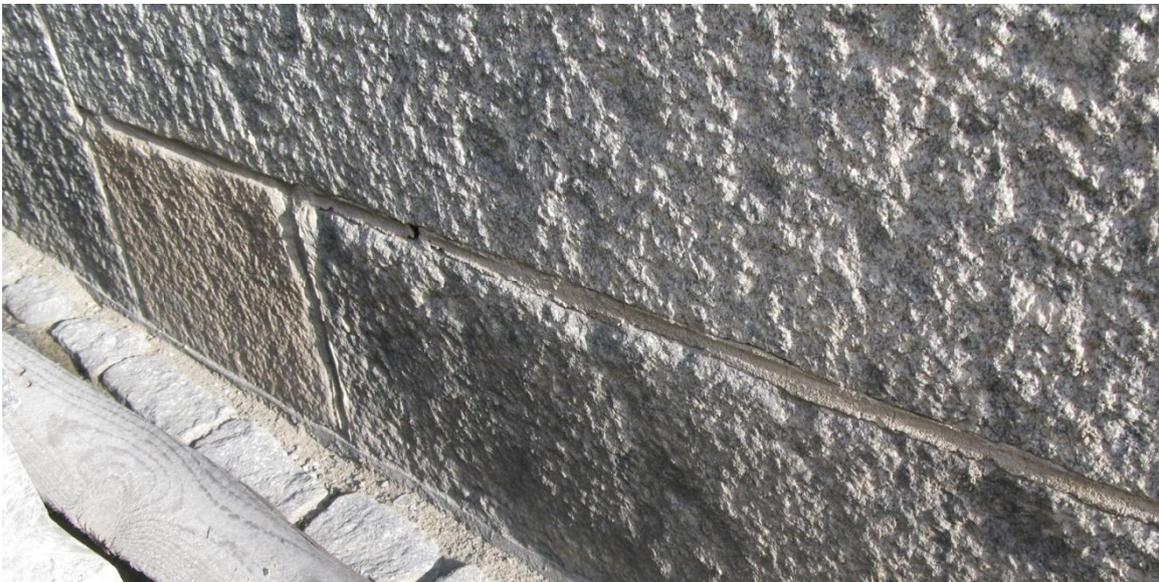
Changes of colour determined by weathering of the material are visible over the building and mainly on the newer enlargements since those have been constructed by homogeneous quarried material. Difference in colour of the whole block is shown in Figure 21, on a block of the part built in 1914 facing Hallikatu. The block looks more yellow than the others even if the material should be similar and coming from the same quarry.

Figure 21. basement facing Hallikatu built in 1914, a block has been affected by higher level of weathering compared to the others used on the same wing. Probably has been taken from a higher part of the crop.

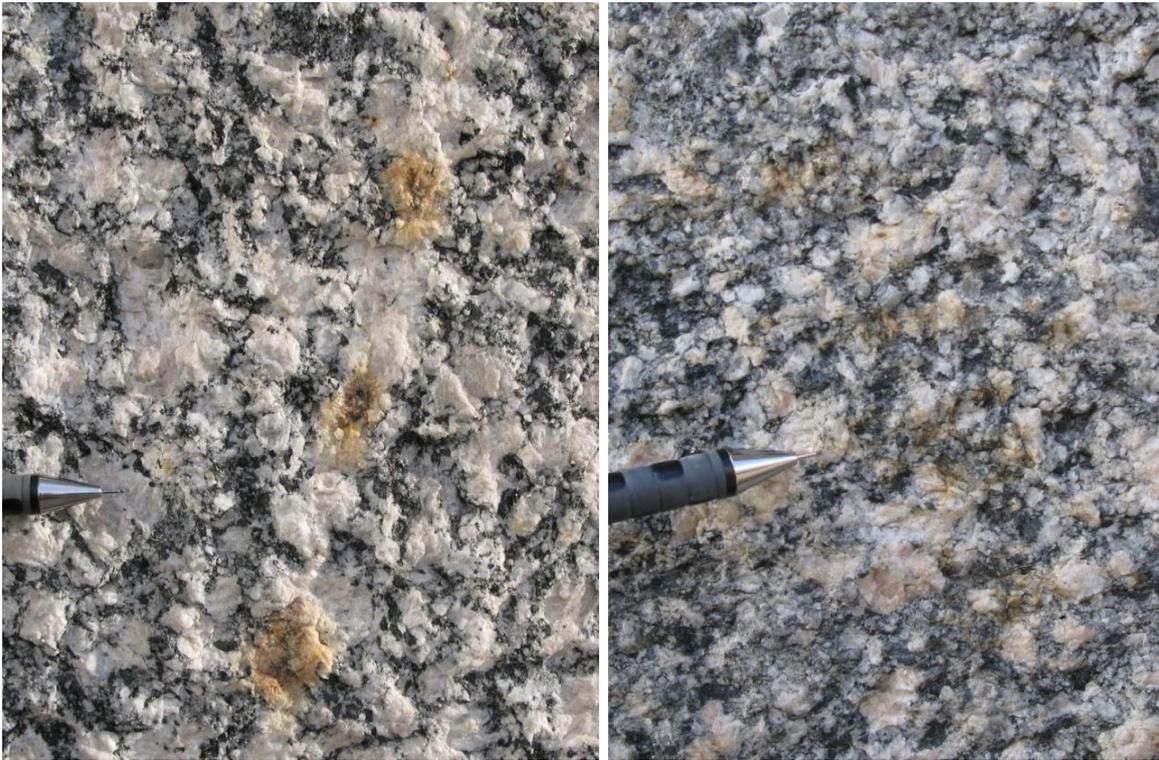
Weathering of minerals has been noticed mainly on the stone used in the inner yard, but both on the wing built in 1914 and in that built in 1885. In the one built in 1885 have been clear spots given by oxidating minerals as visible from Figure 22 and 23 and have been characteristics of a single stone type. The inner yard basement is in fact composed by different stone types and not all are showing the problem. The material used on the wing built in 1914 has shown veins of oxidating minerals as visible from figure 16 and 24.

Figure 22. Oxidation of minerals on the inner yard basement on the wing on Puijonkatu built in 1885

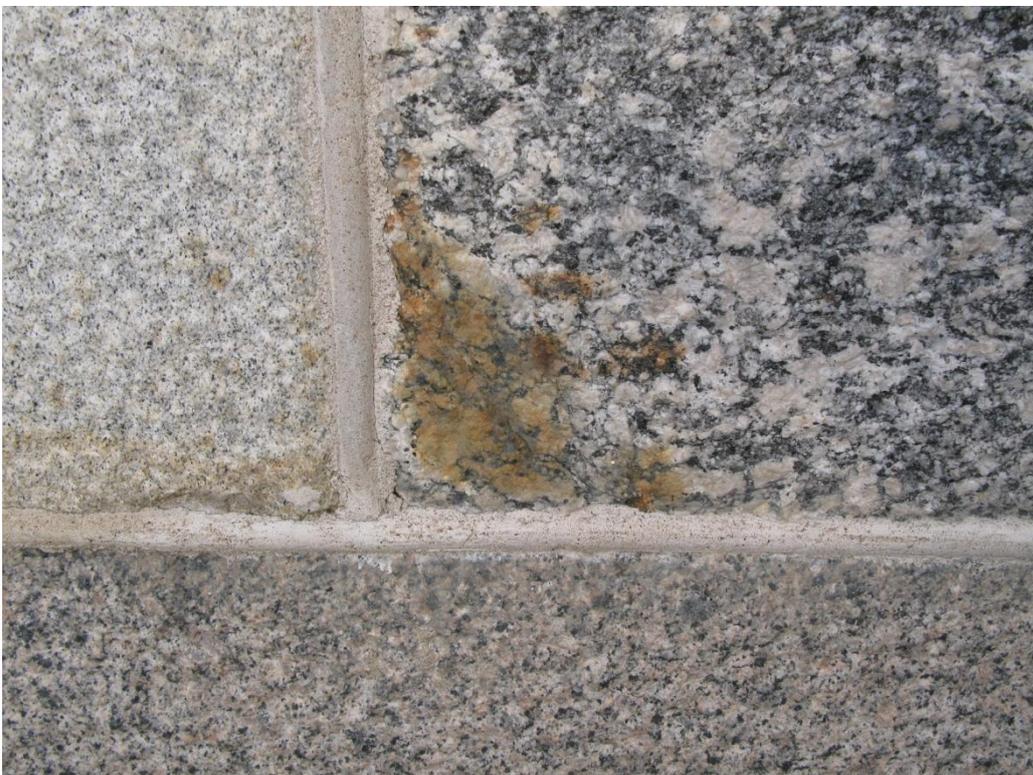
Figure 23. Oxidation of minerals on the inner yard basement on the wing on Puijonkatu built in 1885.

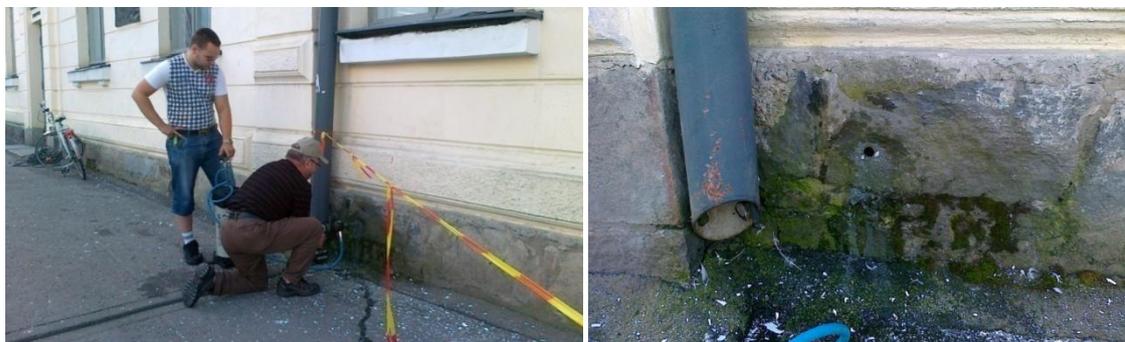
Figure 26 Sampling of "Lyseo 1" core taken from the old basement on the right of the main entrance door on Kauppakatu. It has been chosen a rock near a drain pipe, showing presence of biofilm (taken on 15.8.2012, photo Heikki Pirinen)

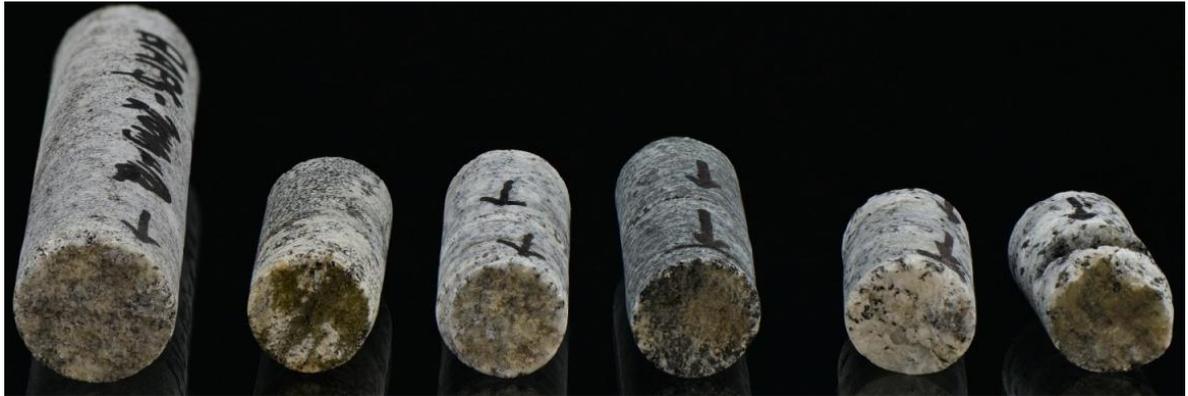
Figure 32 Weathered surface of the drill cores from Kuopio Lyceum . (Photo by Jouko Ranua GTK)

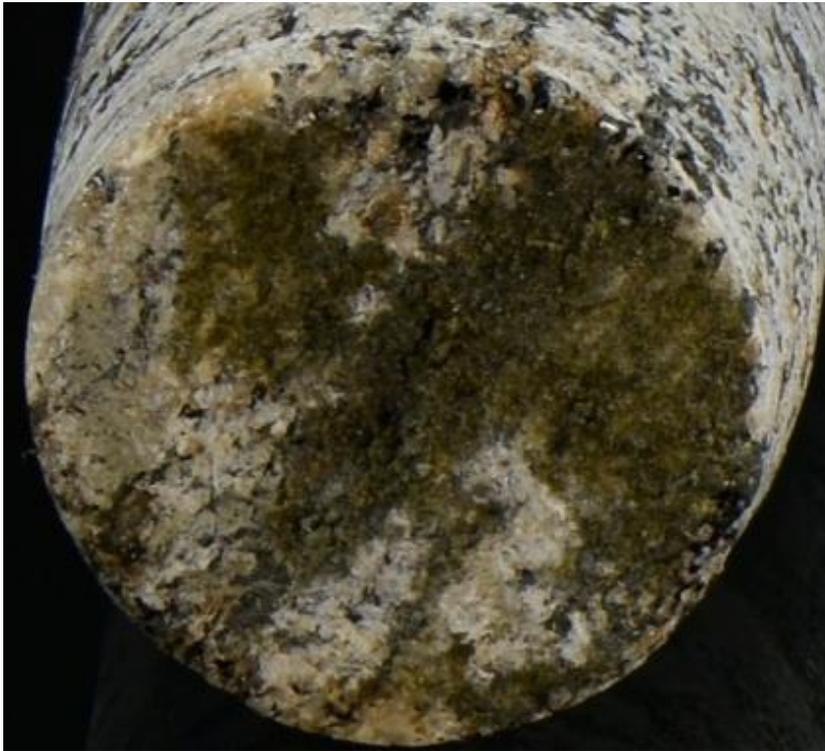
Figure 34 Detail of the surface of the sample Lyseo 1 collected in proximity of a drain pipe on the main facade. The sample diameter in its section is 17mm. (Photo by Jouko Ranua GTK)

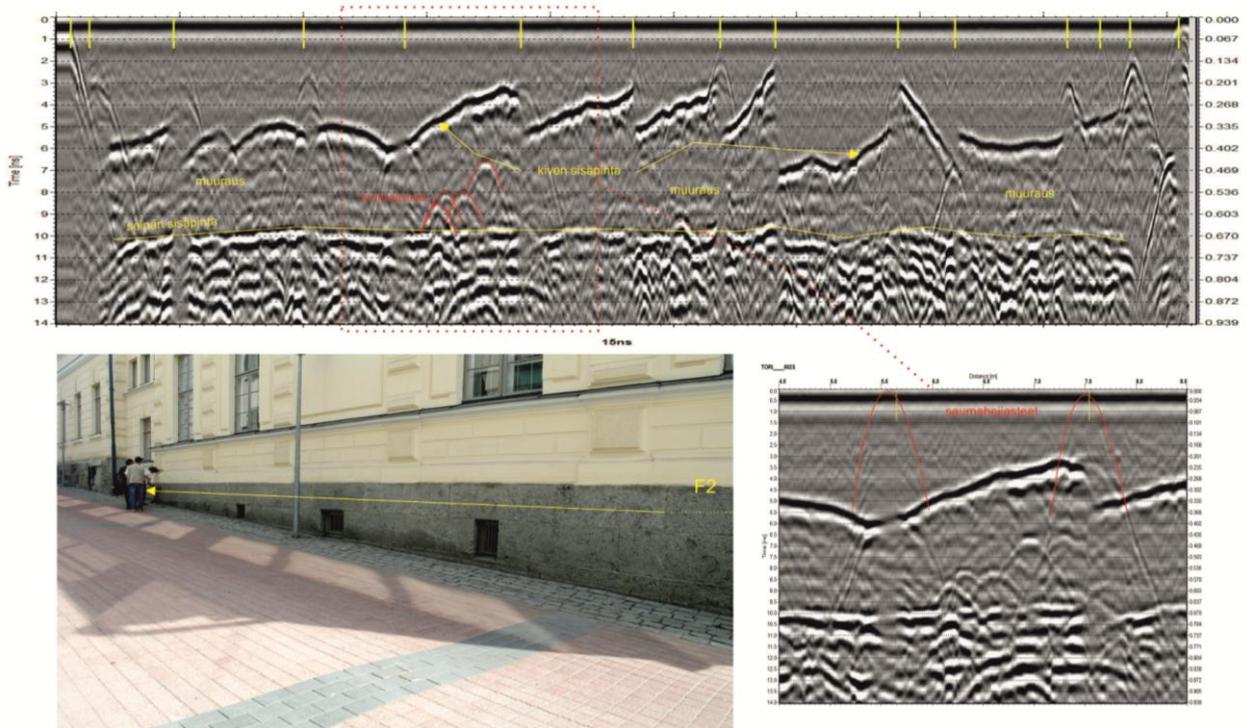
Figure 40. It is shown the radargram of the whole new basement (1914) facing Hallikatu. The antennae had never been taken out from the wall even in correspondence of the light pole standing in front of it. In the figure the joints between the blocks are shown in yellow. (Radardgram and photo: Heikki Sutinen)

From the radargram is visible that the thickness of the blocks varies between blocks and can be understood that the inner face is not squared since the back reflection lines in the radargram are not horizontal even within the same block. The joint's reflections are highlighted in the right lower radargram picture in red.

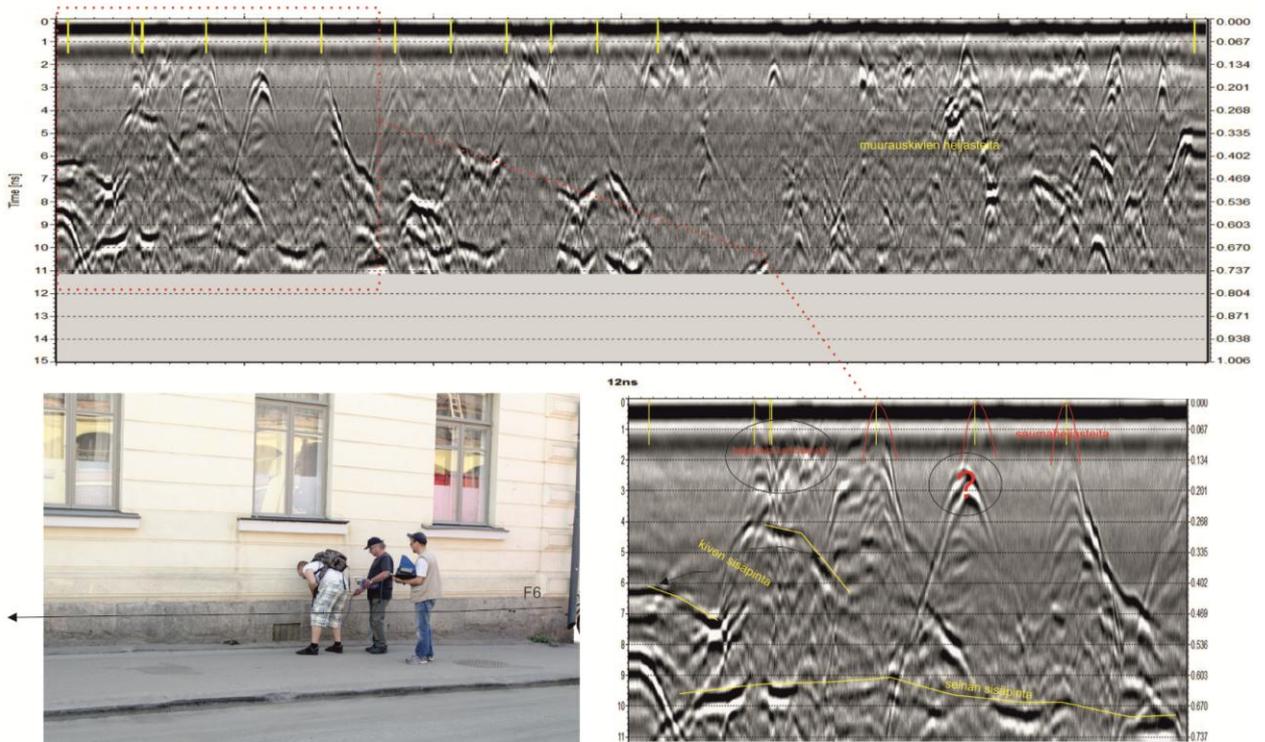
A measurement has been performed on the facade facing Kauppakatu as shown in Figure 41. In this case is visible that there less regular surface cladding material, as the construction typology is different from the previous one. There is not clear back wall neither of the surface stone cladding neither of the back side of the wall, probably unshaped blocks had been placed and cemented together, larger block with smaller in between for the depth needed to create the fundaments.

In Figure 41 is shown an enlargement of the starting of the radargram, taken over the newer part of the wall. On it are shown some higher peaks that could be also caused by metal anchors to keep the wall connected, or by bigger bolders. The typologies of construction look similar since there is not high difference between the radargrams. In some parts of the walls, mainly in the newer part have been used

bigger stones, while in the older one have been used smaller ones, since on the right of the radardgram is visible a much higher density of refractions.

Figure 41 It is shown the radargram of the basement facing Kauppakatu, taken from the side built in 1874 to the one built in 1820.(Radardgram and photo: Heikki Sutinen)
