**SOUTH-EAST FINLAND - RUSSIA ENPI CBC PROGRAMME 2007-2013**  
**Efficient use of natural stone in the Leningrad region and South-East Finland**

## Site Inspections

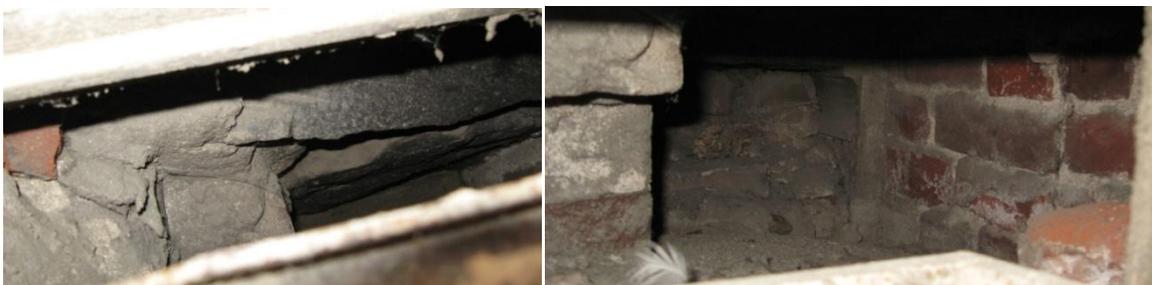
A view of the inner wall has been attempted looking inside an opening on the basement facing Puijonkatu as visible from Figure 42. The walls are built of stones and bricks and are cemented.

Figure 42 Photos taken from an aeration hole of the basement on the side built on Puijonkatu. On the left the upper-left side of the hole, on the right the right-bottom side of it.

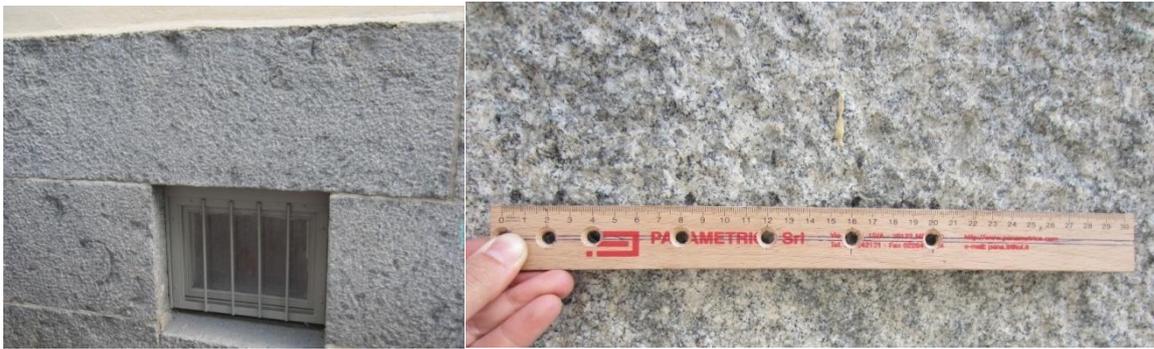
Block *Kuopio Lyceo1* that is the block over the window shown in Figure 45. The material didn't show any particular deterioration problem and the velocity of the material has been of 3010,87 m/s having an interpolating curve linear, not showing problems or weathering phenomena in any point measured.

Figure 45. On the left image of the Block 1, the block over window. On the right image of the measuring area on the block.

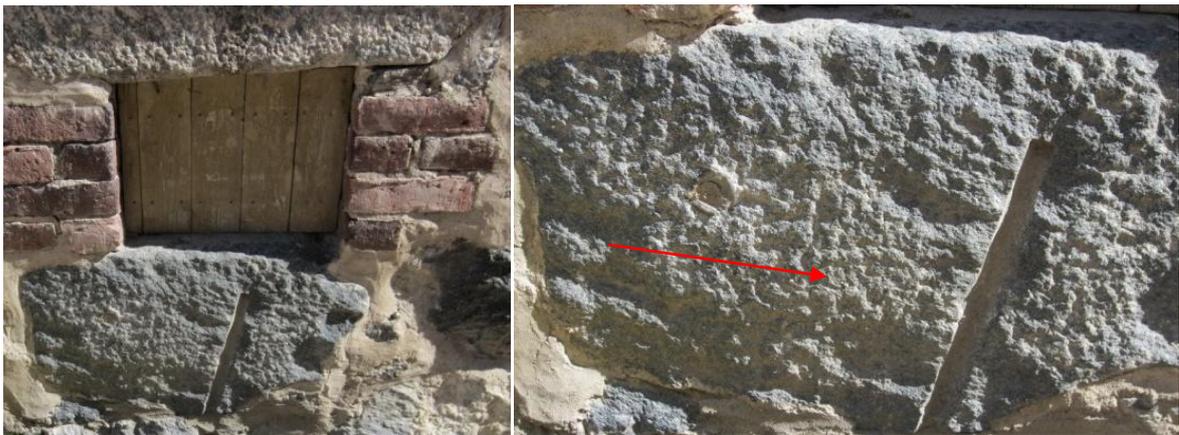
Block *Kuopio Lyceo2* is a Diabase block, an erratic boulder used in the basement part built in 1874-75. On the block is still visible the splitting core. The velocity has been measured being of 3314,07 m/s but the measurement is affected by high uncertainty since the single punctual values have not been showing a constant velocity. The variations could be given by deterioration level of the material, by problems in positioning the transducers over the surface or by the presence of the drill hole created during sampling. In figure 46 is visible the block and in red is marked the position of the measured line.

Figure 46. On the left image of the Block 2, the block under window. On the right image of the measuring area on the block marked with a red line.

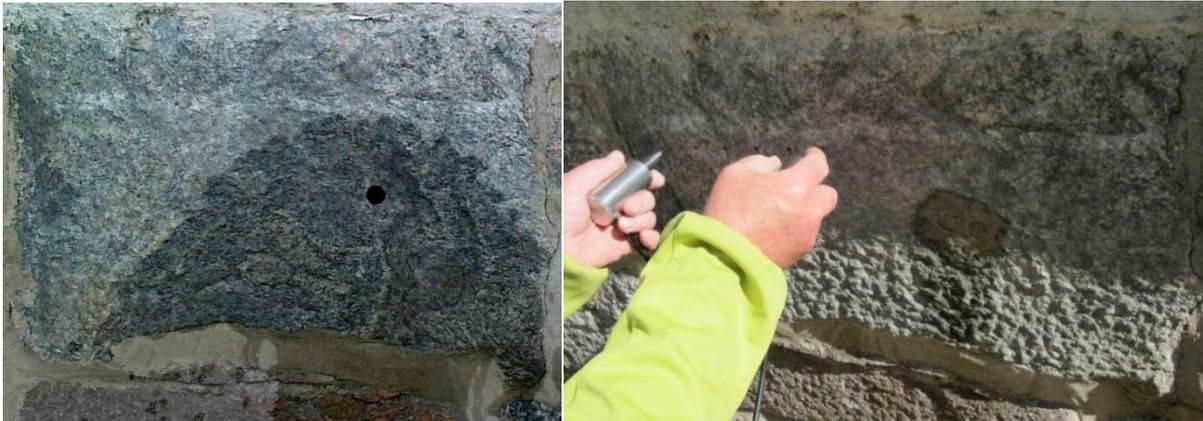
Block *Kuopio Lyceo3* gave more uniform and reliable measurements of velocity, deviating slightly by the expected values in the 2<sup>nd</sup> point, recording slight faster velocity and in the 4<sup>th</sup> point, recording slight lower velocity. The mean velocity has been of 2892,97m/s. The velocity has been probably lowered compared to a similar fresh material - affected by the weathering level of the block, being an erratic boulder. In Figure 47 is shown the block and the measuring activity.

Figure 47. On the left image of the Block 3. On the right image of the measuring activity on the block.

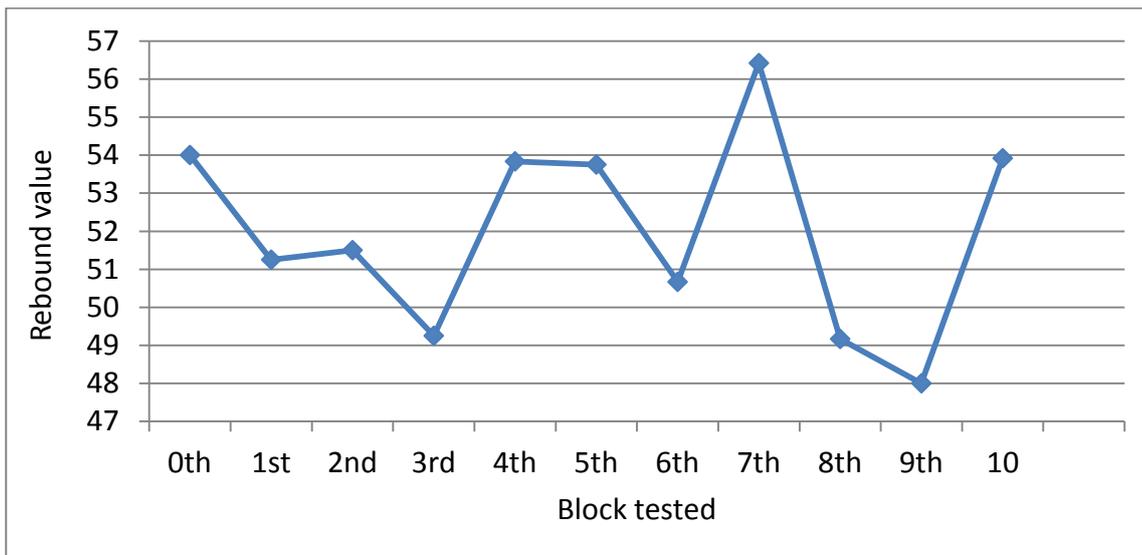
On the 5<sup>th</sup> block the third test rebound tests have been performed over a part more weathered and looking red. The value is in line with the others obtained from the same block and is not lower than others from the basement. The visualization as graphic form of the results is visible in the graph of Figure 49.

Figure 49. Schmidt rebound average values of individual blocks of the basement towards Hallikatu.

Block 3, 8 and 9 show much lower results compared to others. From a visual inspection it is not visible any deterioration effect and the lower values could be given by the minerals over which has been placed the hammer or by the surface finishing, presenting higher irregularities and increased breakability compared to previous blocks.

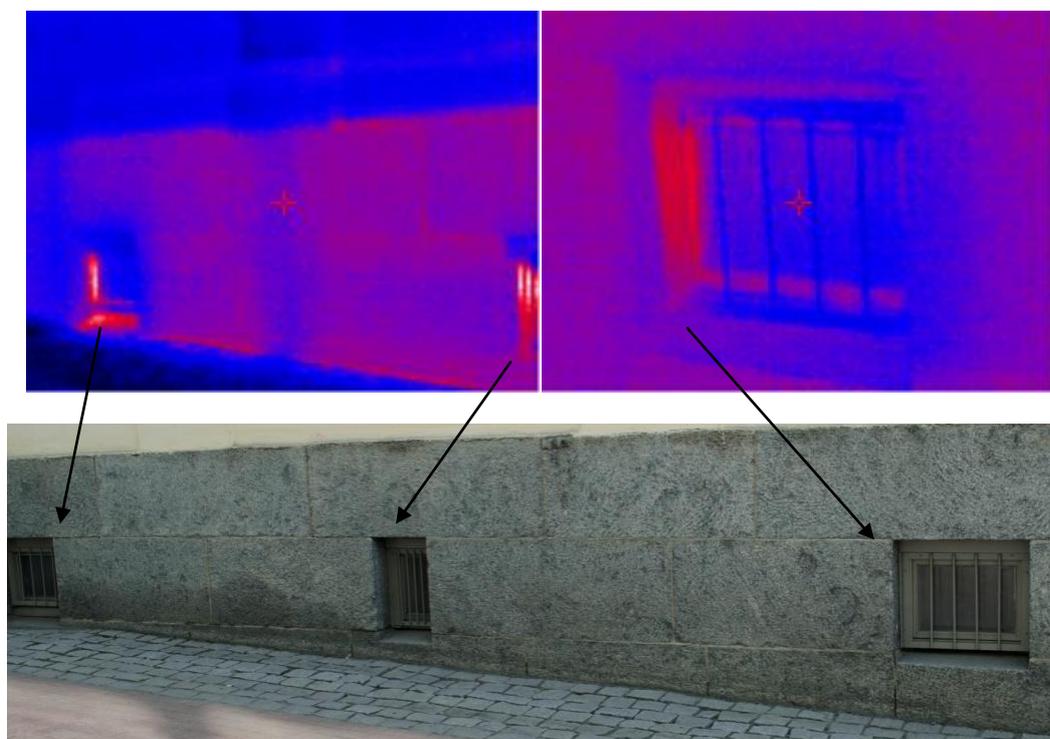
Basement of the Lyceum of Kuopio was as cold as the temperature of the ground and temperature of the air only the areas near the windows had been irradiating more, probably because of lower thermal insulation capacity of the glass. Moreover the images collected had been affected by the higher reflectance of the metal that flattened the temperature of the stone.

Figure 50 Thermal image and photo of the wall facing Hallikatu. (Thermal photo by Aleksei Shkurin, Photo by Joonas Toivanen, GTK)

Since the wall didn't present visible cracks or deterioration points, its surface had not been checked thoroughly. In this case even if it is visible some dust deposition and fixation on the photo of Figure 50, it is not detected change of surface temperature by the thermal camera. The neat difference between the top part in mortar and the basement part in stone is instead clear as visible from the first thermal image of Figure 50.

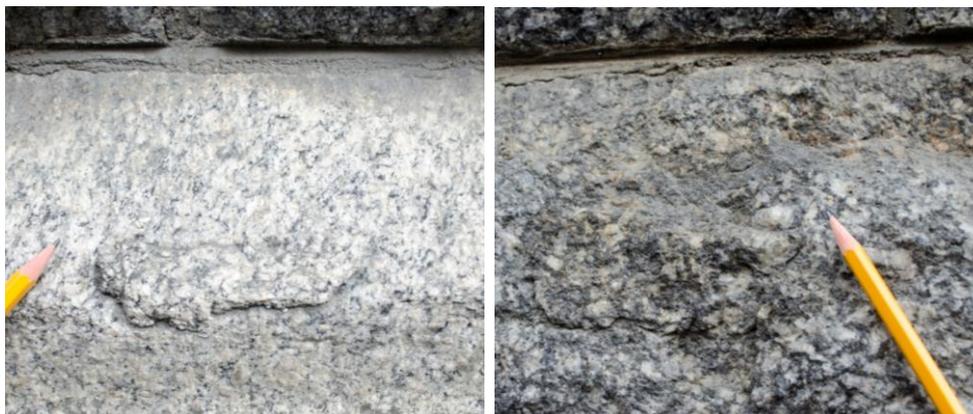
On some blocks could be noticed that there has been fracturing, probably caused by different rate of weathering of the minerals in correspondence of a vein, as shown in figure 5.

Figure5. Fracturing in large flackes, caused probably by weathering of certain minerals, or by original fractures. (photo Joonas Toivanen)

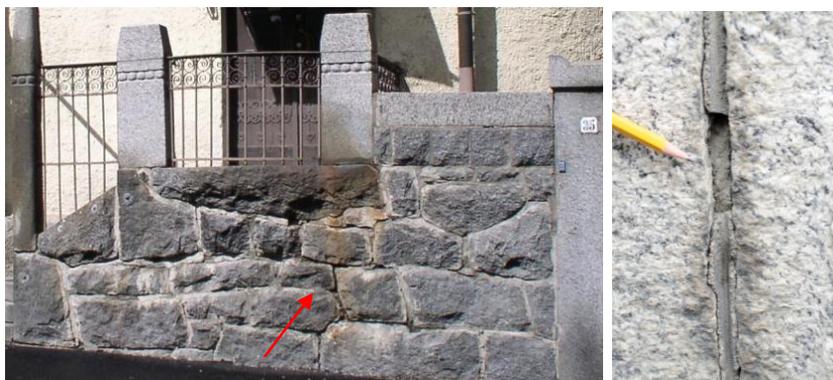
A mechanical deformation has interested the stair in the main facade, as visible from Figure 6 on the left, where a crack had affected the whole height of the structure. On the right instead is visible fracturing of the mortar in correspondence of two blocks, probably cause by their different response to thermal and moisture changes.

Figure6 Crack running on the parapet of the stair, showing that the structure has been moving. On the right the mortar had been cracking because of the natural movement of the blocks.(photo Heikki Pirinen and Joonas Toivanen)

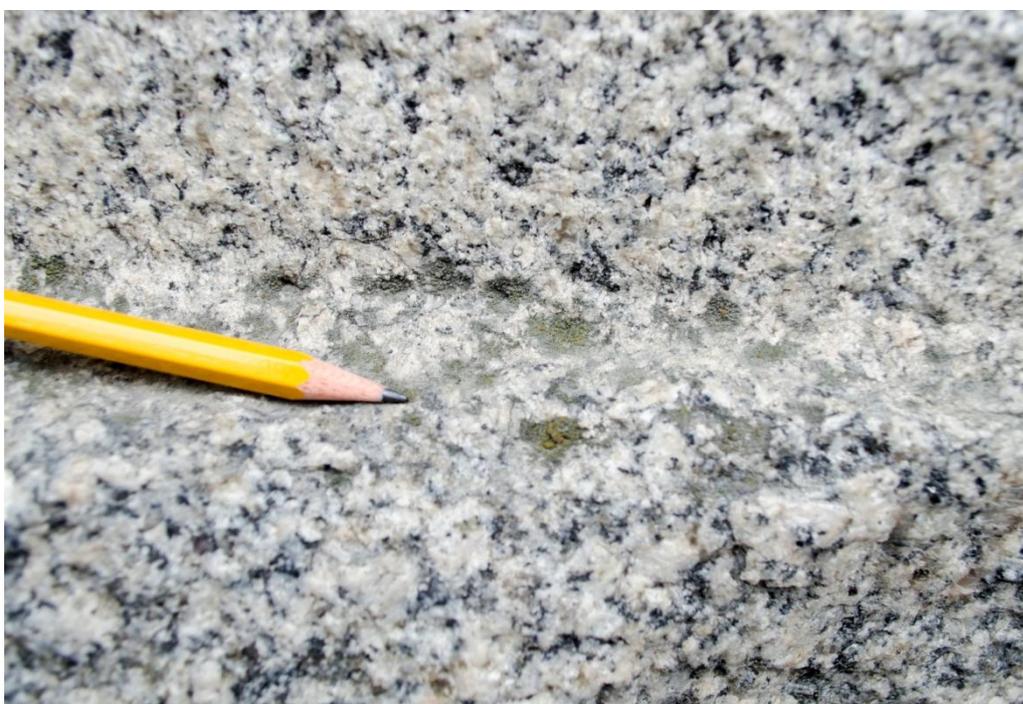
Lichens have started to colonize the material (Figure7) even if the facade had probably been cleaned in recent times or had been subjected to traffic or is too young to present elevated diffusion of lichens.

Figure 7. Initial colony of lichen. (photo Joonas Toivanen)

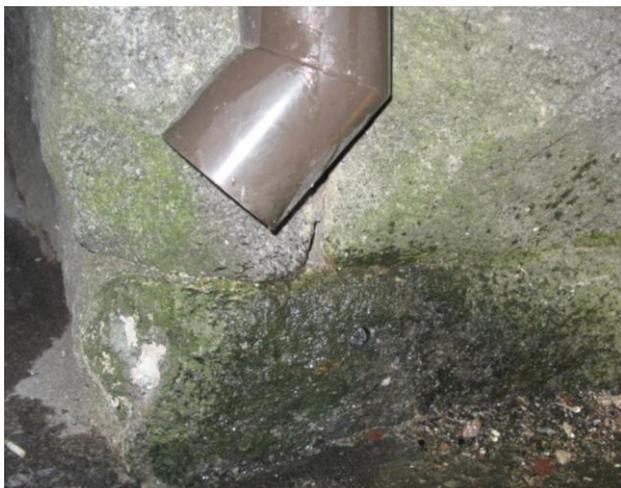
Biofilm has been recognized mainly in correspondence of drain pipes as in the sampling block in the courtyard. Other drain parts areas in the main facade didn't show the problem to such an extent.

Figure 8. Biofilm visible near a drain pipe in the courtyard area. (photo Joonas Toivanen)

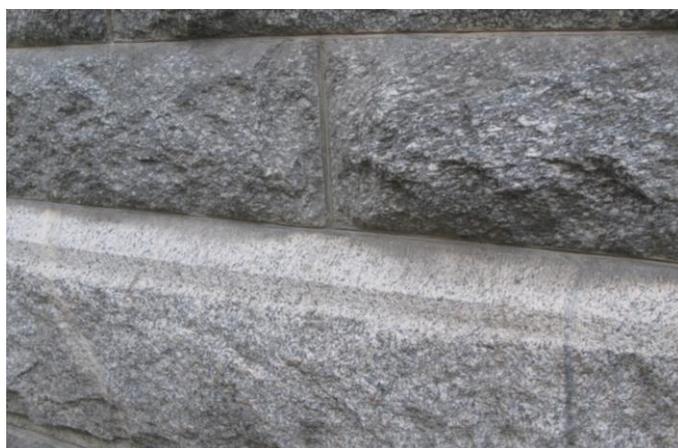
Fixation of dust has happened on the basement, as shown in Figure 9, in the areas not protected by running waters.

Figure 9. Atmospheric dust deposition and fixation. (Photo Nike Luodes)

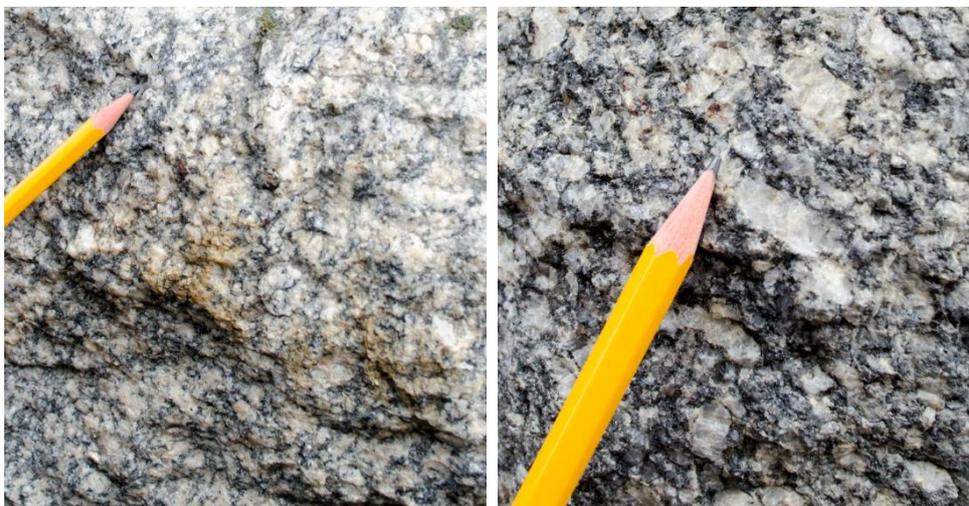
Changes of colour caused by mineral oxidation could be seen in some blocks. Several spots diffused on the surface can be seen in Figure 10 and 11.

Figure 11. Examples of oxidation of elements in the material itself. (photo Joonas Toivanen)

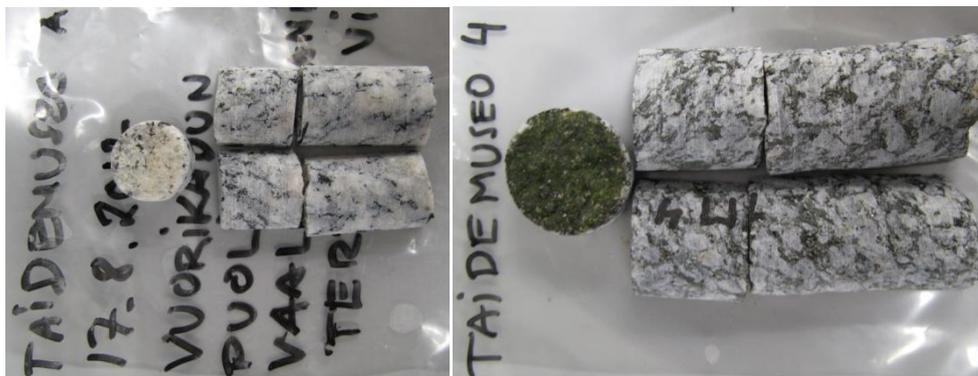
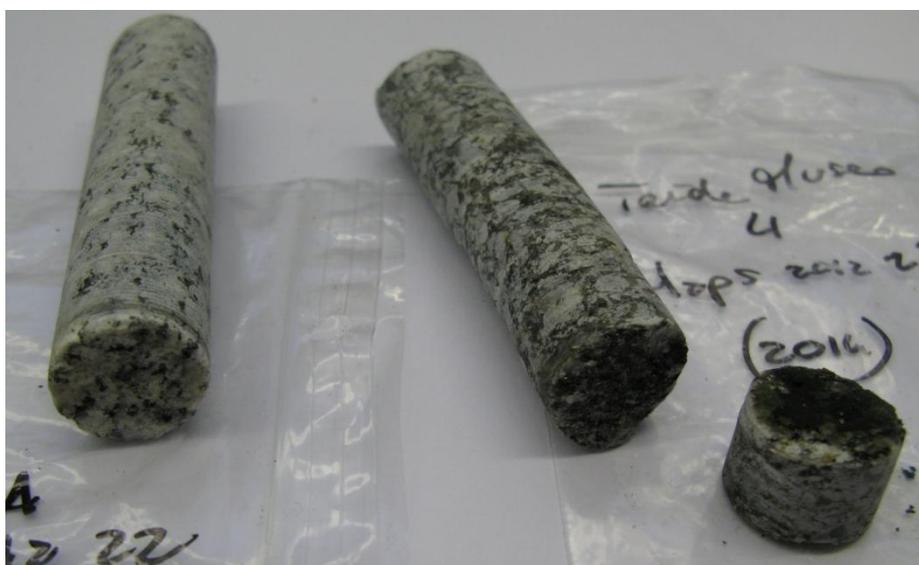
From Kuopio Art Museum had been taken normal photos of the two sampled blocks:HAP\$-2012-22 and 23. The second one is affected by biological growth, as visible from both the pictures 16 and 17.

Figure 16. First samples, collected in 2012, used for surface examinations. (Photo: Heikki Pirinen)

Figure 17 Samples collected in 2013 used for petrographic descriptions.(Photo. Nike Luodes)

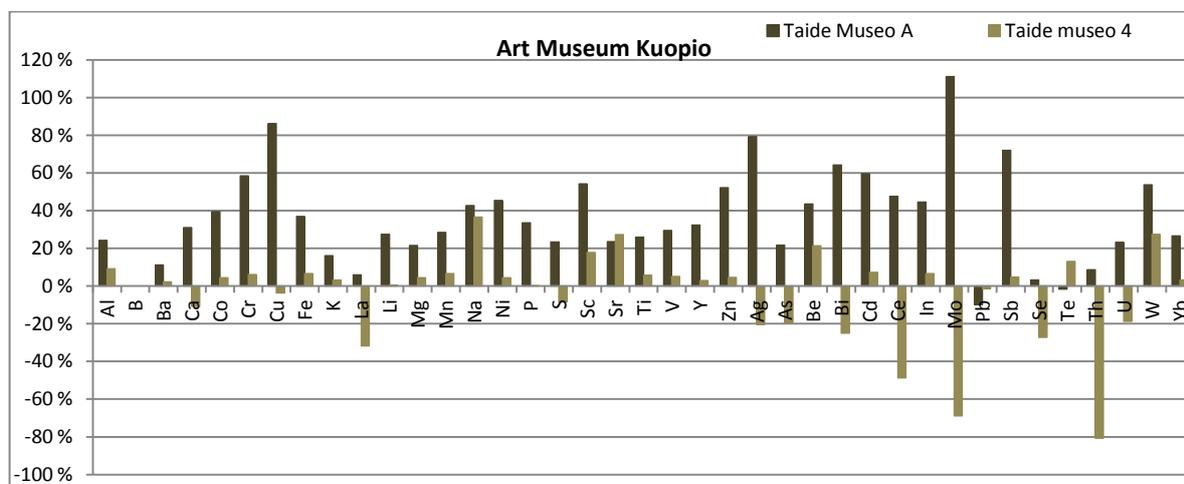
Figure 22. Changes in percentages of the chemical elements of the top respect the bottom of the drill core for the specimens HAPŞ-2012-22.1 (Taide Museo A) and HAPŞ-2012-23.1 (Taide museo 4).

The two samples had behaved in very different way, that probably had been caused by the different kind of material. They do not show evident dispersion of element from the top part, instead some level of enrichment could be noticed, in Fe, Al, Cd, Be, Zn, Ti, Mn. HAPŞ-2012-23.1 should belong to the older part of the museum and it presents biological growth.

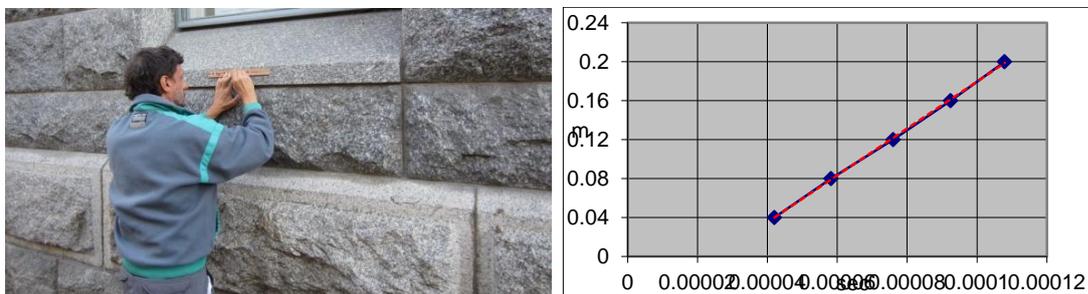
**Kuopio Taide Museo 1 (Kuopio TM1)**

Figure 26. Measuring over the window sill, on dark tonalite, along the main façade. Diagrams of the measurements performed used to evaluate the velocity.

Velocity in the material:  $V=2409,9$  m/s

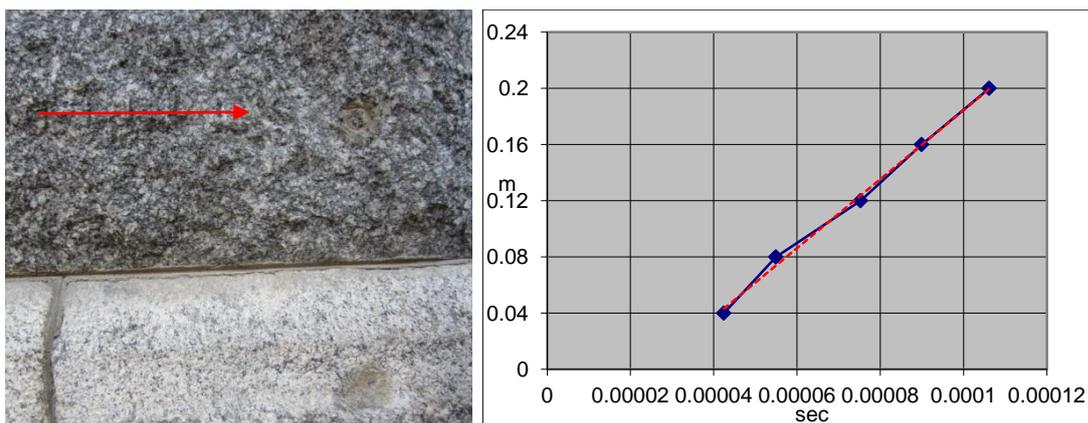
**Kuopio Taide Museo 2 (Kuopio TM2)**

Figure 27. Measuring on the main façade, dark tonalite sampled for chemical analysis. Diagram of the measurements performed used to evaluate the velocity.

The test has been performed on the dark tonalite over which had also been done the sampling. The reading had not been carried over the hole, that, as visible from Figure 27, is on the right side of the measuring line.

Velocity  $V=2462,1$  m/s

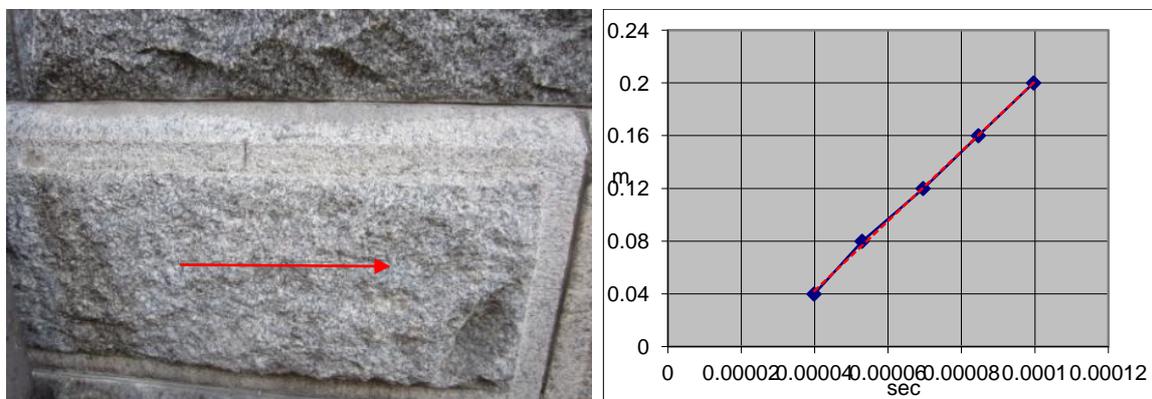
**Kuopio Taide Museo 3 (Kuopio TM3)**

Figure 28. Measuring line on the main facade on light granite sampled for chemical analysis. Diagram of the measurements performed used to evaluate the velocity.

Velocity  $V=2643,4$  m/s

As visible from the diagram of measurements (Figure 28) a faster wave speed has been recorded in correspondence of the 2<sup>nd</sup> point on the diagram (3<sup>rd</sup> measurement in practice). It is not clear the reason that has caused it, the block does not show evident surface weathering. Possible explanation could take into consideration that the surface is irregular and the transmitter could had been located at an angle between them, increasing the speed of reading, or the presence of rain during measurements could have affected the reading over a point more exposed.

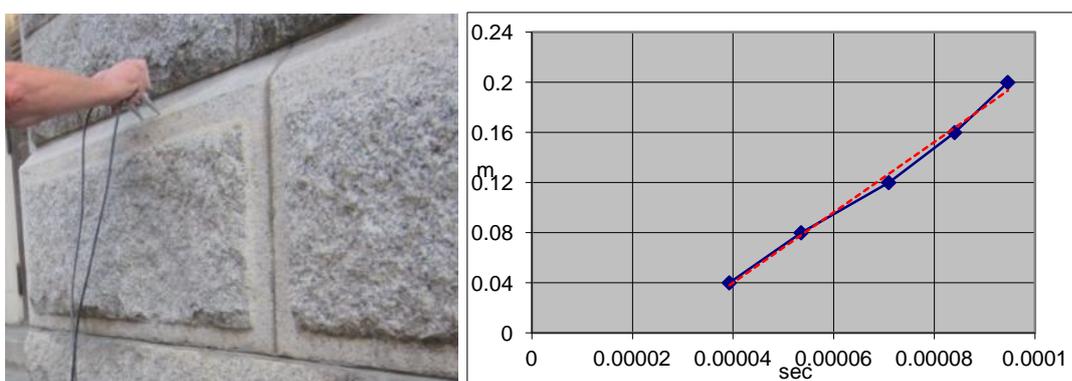
**Kuopio Taide Museo 4 (Kuopio TM 4)**

Figure 29. Measuring process on the main facade on light granite. Diagram of the measurements performed used to evaluate the velocity.

$V=2833,78$  m/s

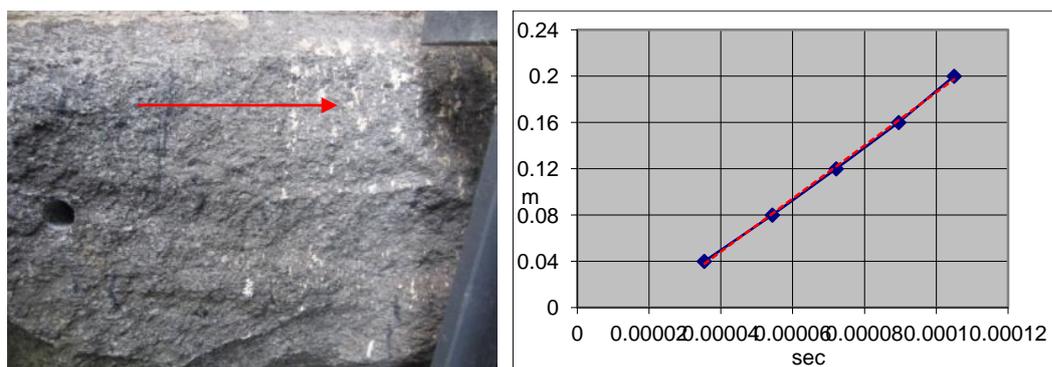
### Kuopio Taide Museo 5 (Kuopio TM5)

Figure 30. Measurements on the backyard block. Diagram of the measurements performed used to evaluate the velocity.

Velocity  $V = 2293,7 \text{ m/s}$

The block is located in the yard, on the corner of the wall, protected by direct rain, against the gate of entrance to the museum. The surface on that corner presents humidity brought by the rain pipe and a biofilm is visible over the block. Presence of bird's dung is also visible.

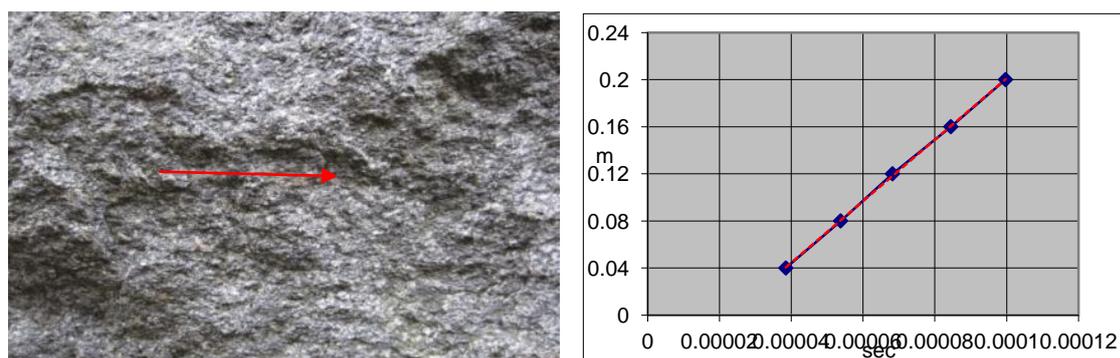
### Kuopio Taide Museo 6 (Kuopio TM6)

Figure 31. Backyard measurements along the side wall. Diagram of the measurements performed used to evaluate the velocity.

Velocity  $V = 2613,0 \text{ m/s}$

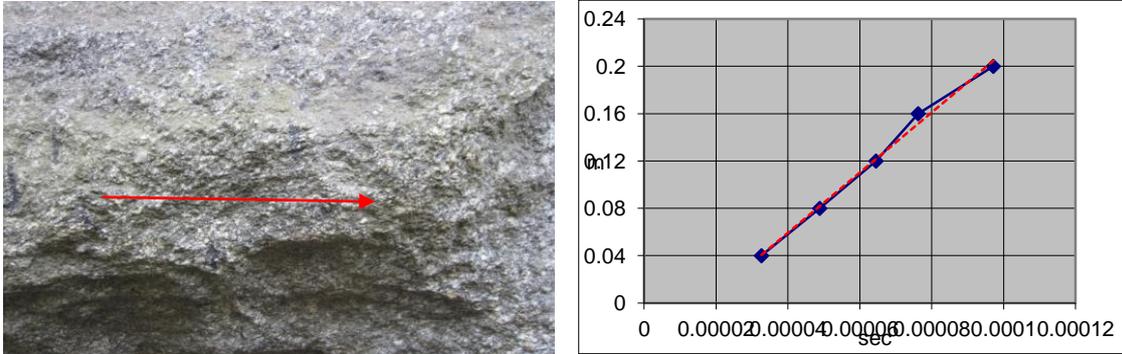
**Kuopio Taide Museo 7 (Kuopio TM7)**

Figure 32. Backyard measurements along the side wall on block that show light presence of biofilm. Diagram of the measurements performed used to evaluate the velocity.

Velocity  $V=2557,4$  m/s

The readings show a deviation from the linear regression line in correspondence of the 4<sup>th</sup> point of the graph in Figure 32 (5<sup>th</sup> reading in practice). A possible explanation is given by the presence of the biological film or presence of higher moisture that have increased the speed of the wave in that specific point, another possibility is given by wrong reciprocal position of the transducers.

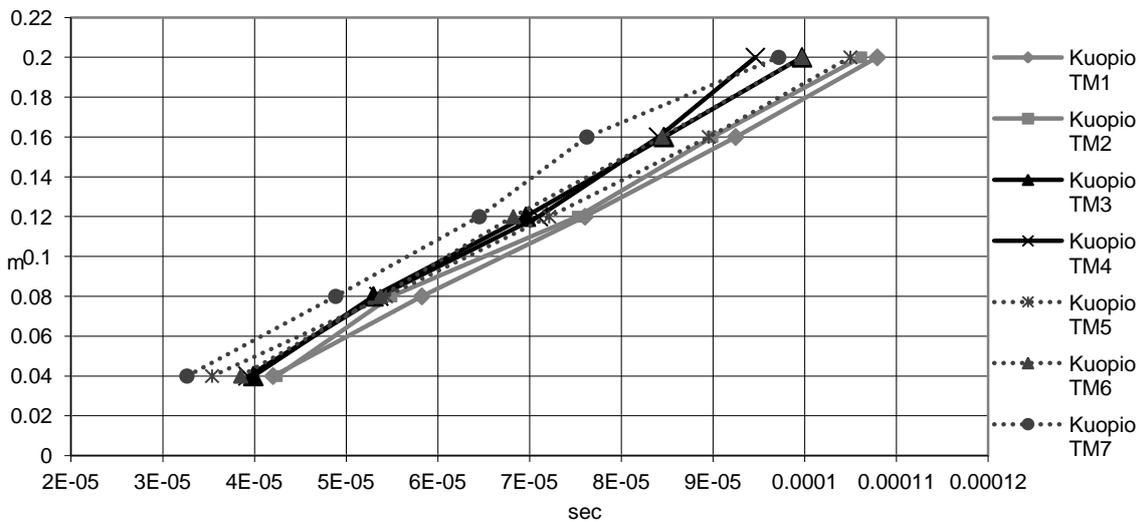
Figure 33.

Graph of the measurements performed on the blocks of the museum.

From Figure 33 is visible that the backyard material had fewer deviations from the theoretical values that run on the linear interpolating line compared to the façade material. Observing the velocities reached represented on the graph of Figure 34 are visible three group of velocities for the three kind of materials, and the effects of errors or surface deterioration.

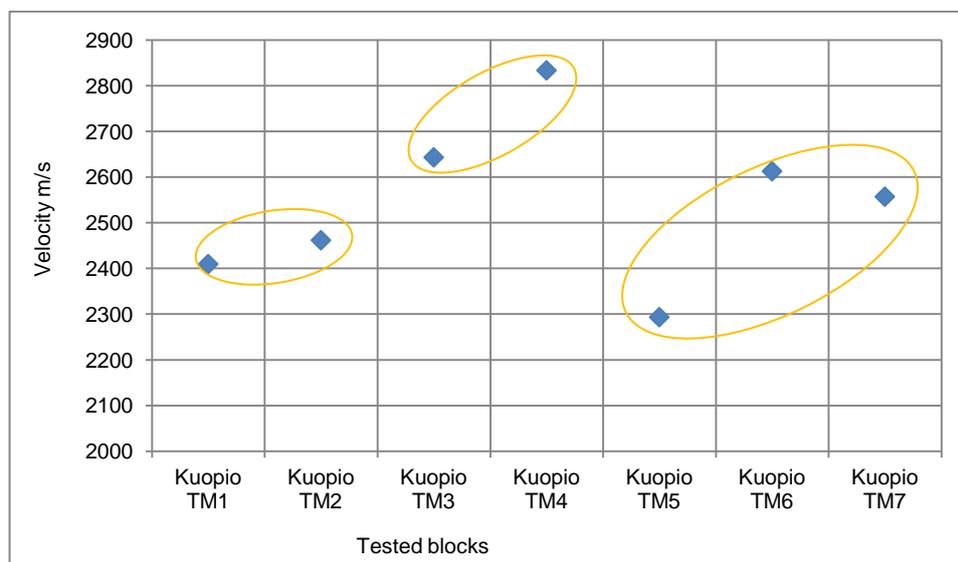
Figure 34. Velocities for each of the block measured on the Museum of Kuopio

Deviations of the readings of arrival time on the black tonalite blocks of the main façade (TM1 and TM2) didn't result in a strong change of velocity.

White granite showed a change of velocity between the two blocks examined, having higher speed in a block presenting a yellow vein. The change of velocity between the blocks can be caused by their different mineral composition, so it might be more related to natural heterogeneity of the material than to weathering effect.

The backyard presented the first block (TM5), that is the one more protected by the rain, with a lower velocity compared to the other two. The velocity of block TM5 is anyway also lower than the one of black granite of the main façade. The first block (TM5) had shown presence of biofilm by visual inspection and for this reason the velocity could had been lower, on the other side, the other back yard measurements could had been affected by surface humidity since the curve of arrival times of block TM5 is the most linear of this group.

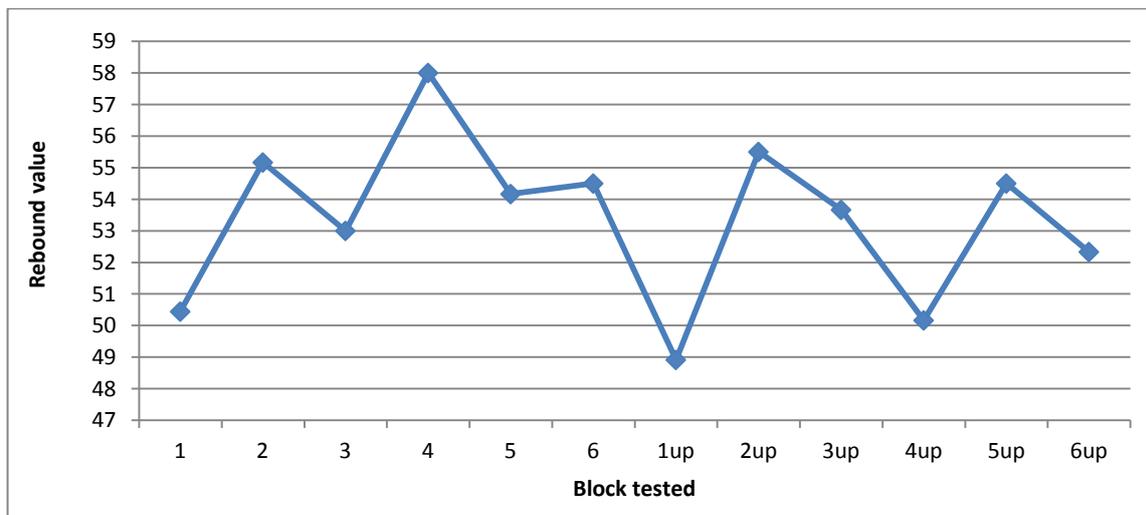
Block 1 presented rusty grains, that is probably the reason for a lower value of rebound,

As block 5 had been chosen the block over which has been performed the sampling. The lower rebound values could be caused by higher humidity originated by the drilling activity.

Block 6 presented a rusty zone.

In the upper row the last block (6up) has presence of old drilling and the lower values came in correspondence of flaking of the surface. It is not known why the block 1up had given so low result, neither have been noticed anomalies related to block 4up.

Figure 35. Schmidt rebound average values of individual blocks of Kuopio Art Museum.

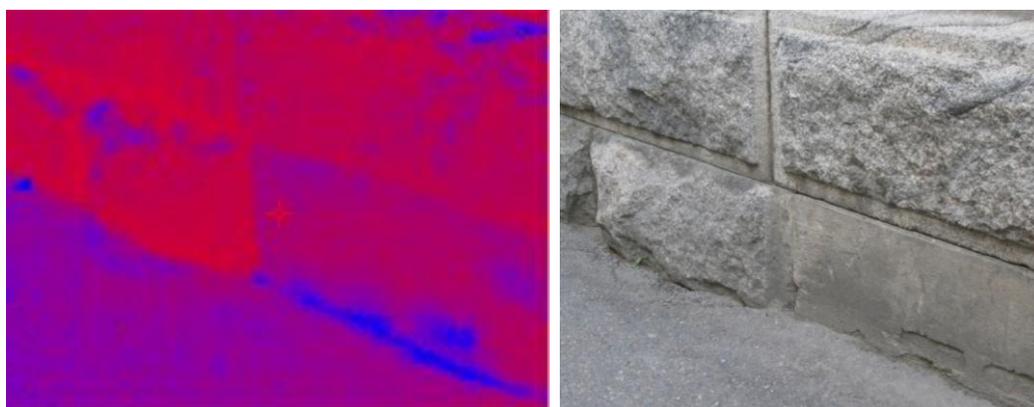
The bossy surface reflects and refracts the light not allowing performing a clear analysis of the facade. A difference within stone and mortar replacement is visible in Figure 37 and 38 where the stone appears warmer, probably drier compared to the mortar block.

Figure37. Difference in heat radiation seen on a mortar replacement compared to the original stone blocks. (Thermal photo by Aleksei Shkurin, Photo by Nike Luodes, GTK)

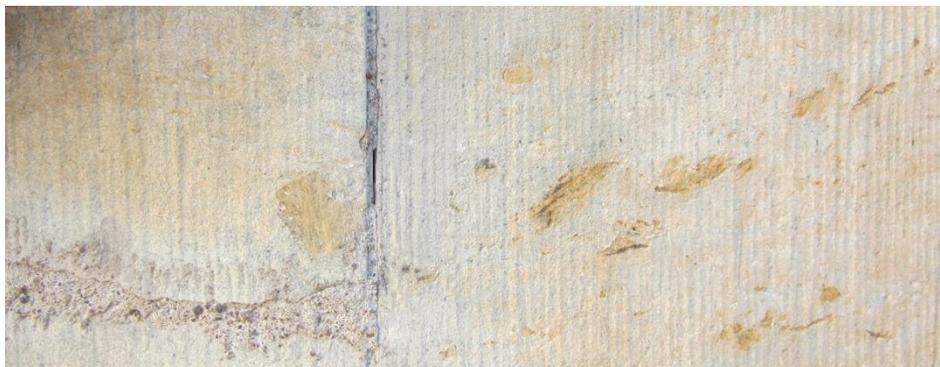
Some cavities had been noticed on the soapstone elements, probably due to detachments or gradual weathering of some softer elements. (Fig.12)

Figure 12 Formation of cavities due to detachment of softer minerals from soapstone decorative elements over the arc of entrance to Inner Yard A, facing West.(Photo: N.Luodes)

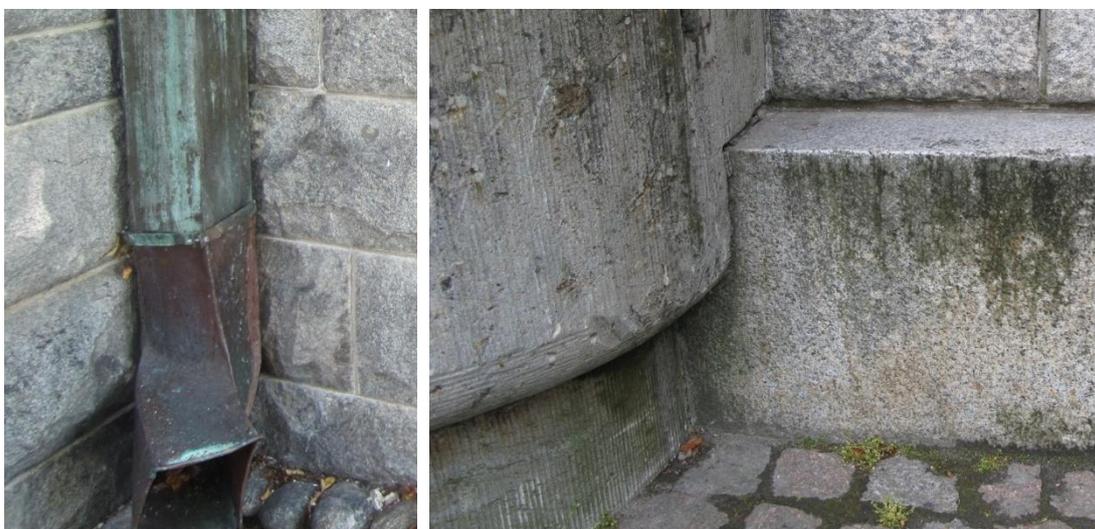
Susceptible areas as draining pipes had not shown presence of bio films as visible from Figure 15 where an area on the basement facing South had been pictured. But biofilm has been noticed on the wall near the main entrance, facing East, as visible from Figure 15. They have grown on the soapstone element and on the granite step. Their colour had been green.

Figure 15. Absence of visible biofilm in possible wet areas, on the left, and presence of biofilm on the walls near the main entrance, on the right. (Photo: N.Luodes)

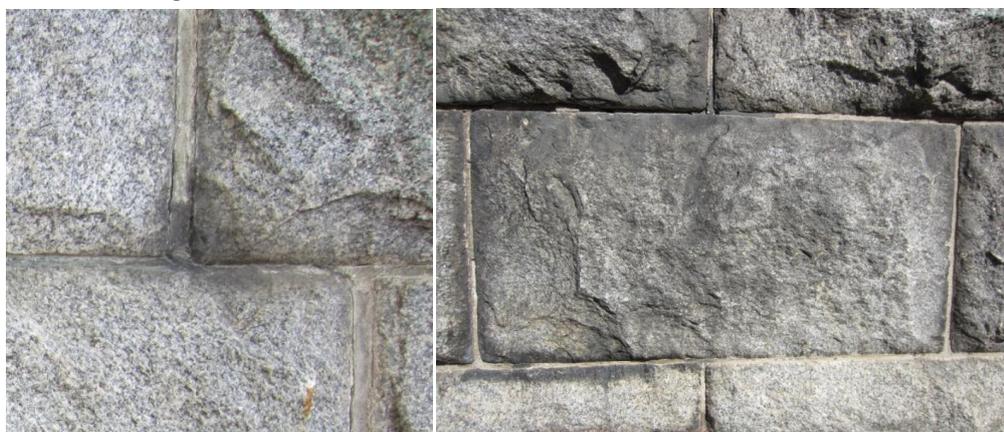
Fixation of dust into crust is visible in some parts of the building, on some blocks near the joints, or near the ground, as visible from Figure 16. In the facade facing north its presence is stronger than on other facades, as visible from Figure 17.

Figure 16 Crust given by deposition of dust (Photo: N.Luodes)

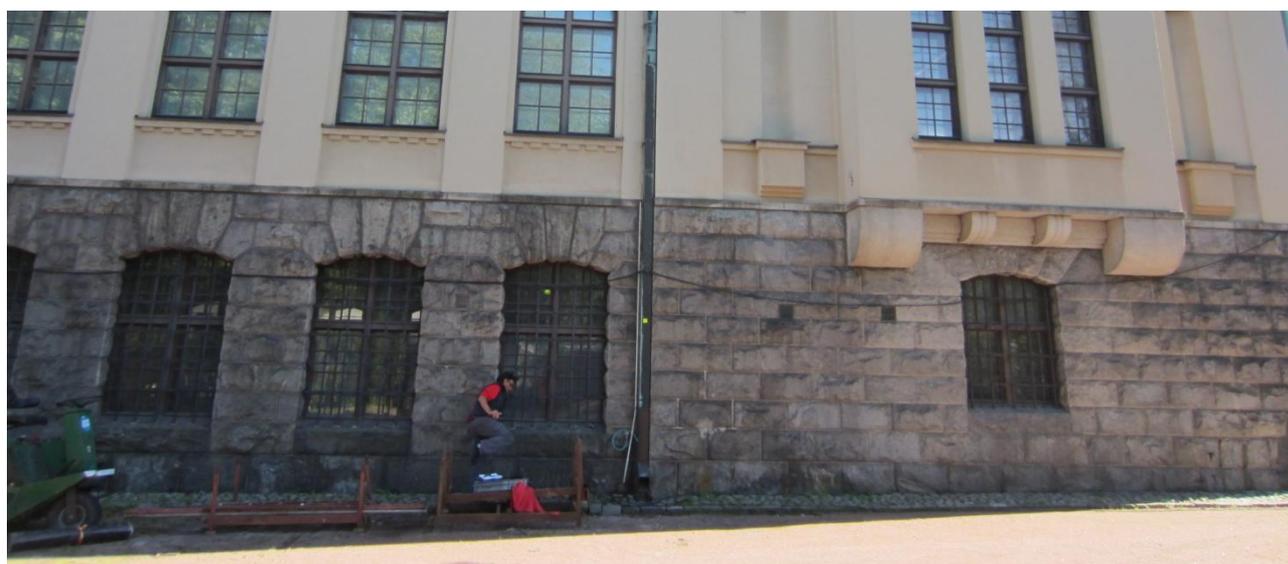
Figure17 Dust fixation visible on the basement facing North. (Photo: N.Luodes)

In Figure17 is visible that the area of the facade covered by the terrace shows lower darkening compared to the one more exposed to rain.

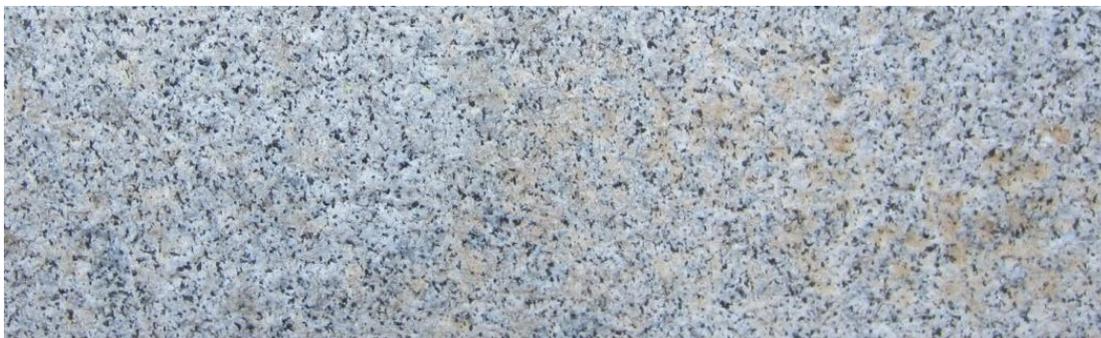
The main bossy basement does not show an inner change of colour, meaning that the minerals had not changed their colour, so had not visibly weathered, but their surface had been affected by dust deposition. The Uusikaupunki granite though, has been studied in its natural outcrops and has been seen that has tendency to get reddish while weathering because of presence of fine grained potassium feldspate./3/ Change of colour could be mainly seen in the bush hammered blocks near the main entrance as visible from Figure 21. In this case it is not clear if it due to the feldspars or to other oxidizing minerals, but it surely attributed to mineral properties of the material.

Figure 21. Block near the main entrance, facing Mannerheimintie showing change of colour. (Photo: N.Luodes)

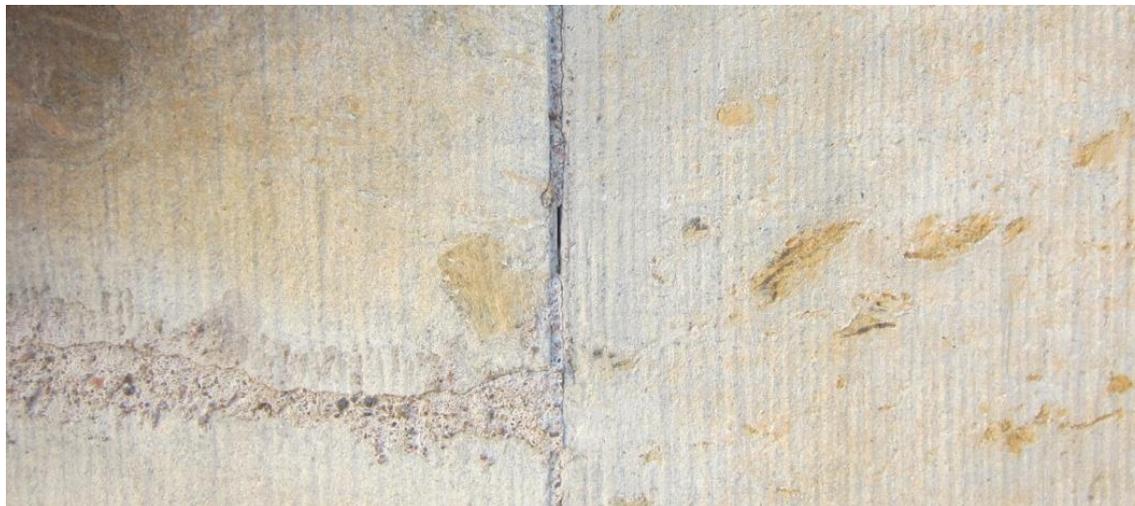
The ornamental elements made by soapstone had instead shown a change of colour, given by the oxidation of the small amounts of iron present in the magnesite as visible from Figure 22.

Figure 22. Soapstone on the arc of entrance to Inner Yard A, showing changing of colour, from original grey to brown/yellow due to oxidation of iron minerals. (Photo: N.Luodes)

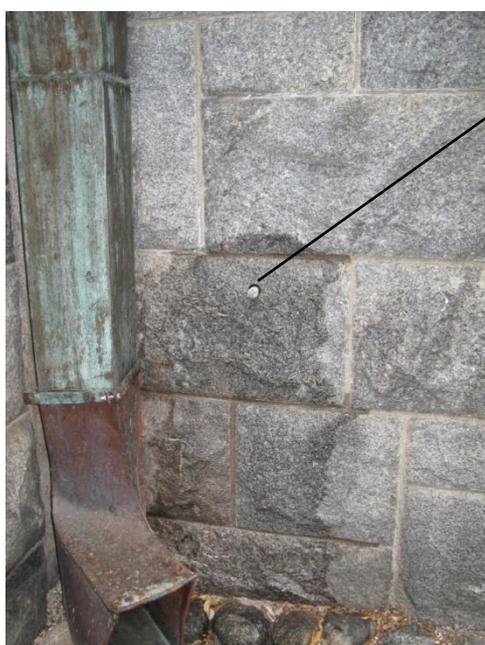
Kansallismuseo 3 / HAPŞ-2013-36.3

Figure 24. Sample Kansallismuseum n.1 taken from a part that has usually been wet and has indoor problems of humidity while Kansallismuseum 3 have been taken on an area that could had been affected by humidity being near a draining pipe.

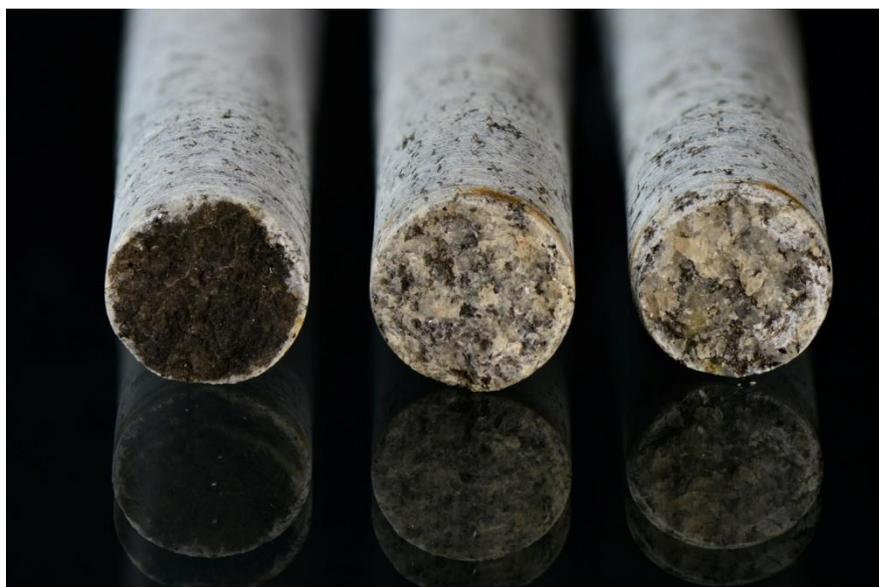
Figure 30 Weathered surface of the drill cores from the Uusikaupunki granite of the National Museum. (Photo by Jouko Ranua GTK). Samples from left to right: 31-35-36

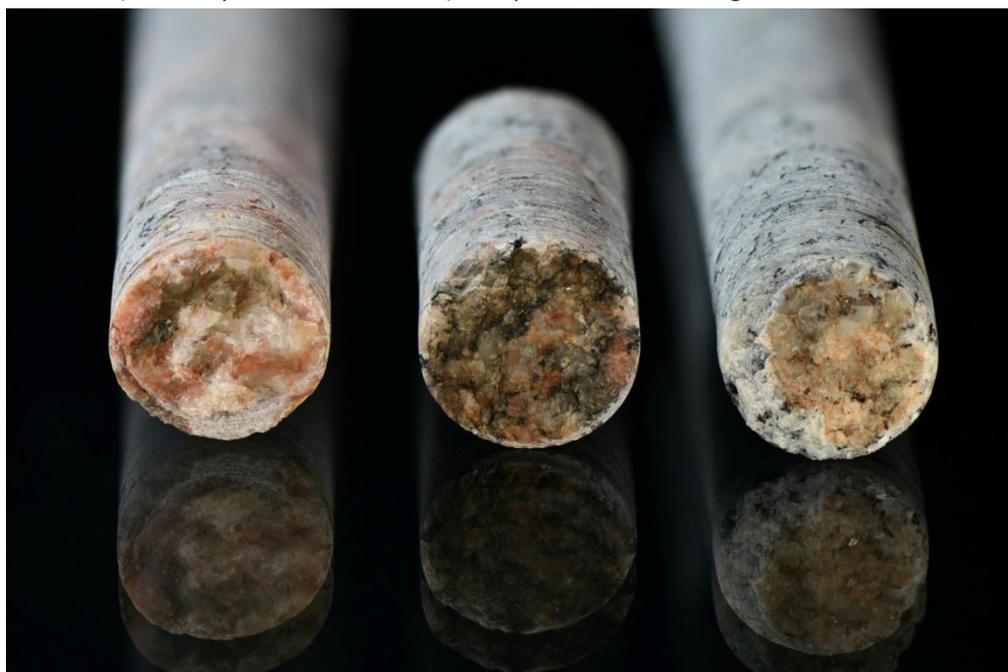
Figure 32 Weathered surface of the drill cores from the red granite of the National Museum (Inner Yard A). (Photo by Jouko Ranua GTK). Samples from left to right: 32-33-34

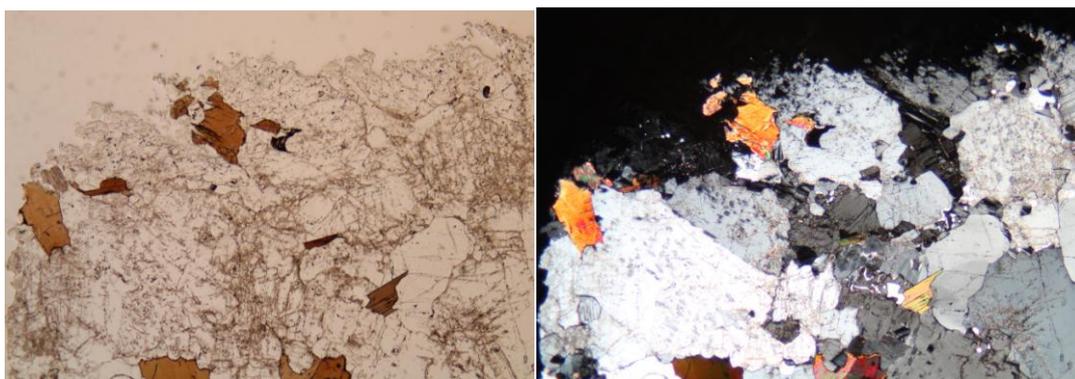
Sample HAPŞ-2013-36 (Figure 35 and 36) is also showing high weathering degrees, in which microcracks had evolved along the borders and within the minerals.

Figure 36. HAPŞ-2013-36. Broken mineral structure on the stone surface characterized by formation of small internal fractures in feldspar grains.

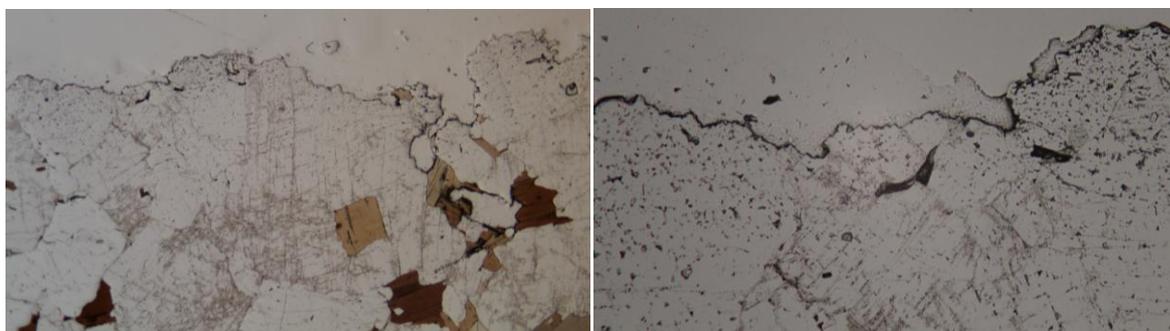
Figure 37. HAPŞ-2013-36. Weathered stone surface characterized by intensive fracture formation in feldspar grains.

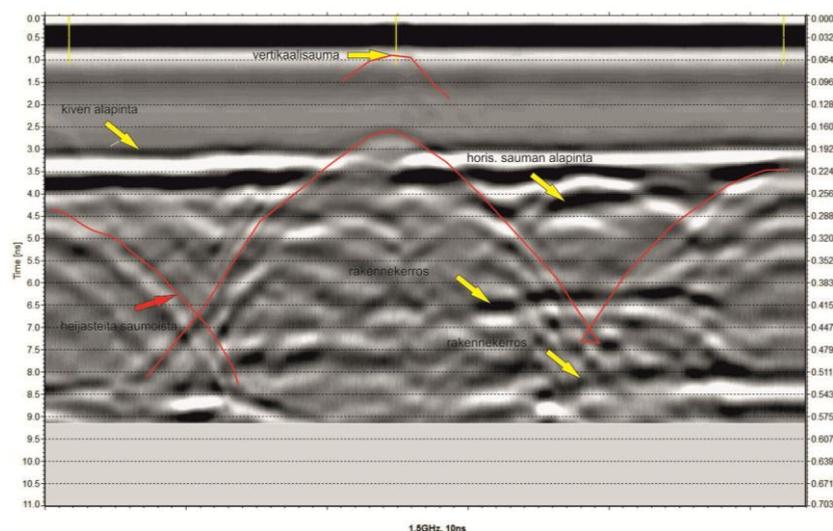
Line F4 is shown in Figure 45 and its GPR interpretation in Figure 46. The surface stone is compact and presents a neat rear surface (kiven alapinta), the surface does not present visible cracks. The joint between the blocks is also visible, giving a clear hyperbole (vertikaalisauma). The material that is behind it is a mixed material that shows several small reflections and some higher ones, it is possible however to identify two deeper construction layers (rakennekerros) of the wall. The measurement has been taken along the sill, that was bent to allow run off of the water, and as visible from the picture, during a rainy day.

Figure 46. GPR interpretation for line F4 (vertikkalisauma: vertical joint; heijasteita saumoista: reflections from joints, horis. sauma alapinta: horizontal joint indicating the back surface of the stone, rakennekerros: construction layer) (Radardgram: Heikki Sutinen)
