**SOUTH-EAST FINLAND - RUSSIA ENPI CBC PROGRAMME 2007-2013**  
**Efficient use of natural stone in the Leningrad region and South-East Finland**

## Site Inspections

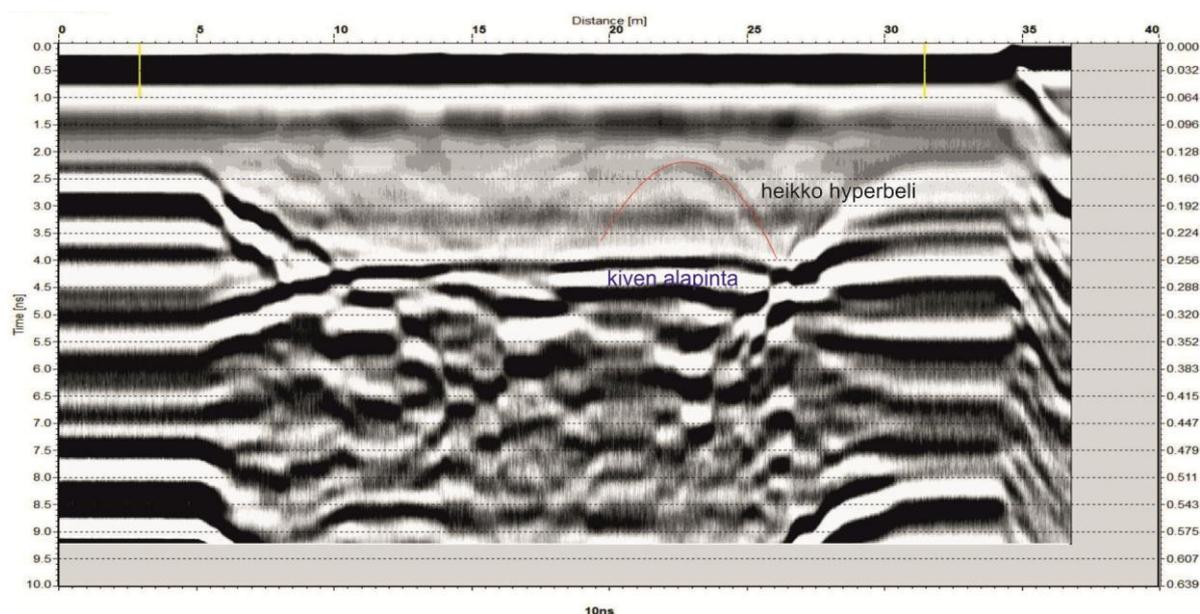
Figure 48 interpretation of GPR results for line F7 (Radardgram: Heikki Sutinen)

From Figure 48 is visible presence of weak hyperbole (heikko hyperbeli) given by an anomaly. Since it is not strong it should not be an iron element, but can be a crack in the back part of the material or a tube attached to it in the back or, still, a small iron element. It is visible clearly the back surface of the blocks (kiven alapinta). Behind the block is visible presence of heterogeneous material, characterized by high scattering.

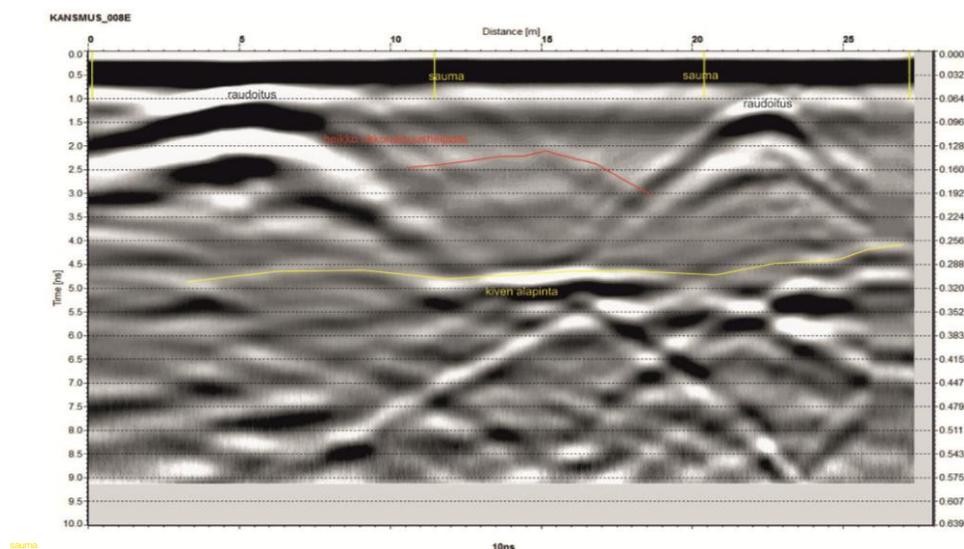
The line F8 of the National museum has been taken from the entrance arc to Inner Yard A, the Line 9 is not here discussed but had been measured. In the measurements of Line F8, as visible from Figure 50, there are two strong

reflections, that could be given by iron anchoring (raudoitus). The material is a soapstone and naturally could present some magnetic minerals but their presence should had been visible also elsewhere in the mass of the stone. It is visible a back surface of the stone at approx.25-32 cm. A light reflection in the stone could be given by stone structure (heikko riikonaisuusheijaste).

Figure 50. Interpretation of line F8 (Radardgram: Heikki Sutinen)

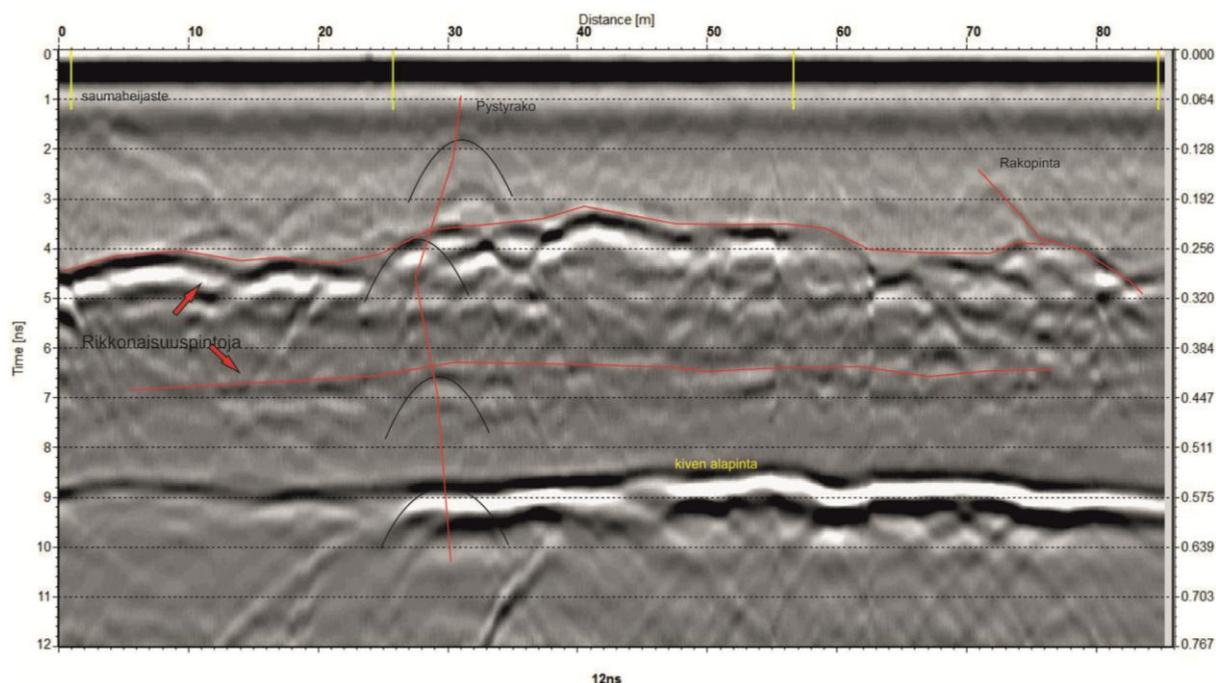
The Line F10 and F13 have been measured from the left side of the basement on the entrance arc towards the inner yard A (Figure 52). In the interpretation of the measurements, shown in figure 53, are visible 3 neat layers. Could they be attributed to three layers (stone surface of approx.20-25cm, mid stone layer, back layer) or to fractures in the stone, has to be evaluated, also from comparison with the other side of the entrance.

Figure 53 Entrance to Inner Yard A, left side, interpretation of GPR of Line F10 (Radardgram: Heikki Sutinen)

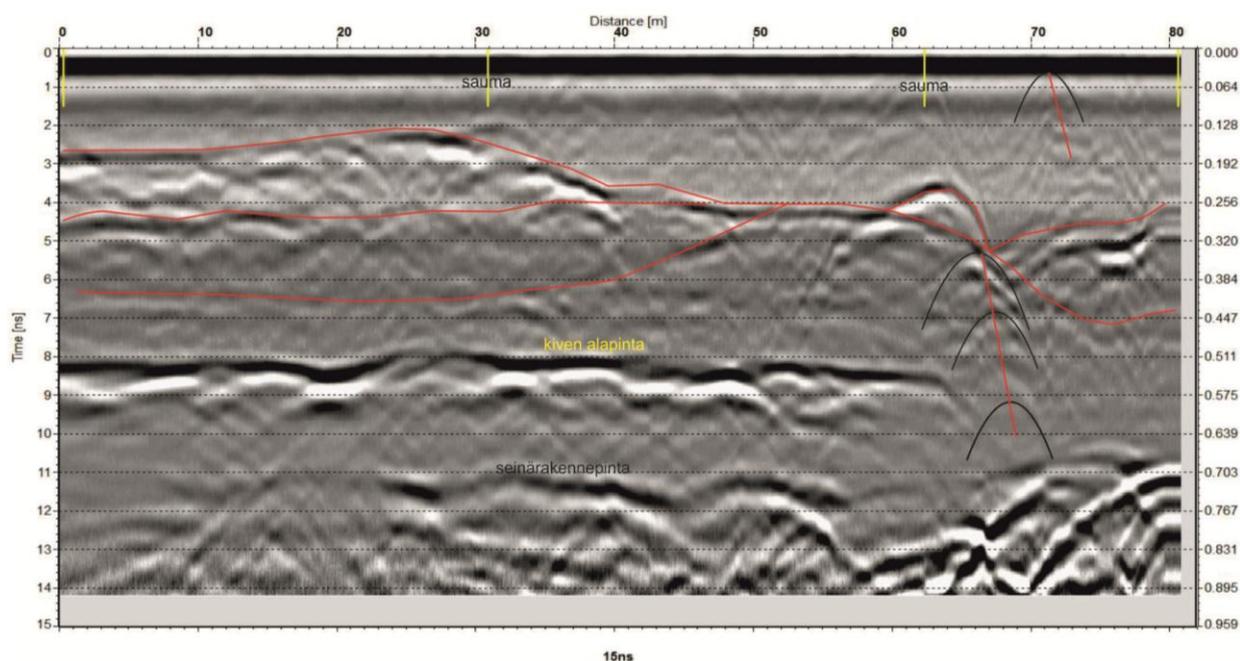
Line F11, visible in Figure 54, is measured on the right side in the entrance arc to the Inner Yard A. In figure 55 are visible a strong back reflection and middle reflections, either given by wall layers or by internal fractures.

Figure 55 Entrance to Inner Yard A, left side, interpretation of GPR of Line F11 (Radardgram: Heikki Sutinen)

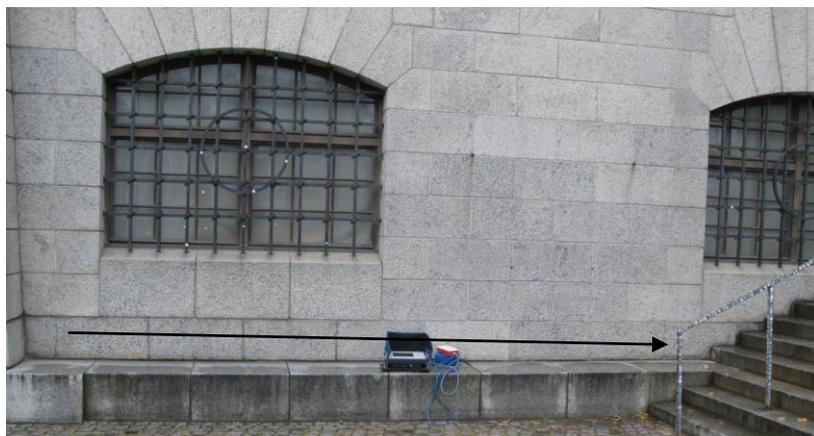
In Figure 58 is shown the measurement performed over the brush hammered part near the entrance. The granite is Uusikaupunki, the radargram showed the presence of the iron anchoring of the window and the three layer wall. Internal cracks have not been visible.

Figure 58. Measurement Line F16 has been collected.

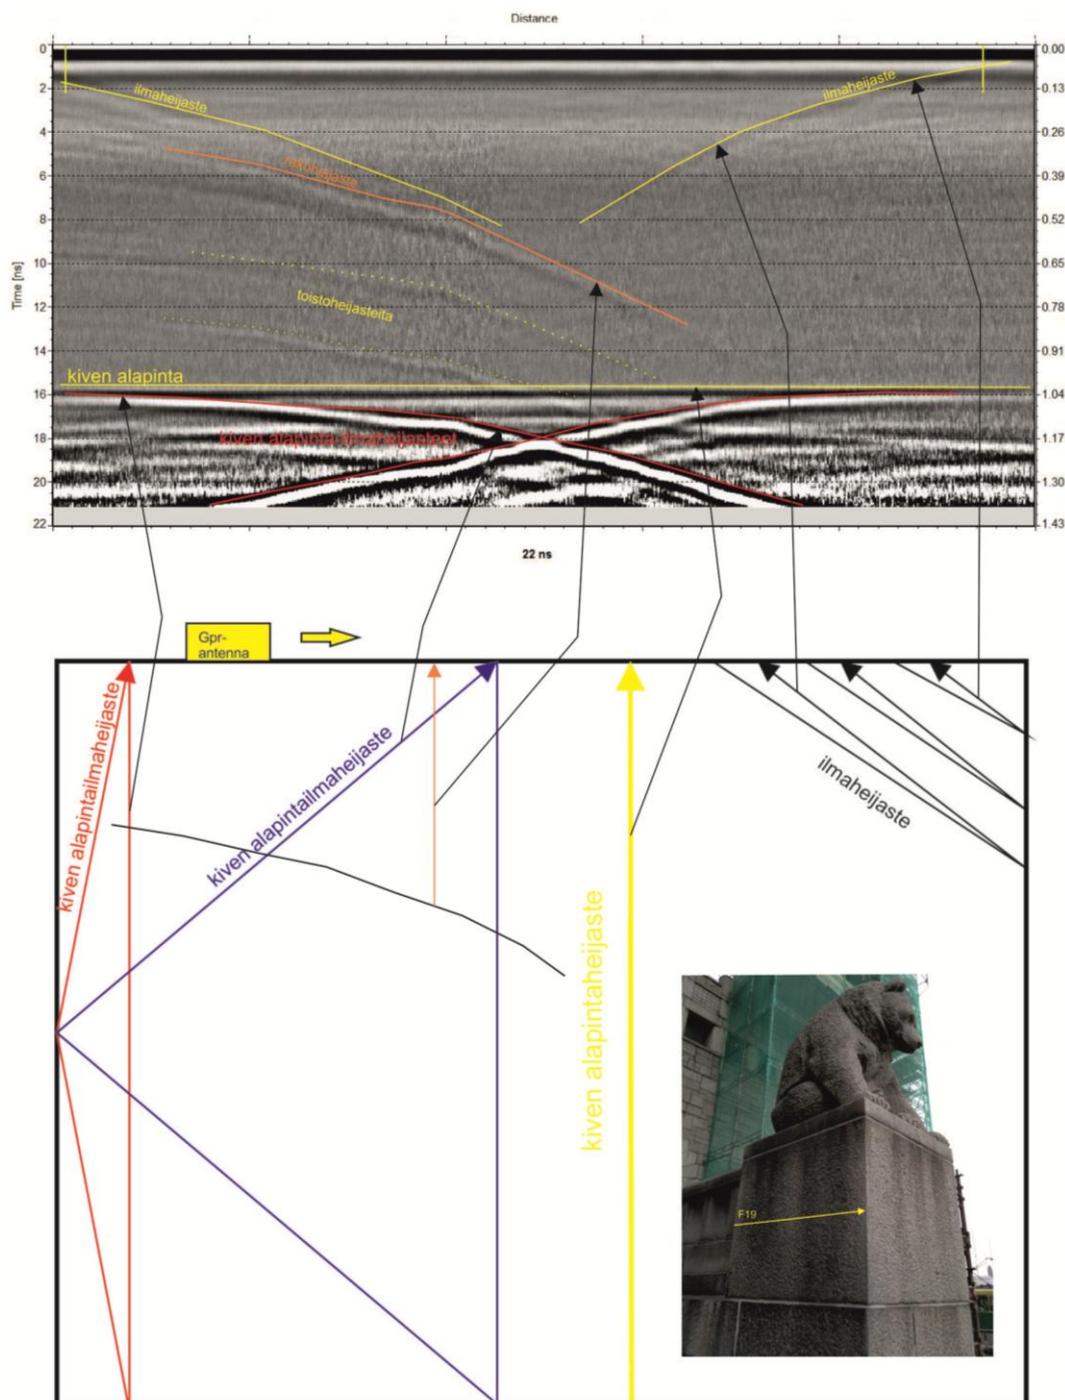
From the line F19 are visible anomalies. In Figure 60 is has been schematized the meaning of the anomalies, trying to picture on a base map of the pillar their origin.

It is visible the back side of the stone (kiven alapinta) and after it the interference given by the air (kiven alapinta ilmahejasteet). Are also visible two curves, one on the right and one on the left underlined in yellow, determined by the reflection of the corner of the block (ilmaheijaste). There is a curve (visible in red) determined by an internal heterogeneity, that could be a fracture or a vein (rakoheijaste).

Figure 60. GPR measurement on one side of the basement of the statue of the bear and the explanation and interpretation of the radargram.

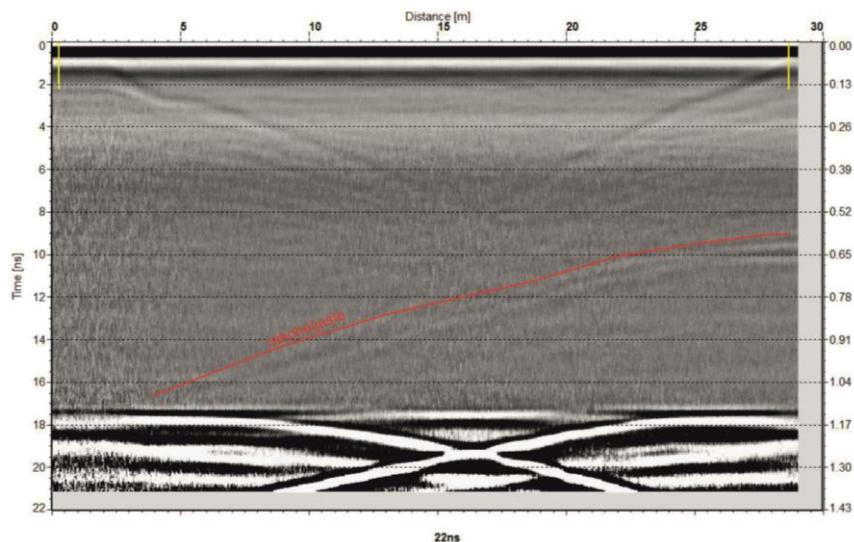
In Figure 61 are shown the results from the measurement performed on the adjacent side and it is visible from Line F20 the same curve given by internal heterogeneity.

Figure 61. The curve showing the internal anomaly is visible also from this side, as was visible in Figure 60. (Radardgram : Heikki Sutinen)

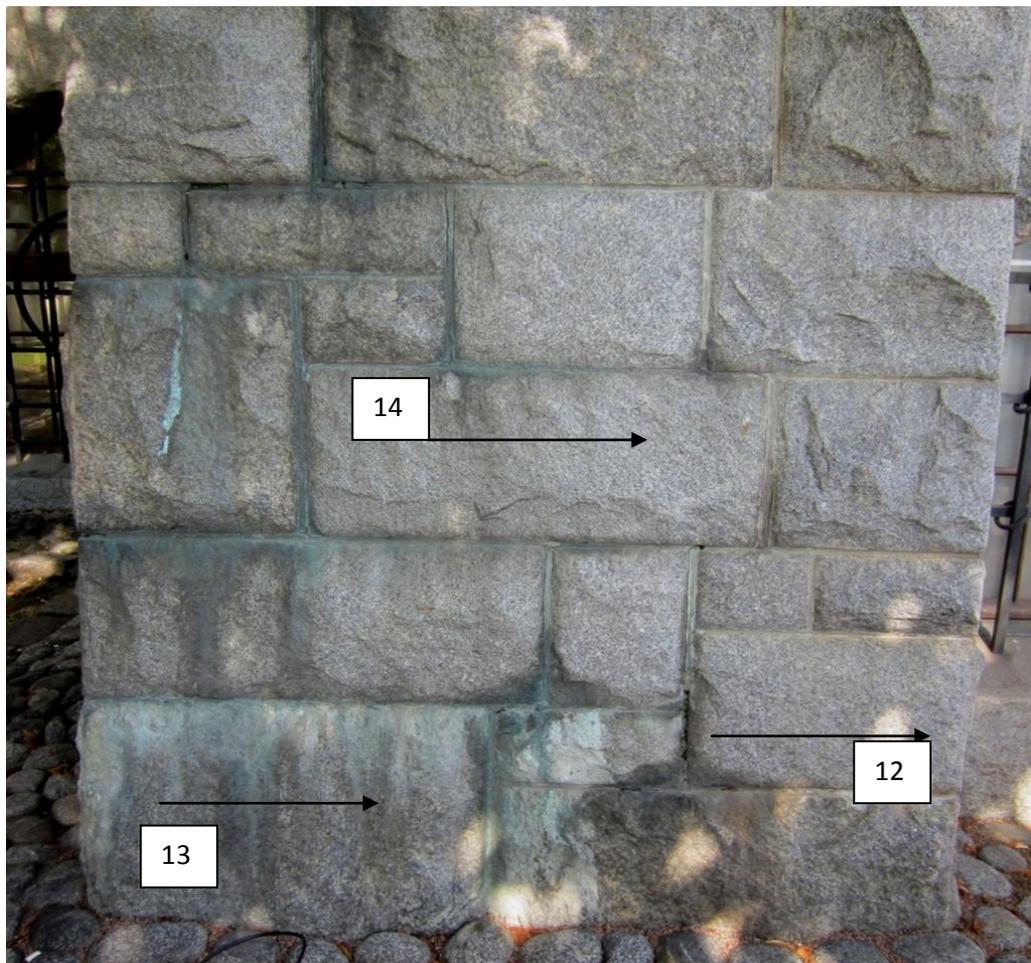
Figure 66. Exposition to the South, left wall of the second window from right to left looking at the façade. Blocks 12,13,14 measured.

The measured n 13 has the last measures (5<sup>th</sup> and 6<sup>th</sup>) over the crust given by copper deposition.

Blocks 1-5 have been over a part of the building that presented humidity problems but their velocity is quite regular not showing particular deviations over the specific blocks. The block n 13 had been measured partially over the crust given by deposition of copper but it does not show a deviation in velocity compared to the average.

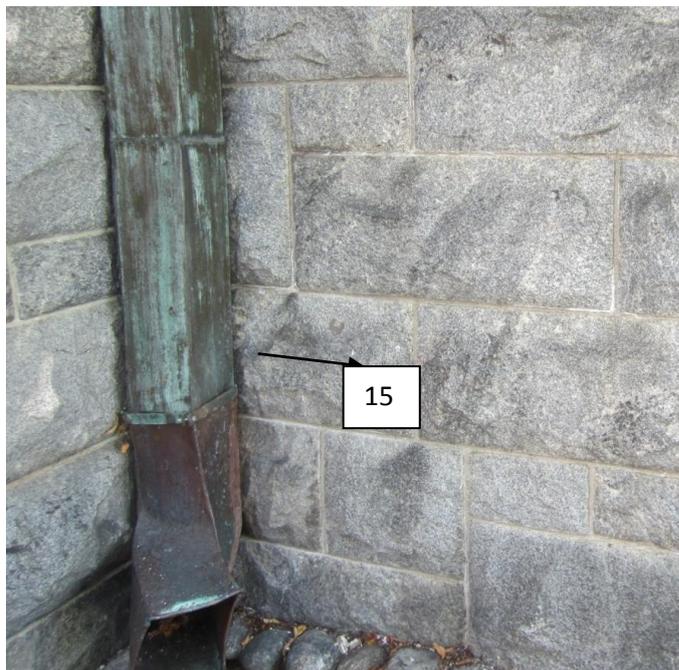
Figure 67. In the figure is visible the block that had been sampled, near the drain pipe, on the corner from the facade facing South, but as a block exposed to West . On it had been evaluated the UPV.

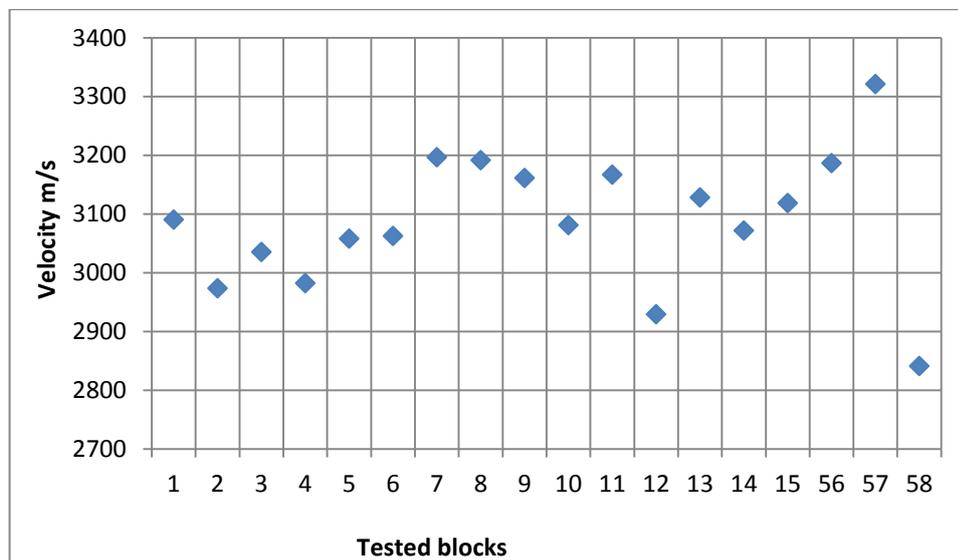
Figure 69 Velocities calculated for each block from the facade facing South.

Blocks 56, 57 and 58 are from a more traffic area compared to the other measurements and the surface is bush hammered, that might be a reason for the higher results obtained over block 57 for example, having the possibility to position better the transducers over the surface. Block 56 is affected by black crust and its value of velocity is in the average. The block 58 presented a crack and that is most probably the reason for the low average velocity over that specific block.

The low velocity measured over block 12 cannot be attributed to a crack or to a deposition layer over the surface, since those had not been determined visually but could be determined by the properties of the material of that block or by its humidity levels.

Even if the material is the same the values are very heterogeneous, with values generally oscillating between 2990 and 3200 m/s.

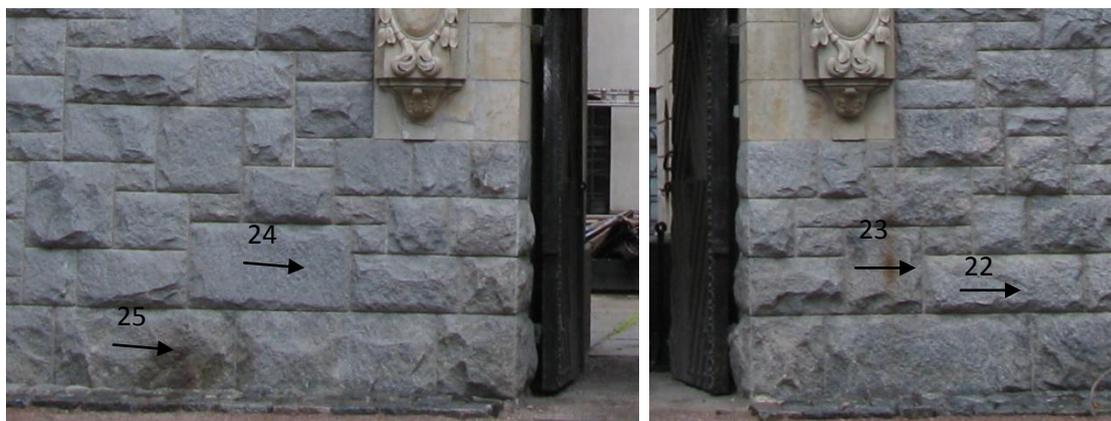
Figure 70. Blocks at the sides of the entrance to Inner Yard A. Measurements over blocks 22,23,24,25, have been taken. Block 23 had a rusted spot and the measurements have been performed over it.

Also for this exposition the material show variations between 2990 and 3200 m/s. Block 23 had been sampled over a rusty area but its velocity does not show an increment compared to other average velocities, as well as block 42, while the block 41 showed a high increase in velocity probably given by a higher metal deposition, visually looking as a clear percolation over the surface. Block 41 and 42 are shown in Figure 75.

The higher velocity of block 25 could not be caused by internal fractures but is probably due either to an increase in humidity or by the influence of its irregular surface. The fact that the measurements have been performed in direct sun from block 34 to 42 does not show a clear effect on the results, as blocks 23,24,35,38, 40 and 42 have shown similar velocities.

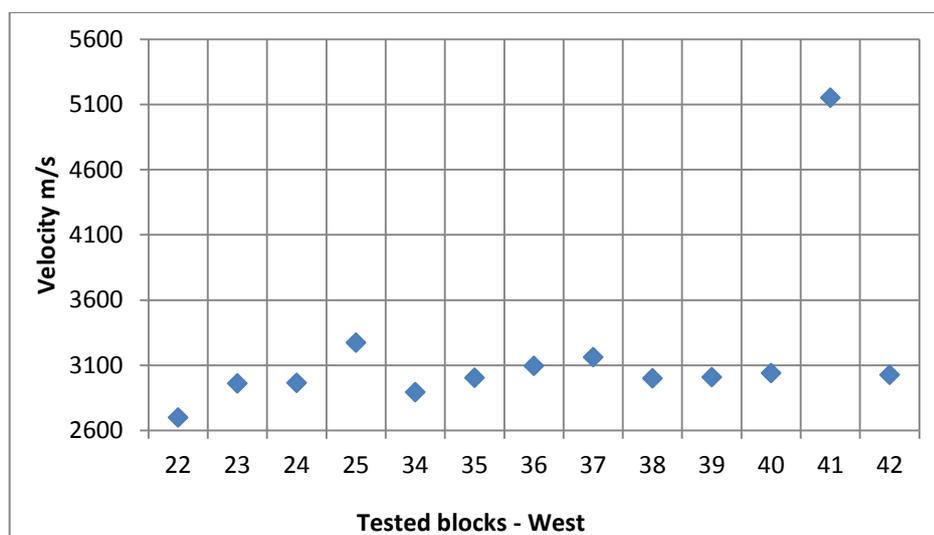
Figure 73. Velocities calculated for each block from the facade facing West

From figure 73 it is visible that block n 41 had shown much higher velocity compared to all the others and in order to visualize the average of the others it is excluded from the evaluation. In Figure 74 is shown the new representation.

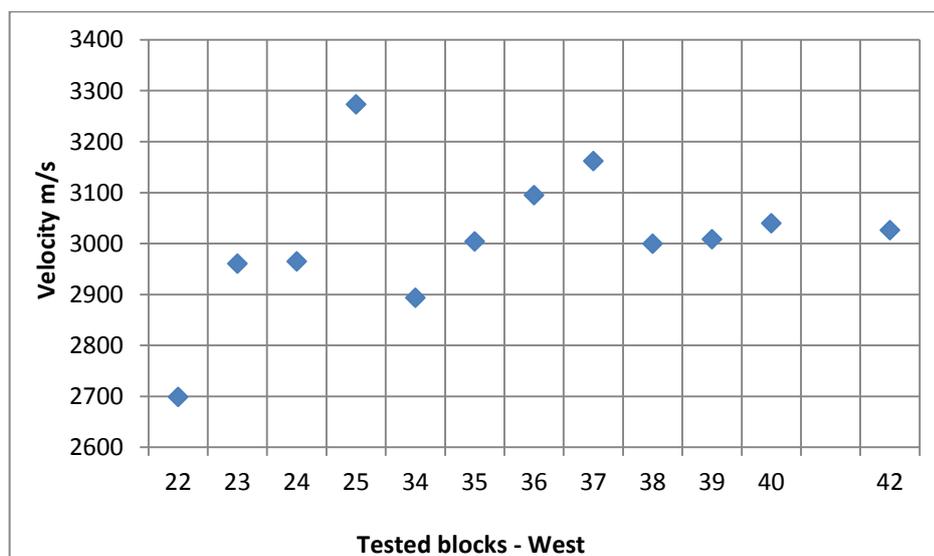
Figure 74. Velocities calculated for each block, excluding block 41, from the facade facing West

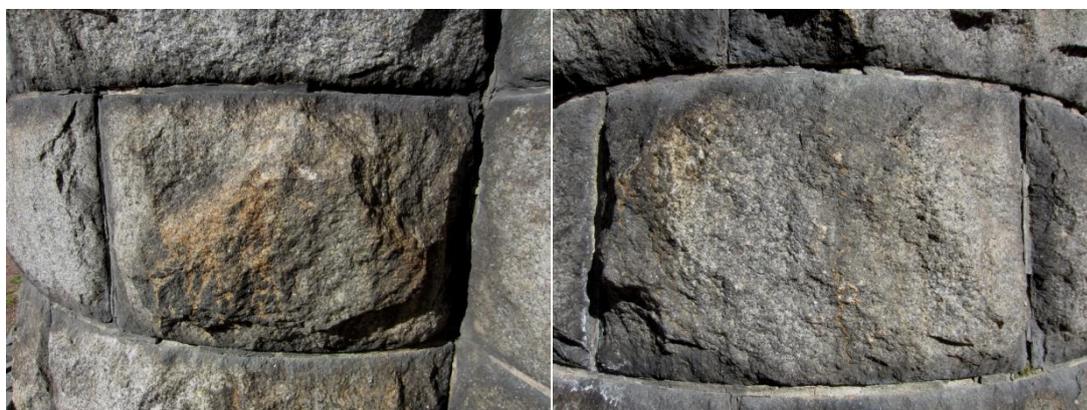
Figure 75. Block 41 on the left and 42 on the right, over the semicircular element facing West.

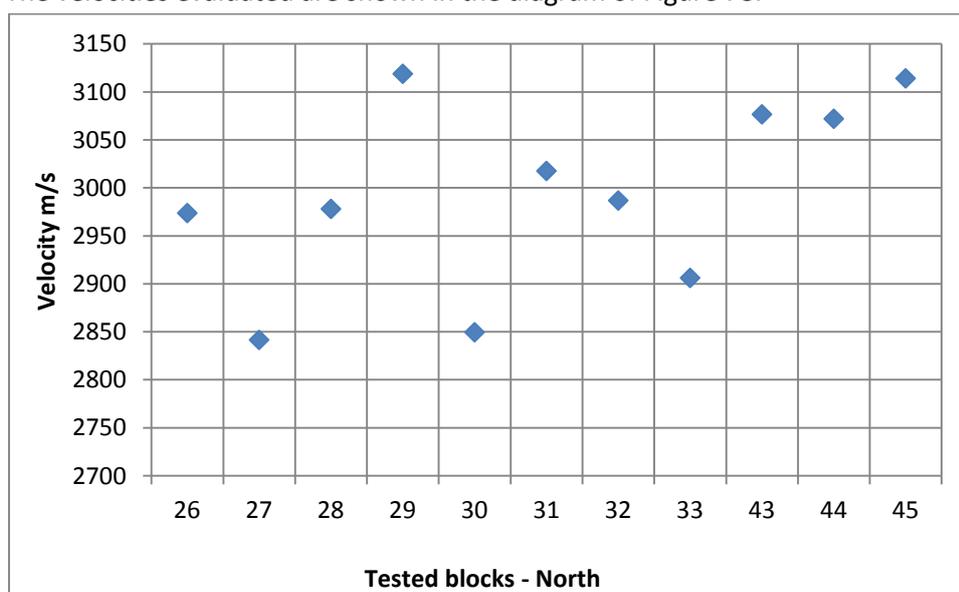
Figure 78. UPV on the blocks evaluated from the basement facing North.

The results are very heterogeneous and oscillating between 2850 and 3100 m/s, in line with the previous values obtained for other expositions.

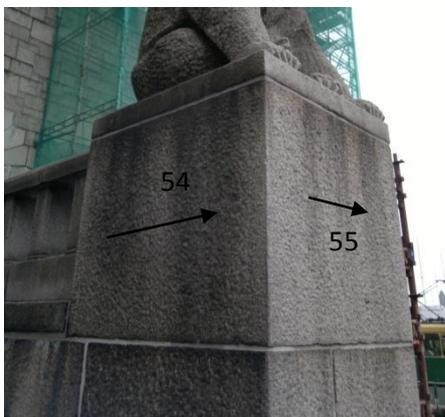
Also the pedestal of the bear statue has been measured as shown in Figure 83, over the measuring line 54 has been evaluated a speed of 3100 m/s, while over the measuring line 55 a speed equal to 2939 m/s has been evaluated.

Figure 83 Basement blocks had been measured and numbered 54 and 55.

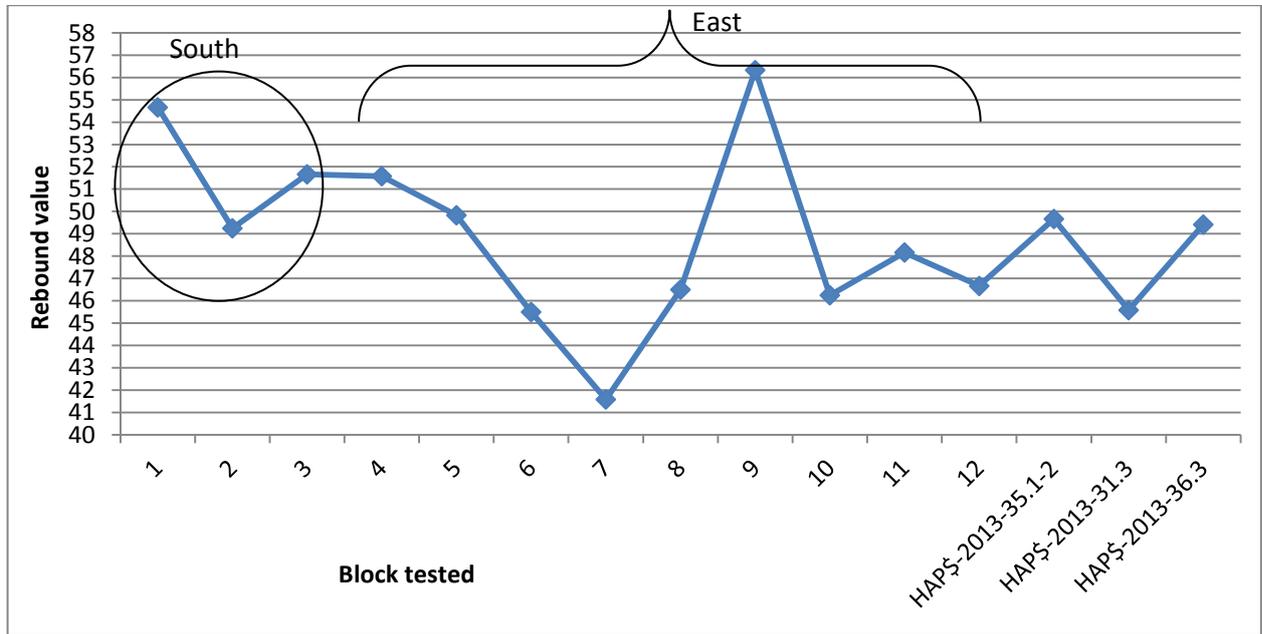
Figure 89. Diagram showing the average rebound for each block of Uusikaupunki granite tested.

The block number 7 has shown the lowest values even if has not shown visual differences compared to other blocks, while block n 9, that presented yellow vein, showed highest values. Blocks 1,2,3 had been measured from the façade facing South, while blocks 4-12 on that facing East. The blocks facing East, bush hammered, are showing change of color, also block n.7 and block n 5 even if the impacting point has not been straight over a yellow area.

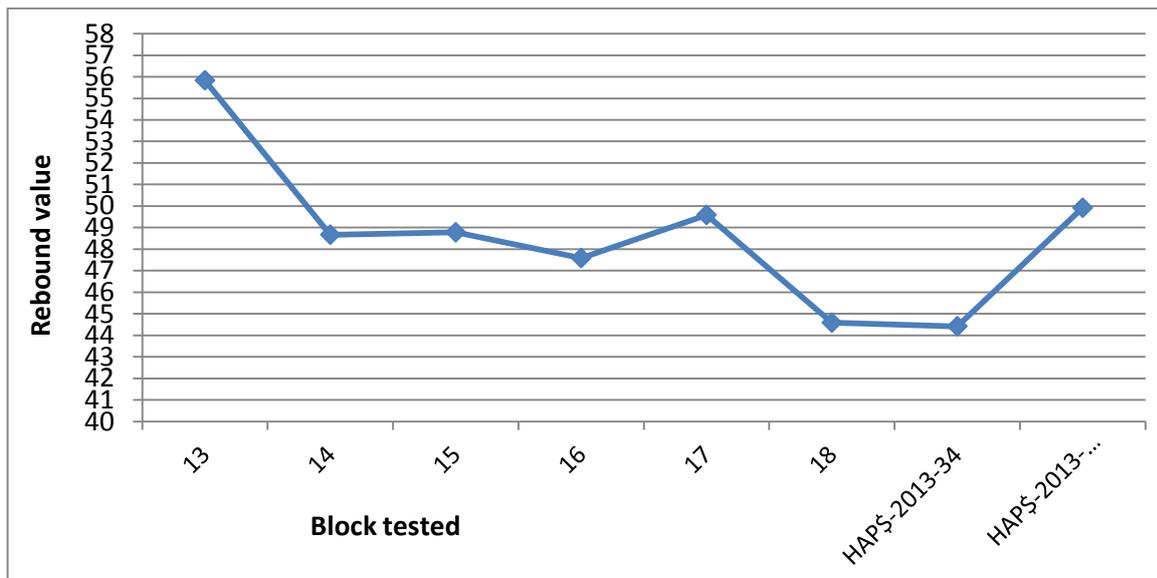
Figure 90. Diagram showing the average rebound for each block of red granite tested from the entrance of Inner Yard A.

The values are heterogeneous but also the material itself has not been homogeneous. Some blocks show a much lower value, and one of them, block n.18, had been tested over dust deposition or black crust that has lowered the value of rebound. Other instead, as block 13 shows a very high rebound value, indicating that the material has higher surface strength compared to the others, or it is a different material, having more hard minerals compared to the other blocks.

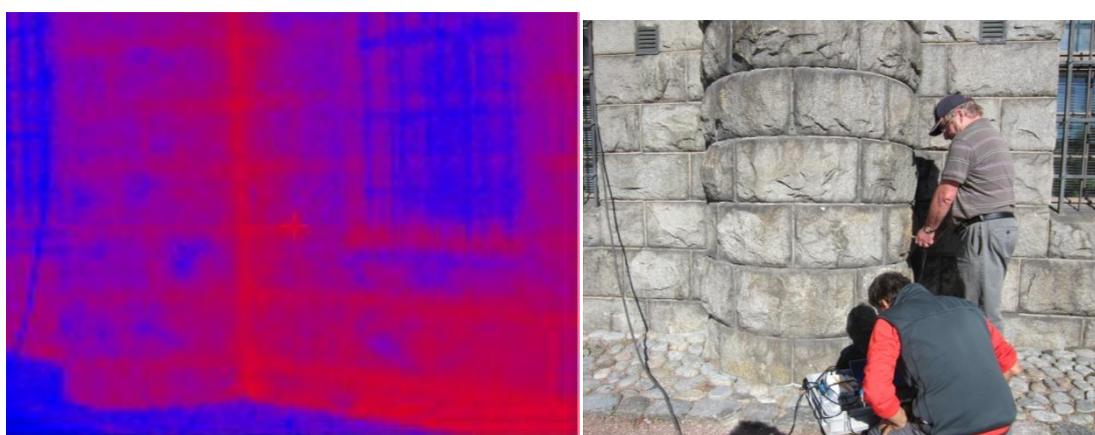
The measurements have been performed in an evening, not in direct sun, in a cloudy and rainy day. Temperature has been higher in the corners, as also seen in other buildings, it can be seen for example from figure 91.

Figure 91 Corner of the semicircular tower facing West

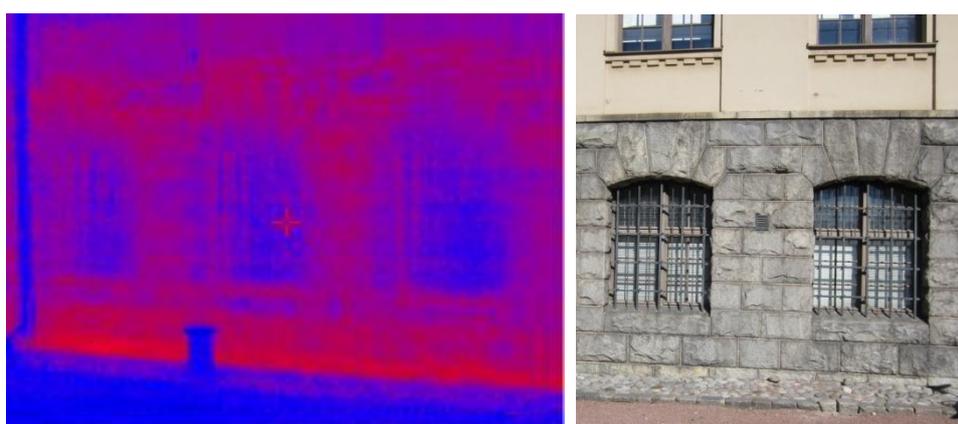
The lower part of the basement has also been showing higher temperatures compared to higher parts as visible from figure 92 and a possible reason is the differences of construction of the walls or different use of the floors.

Figure 92. Basement facing West

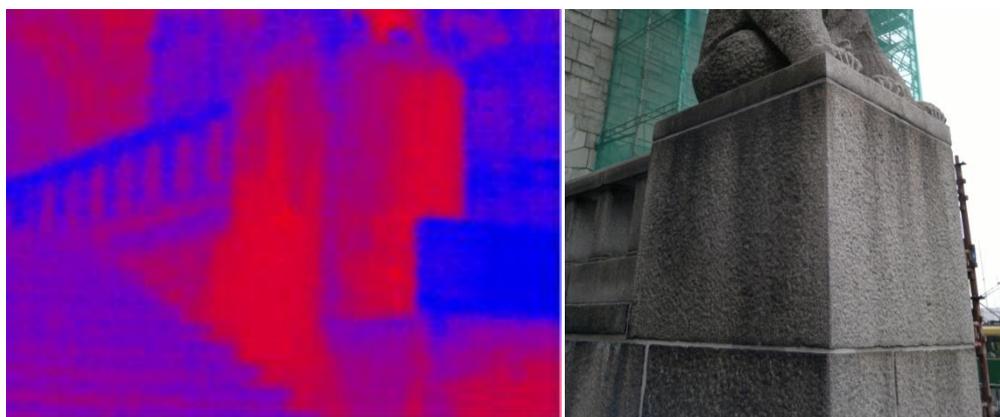
The basement of the bear statue has also been photographed with the thermal camera, as visible from Figure 93 and it is visible that the basement is warmer than the stairs and along the stairs the parts more exposed to the wind looks colder.

Figure 93 Basement of the bear statue near the entrance

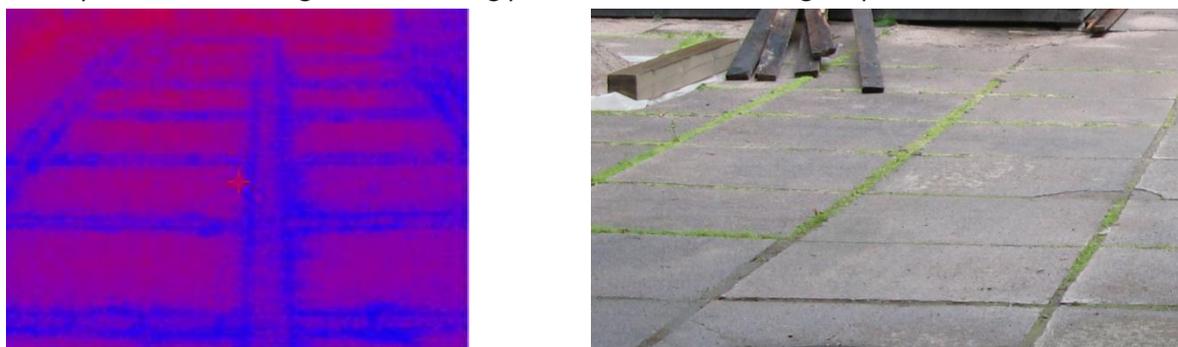
Figure 94 Mosses and higher plants over internal yard paving.

Vegetation appears as a colder part on the image. Depending on weather conditions and on kind of organism colonizing the material it could appear both colder and warmer compared to the stone. Probably it depends on its kind of vegetation, on the amounts of sunlight and on the difference between temperature of surface and air.

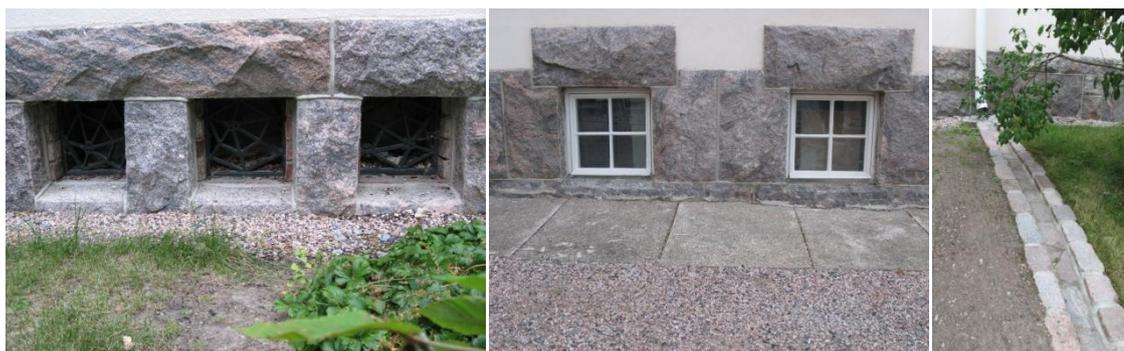
Figure 3. Particulars of the windows on the basement and of the water drain. (Photo: N.Luodes, GTK)

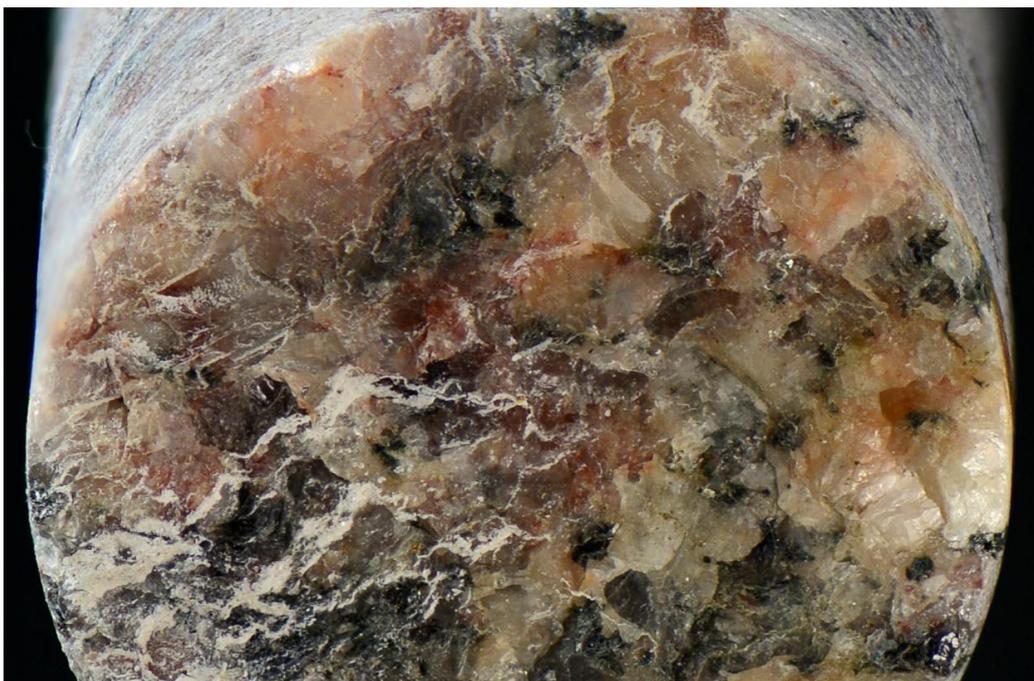
Figure 12 Detail of the weathered surface of the sample HAP\$ -2013-26.1-2 showing dust deposition and iron oxidation (up-right). (Photo by J. Ranua GTK)

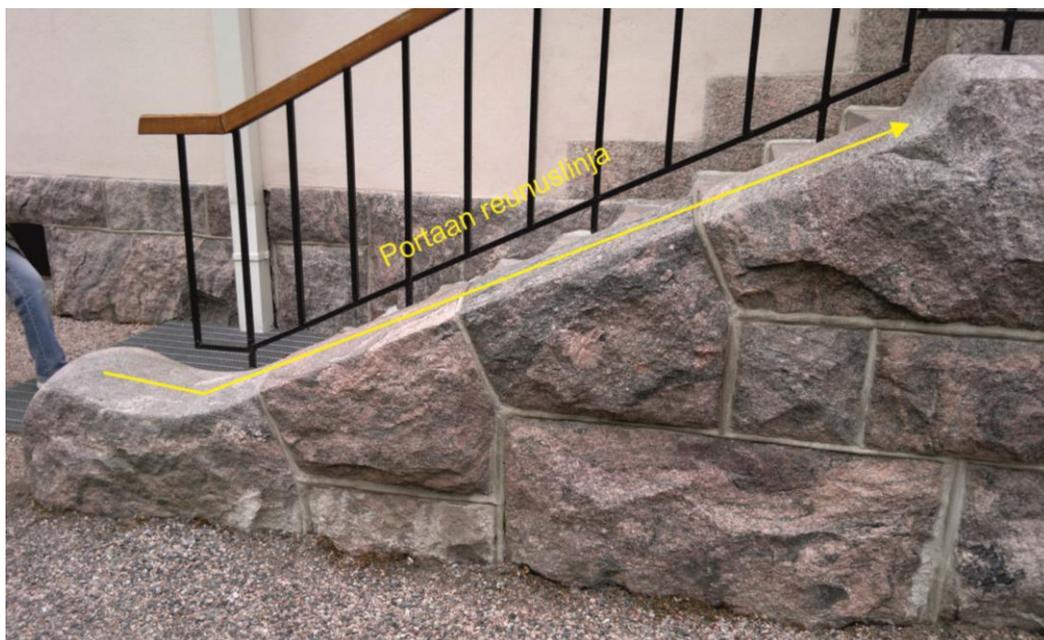
Figure 17. GPR measurements performed over the stairs.

There is presence of anomalies visible as reflections. Those coming to surface are given by mortar joints, the strong ones deeper are given by the lower and side surface of the blocks. Following are the elaborated images of the radargram collected.

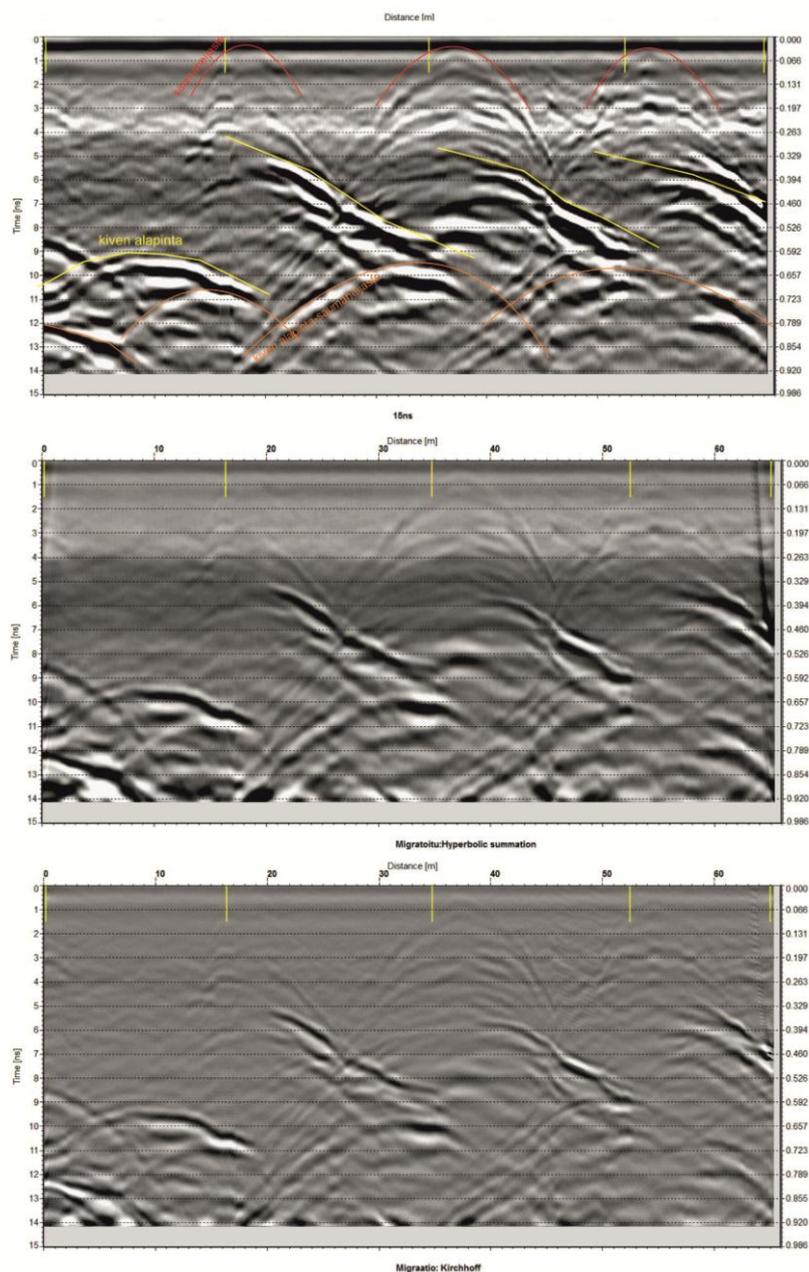
Figure 18. Analysis of the radargram measurements (in yellow: reflection given by block's lower face, in red: reflection given by mortar joints, in orange: reflections given by mortar joints of the lower surface of the blocks)

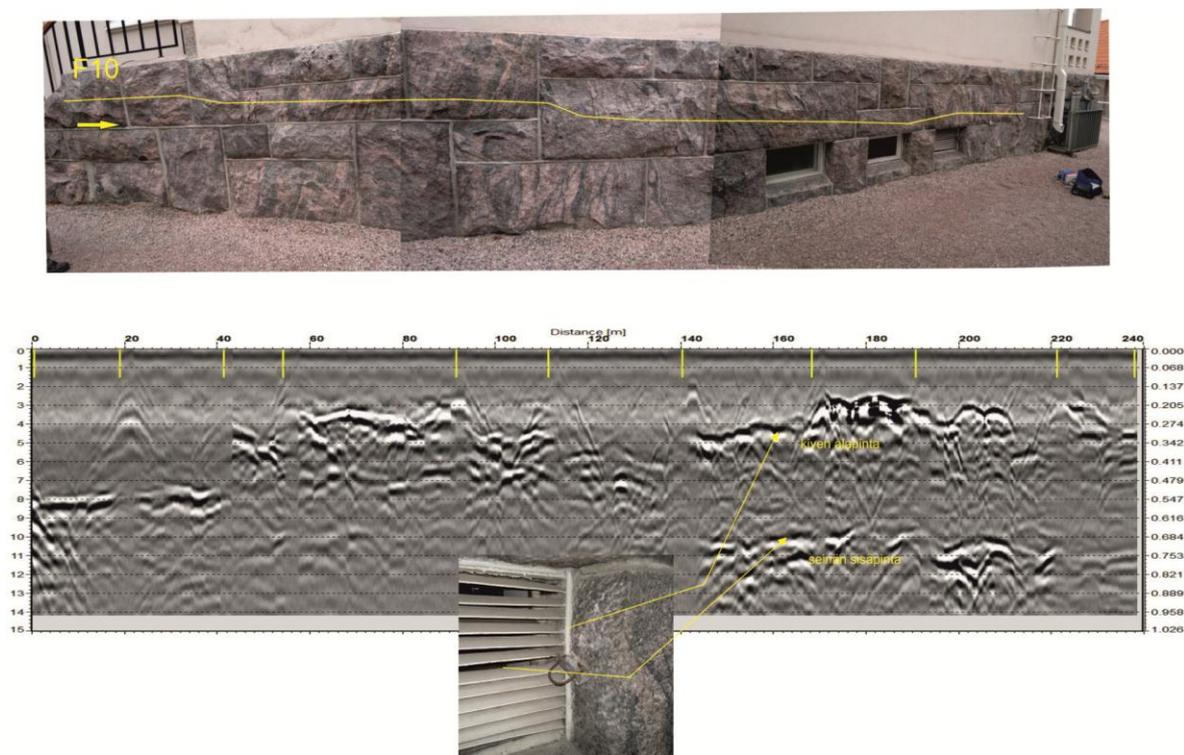
From the analysis done over the wall the material does not present fractures. GPR technique had been able to identify the changes in thickness of the wall, thicker in the first part of the wall and thinner, as multi-layer wall, in correspondence of the room underground (visible in detail in Figure 19).

Figure 19. On the top are shown the positions of the GPR measurements collected over the wall, F10, on the bottom is shown the radargram collected along the measuring line. (In yellow are shown: Kiven alapinta: stone's lower surface, Seinän sisäpinta: wall's internal surface).

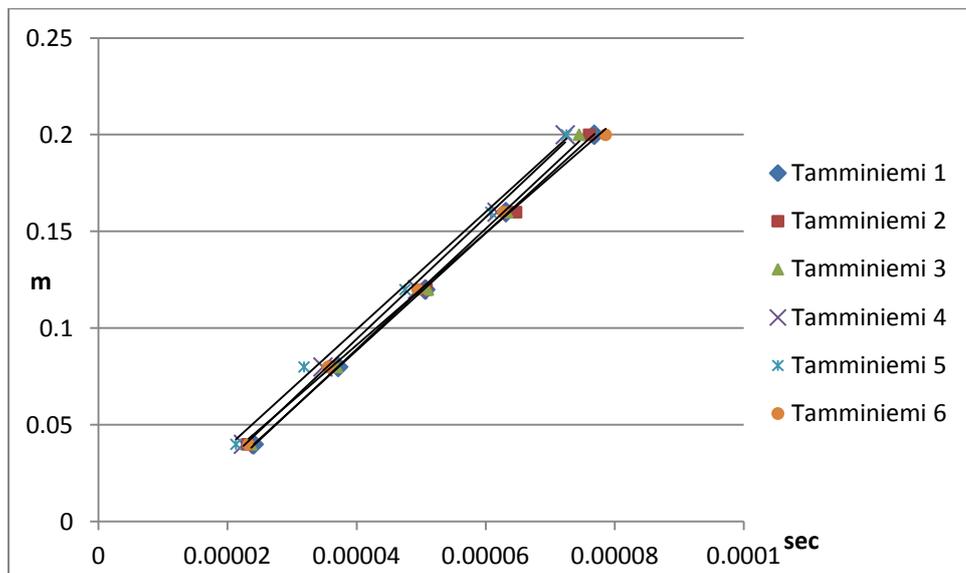
The results have been showing a very compact material, not affected by weathering, with high speed and linear graphics, even if the material had been presenting irregular surface and visible veins. The diagrams of the velocities for the 6 measurements are shown in the graphic of Figure 21.

Figure 21. Graphic of the measurements performed

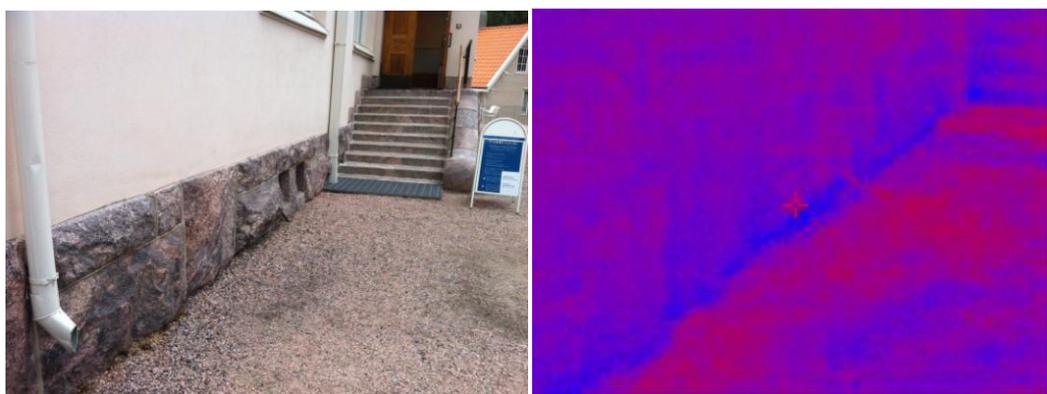
The measurements have been performed during a partially cloudy day, has been noticed mainly the wet areas: the contact area of the basement to the ground (Figure 22, and Figure 23), differences in temperature between the mortar joints and the stone blocks (Figure 23), moisture areas in correspondence of the drain pipes (Figure 24).

Figure 22 Contact area between the basement and ground (Photo: A. Shkurin)

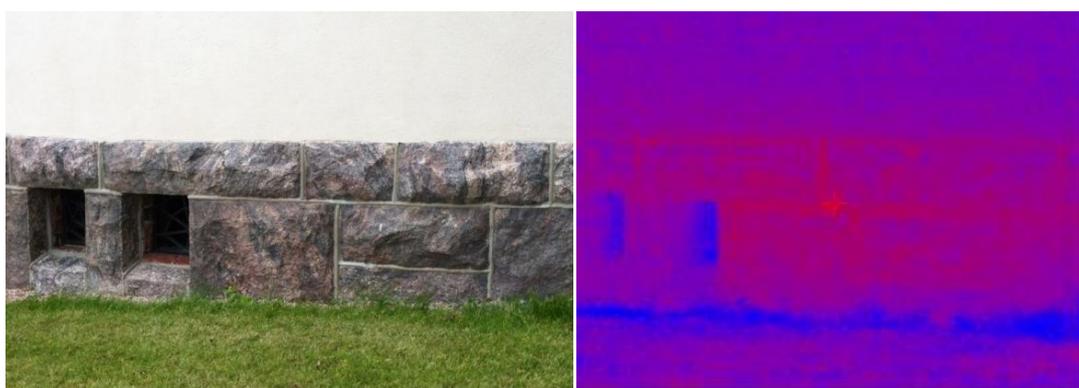
Figure 23 Contact area between the basement and the ground as colder, while as warmer the mortar compared to the stone material (Photo. A Shkurin)

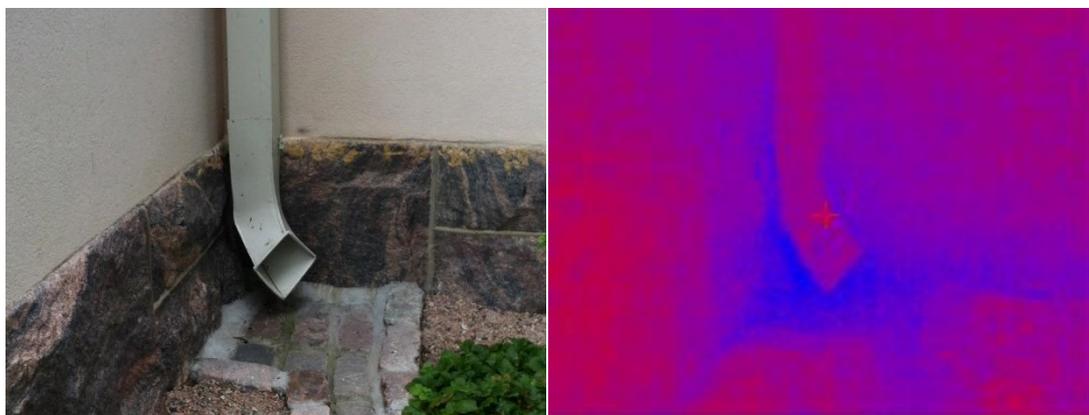
Figure 24 Moisture areas in the corner in correspondence of the drain pipes (Photo. A Shkurin)

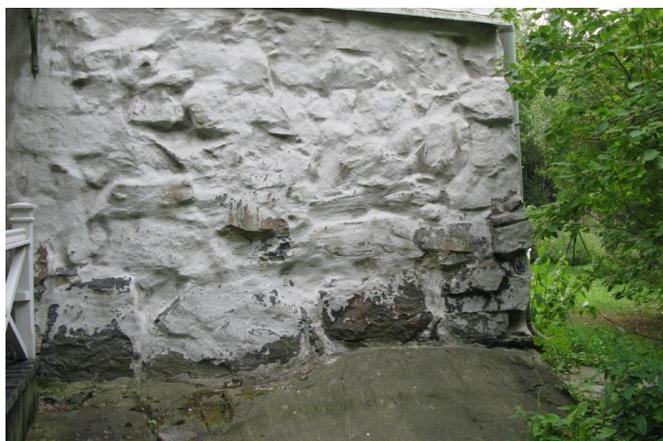
Figure 2. Particular of the basement where it is visible that the blocks are laying over the bedrock (Photo: Nike Luodes, GTK).

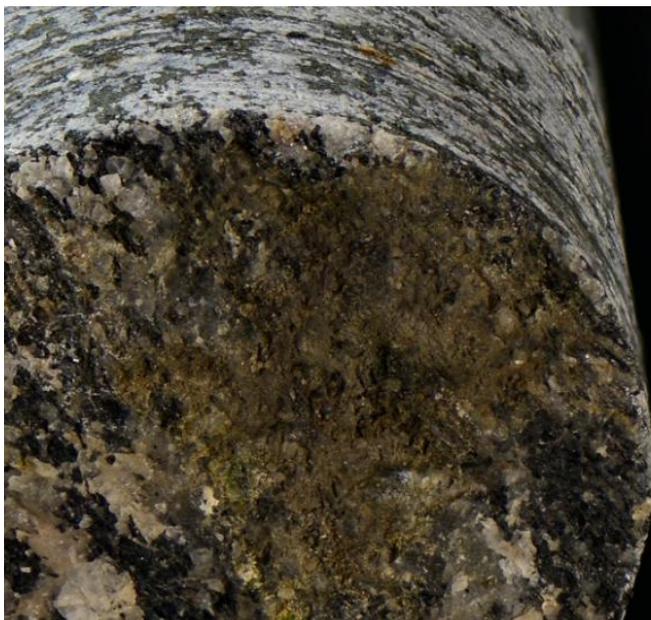
Figure 12 Detail of the weathered surface of the sample HAP\$ -2013-29 showing dust deposition and fixation. (Photo by J. Ranua GTK)
