**SOUTH-EAST FINLAND - RUSSIA ENPI CBC PROGRAMME 2007-2013**  
**Efficient use of natural stone in the Leningrad region and South-East Finland**

## Site Inspections

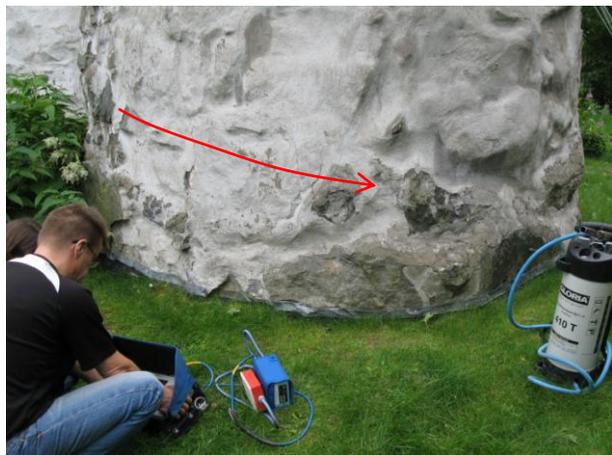
Figure 16. Are shown the positions of the GPR measurements collected F1 and F2. (Photo: N.Luodes)

The results had been difficult to be interpreted because of the heterogeneity of the wall structure. Anomalies given by contact of the blocks had been giving strong reflection, minimizing possible structural deficiencies.

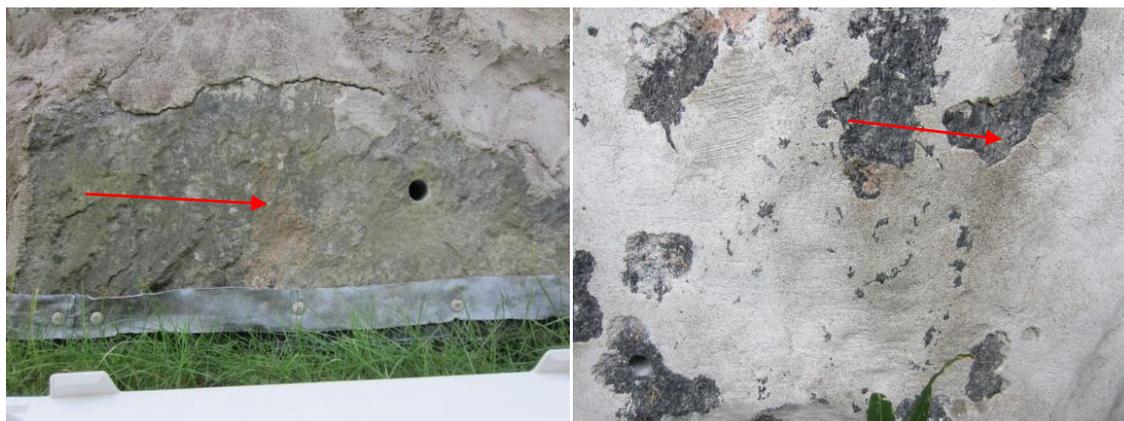
The measurements have been performed in an indirect way according to the report “Methodology UPV”. The blocks tested, shown in Figure 17, have been near the ground floor, on the blocks sampled for other analysis.

Figure 17. Positions of the measurements performed over Cygneuksen Galleria basement. (Photo: N.Luodes)

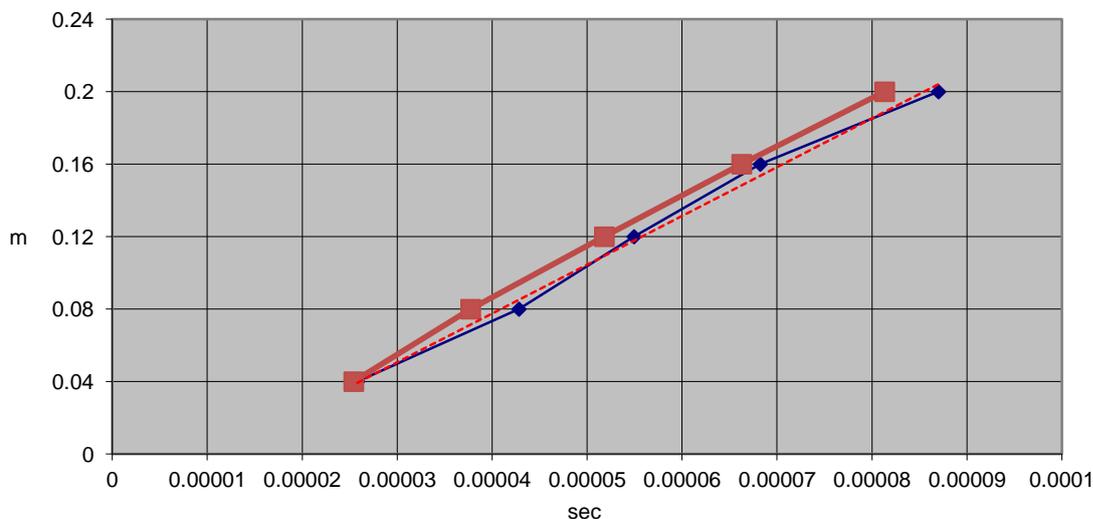
Figure 18. Diagram showing the measurements collected on the two blocks of the Gallery (red squares are for HAPŞ-2013-28 and blue squares are for HAPŞ-2013-29).

Velocities are: 2850 and 2706 m/s excluding the first point of measure to reduce uncertainties. The curves show that there have been slight deviations from the expected readings, this could be caused by irregularities of the surface and by shistosity of the stone. The structure is formed by unshaped heterogeneous blocks of different kind of rock. The velocities are a bit lower than what could be expected for this material.

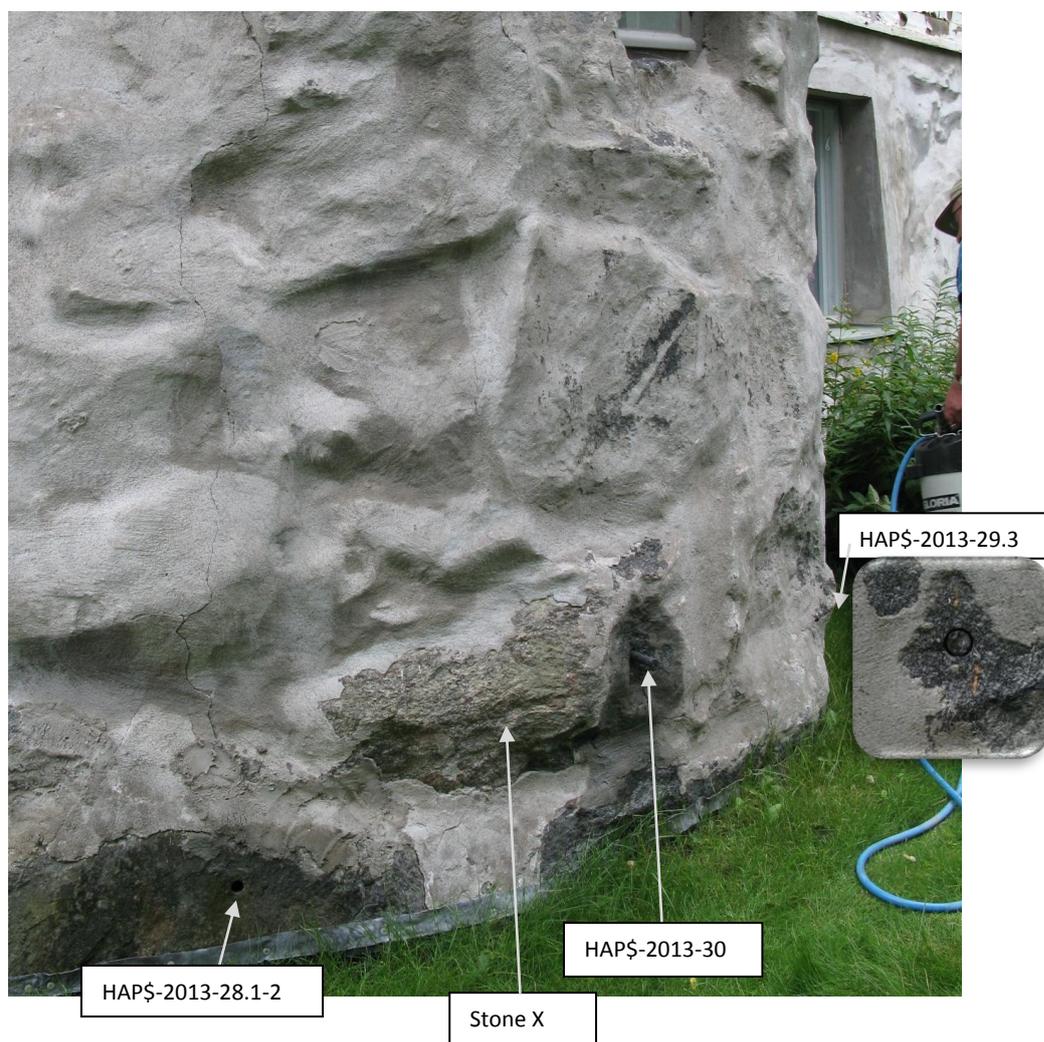
The Schmidt Hammer has been used perpendicular to the surface to be tested, according to the methodology described in "Methods Schmidt Hammer" and has been performed on the same blocks on which has been sampling (Fig 19). The measurements are shown in table 1. Comparing the results got with this tests to those got with other tests and other analysis can be seen that the results have been lower than the expected values for the kind of stone and its compactness. Rebound values in fact had not been very high, showing that the material might have been affected by humidity, lowering its properties. The blocks have been heterogenic so they presented different mineral composition and possibly different level of surface weathering.

Figure 19 Positions and detail of blocks tested with Schmidt hammer

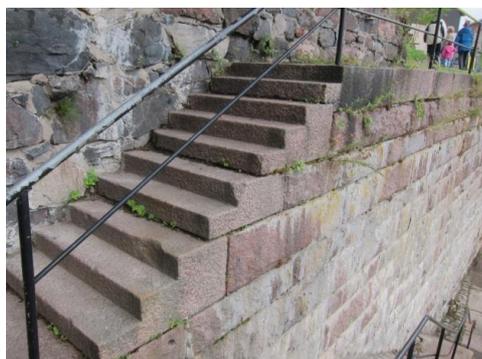
Figure 5 Particular of the stairs in the dry dock. They have been carved from a bigger block probably during later reconstruction. (Photo: P. Härmä)

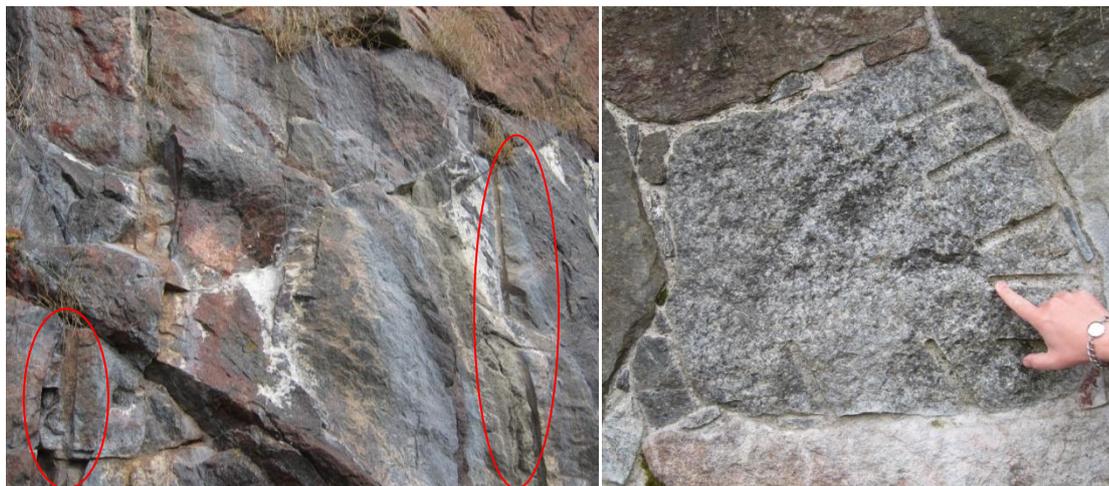
The blocks used for the construction of the fortress have been erratic blocks or blocks blasted and collected from the site as visible from Figure 15. The fortress has been undergoing modifications, reconstructions and restorations during the years but different weathering effects have been still visible.

Figure 15. On the left the marks of the holes for wedges for detaching blocks, and on the right a block presenting the holes for wedges for splitting a larger block into a smaller one. (Photo: P. Härmä)

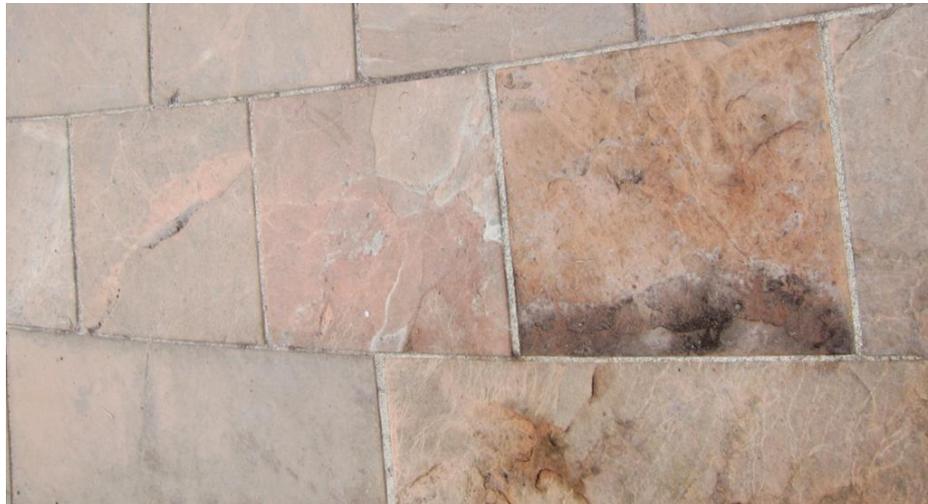
The limestone used to reconstruct the front part of the king's gate in 1925 is showing weathering effects probably given by the sea and that are typical of limestones: exfoliations as visible from Figure 16.

Figure 16 Example of exfoliation on limestone in front of King's gate. (Photo: P. Härmä)

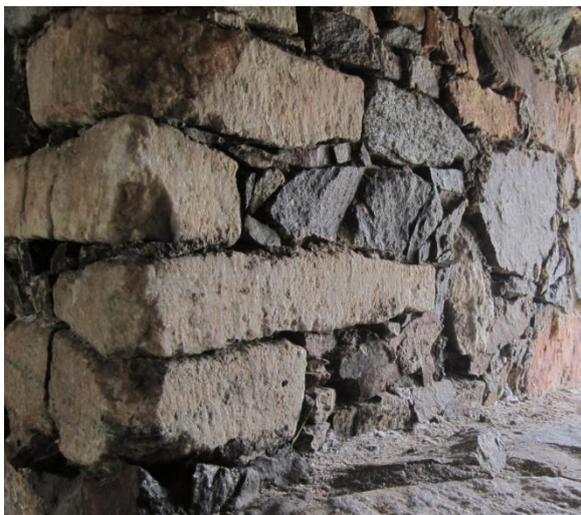
The surface of the blocks in some parts present changes on the original surface of the material, increasing the roughness as visible from Figure 17.

Figure 17 Increased roughnesses of some blocks (Photo: P.Härmä)

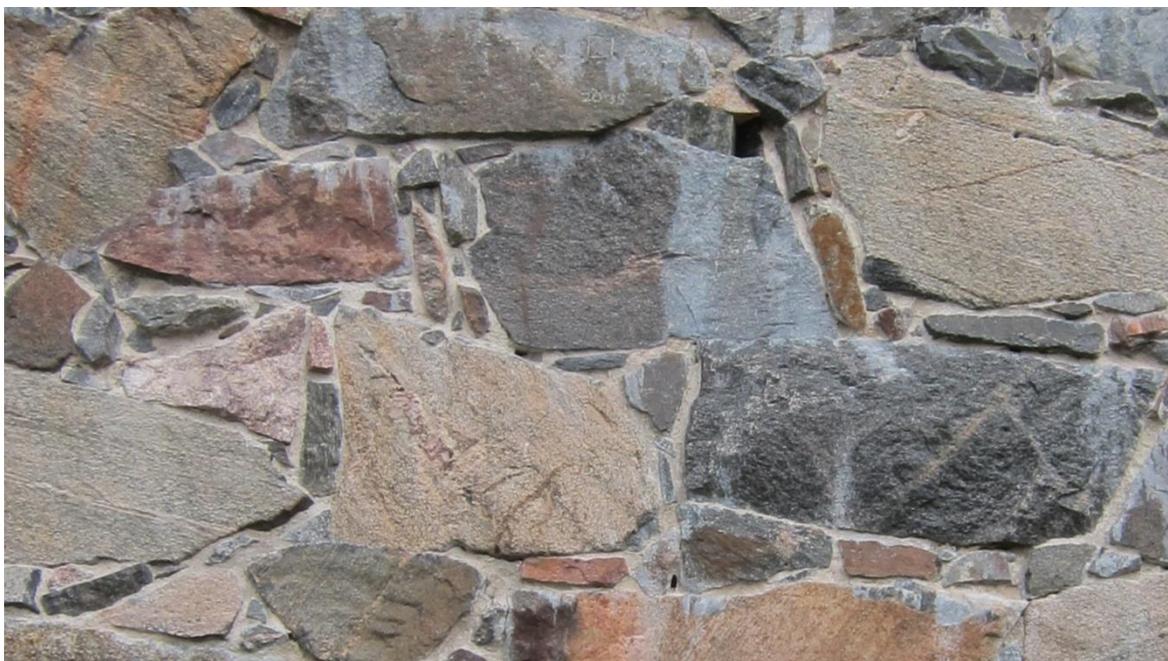
On the external walls where had been used different stone types can be seen that softer materials started to weather faster than harder ones. Generally the diabase kind, the black ones, do not show visual weathering effects, while the light ones show at least an increase of roughness of the surface as visible from figure 18.

Figure 18 Blocks of different stone materials showing different level of weathering. (Photo: P.Härmä)

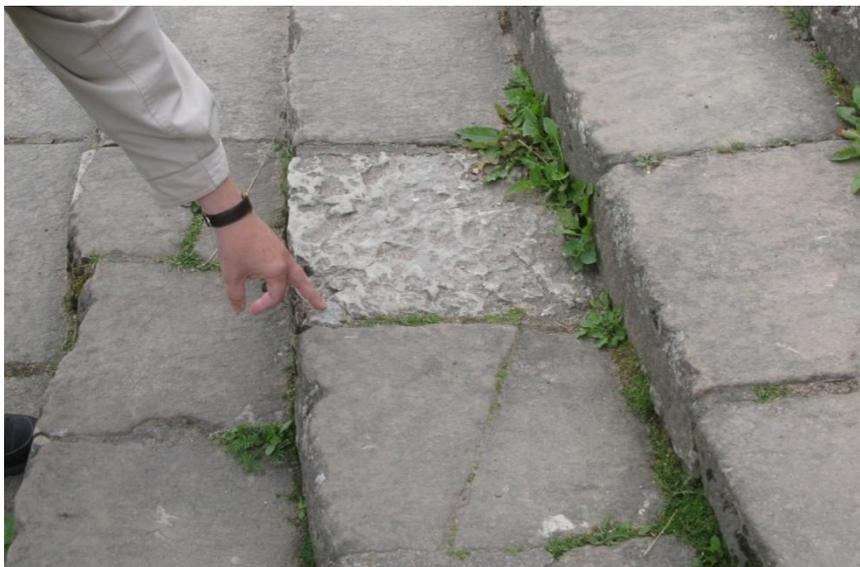
A limestone slab installed in 1925 used in front of the King's gate had shown deepening probably due to sea water effects, passage of people and dung of birds as shown in Figure 19.

Figure 19. Limestone weathered

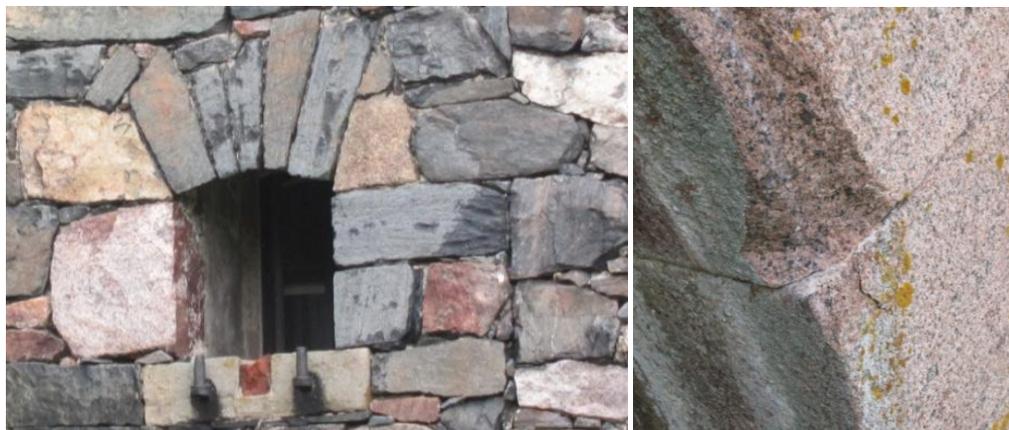
Cracks are also due to man's actions, being a fortress has undergone several attacks.(Fig. 23)

Figure 23 The stones over the window show impacts of anthropogenic origin.(Photo: P.Härmä, N.Luodes)

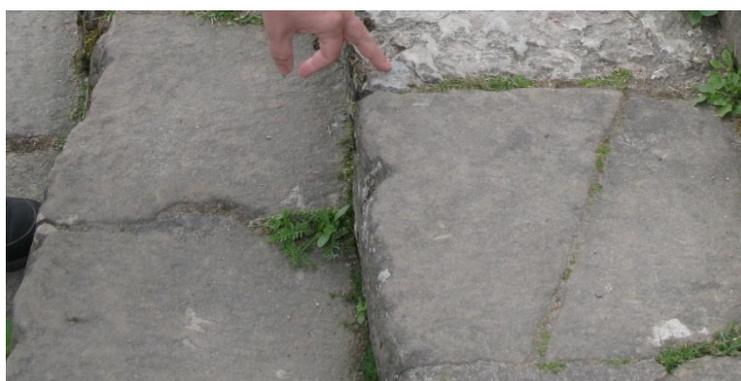
Limestone stair had shown cracking (Fig.25) that can be caused by basement movements or by impact on a material that had already been suffering from weathering actions and that had lowered its resistance.

Figure 25 Cracks on a limestone slab in front of the king's gate.

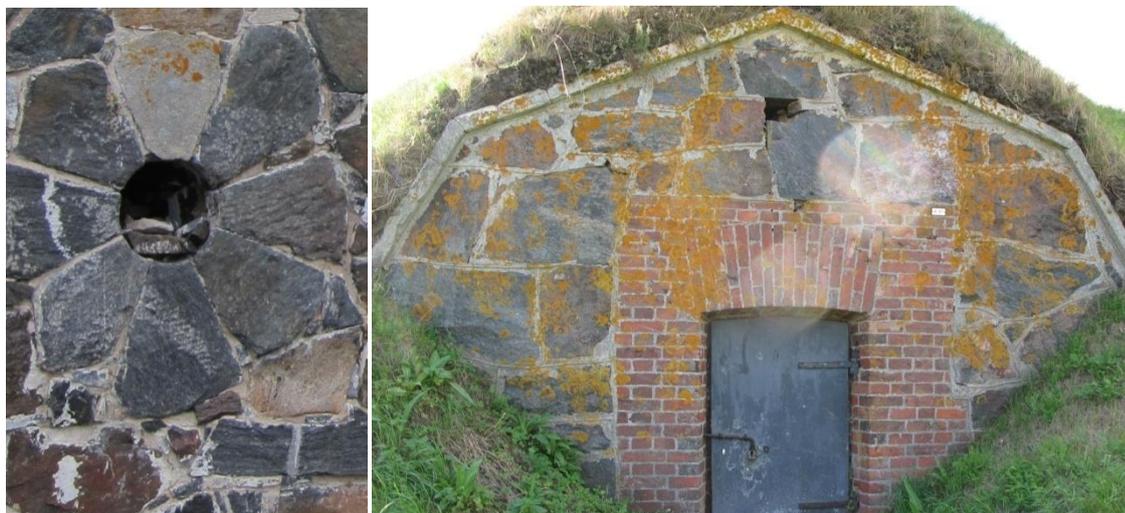
Lichens have been growing abundantly on the structures, privileging some materials but definitely colonizing also those less favourable for their growth, as can be seen from figure 29. It is visible that the colonization starts from a stone material that probably can offer better substrate for their growth, but after several years they are able to colonize also the other stone kinds.

Figure 29 On the left a part of the wall in the King's gate where colonization of lichens started probably after a refurbish of the wall in recent years, on the right a wall that present diffuse colonization. (Photo: P.Härmä, H.Pirinen)

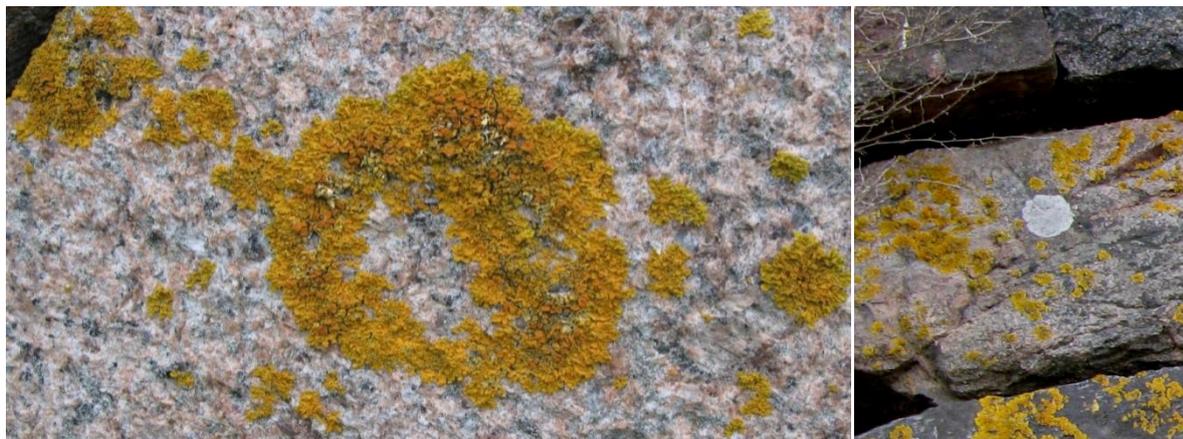
It has been noticed mainly one kind of lichen as visible from figure 30 on the left, but also other type could occur as shown in Figure 30 on the right.

Figure 30 Detail of the most diffused lichen on the left, and a particular with a different lichen colonization on the right. (Photo: N.Luodes, H.Pirinen)

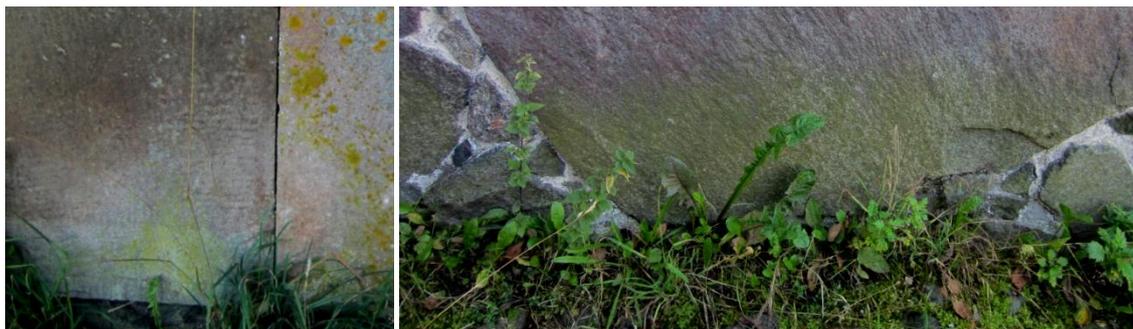
Biofilm has been recognized in some more humid areas as for example at the contact with ground on the upper walls facing the dry dock, as visible in Figure 33. The biofilm had been generally of green color.

Figure 33 Examples of biofilm found on the basement of the upper buildings facing the dry docks: on the left limestone basement of the portal, on the right basement of the walls.(Photo:N.Luodes)

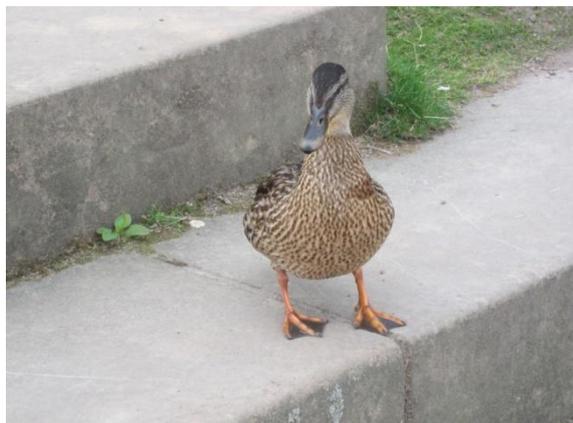
Ducks are living on the island and on the paving stones their impact should be considered, as for example on the limestone stairs in front of the king's gate (Figure 34). Ducks are generally not circulating over building structures and seagulls are not so numerous to cause a problem to the main defence structures. They could cause a problem if they are collecting in a specific place on a building or an area, but the behaviour of the birds has not been monitored during this study.

Figure 34. Duck over the limestone steps in front of the king's gate (Photo: P.Härmä)

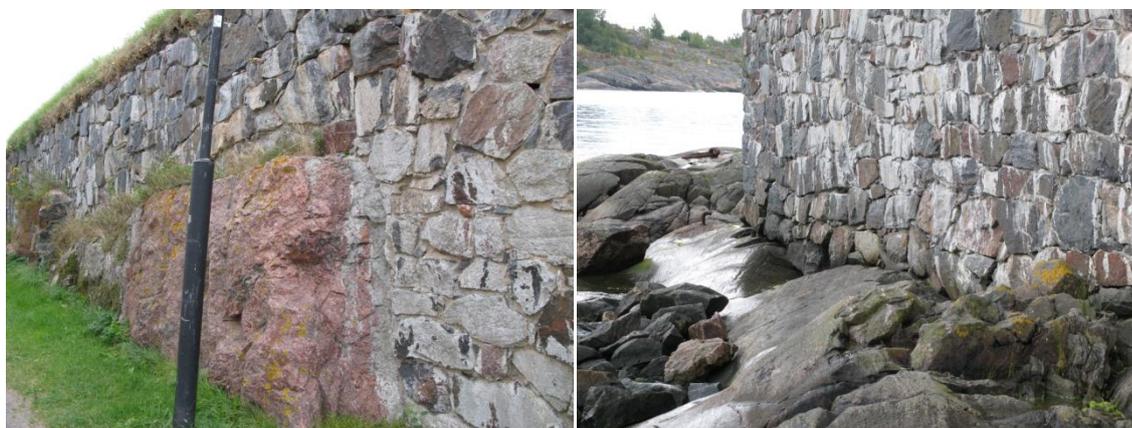
Suomenlinna is not affected by traffic impacts but is mainly affected by salt deposition and the salt has been considered main problem also for other brick constructions of the heritage. Studies have shown that there has been high concentration of salt coming as salt mist from the marine environment. Traces are visible also on the stone walls as visible from figures 35-37.

Figure 35 Deposition of salts on the walls in an inner wall and an outer wall of the fortress. (Photo: H.Pirinen)

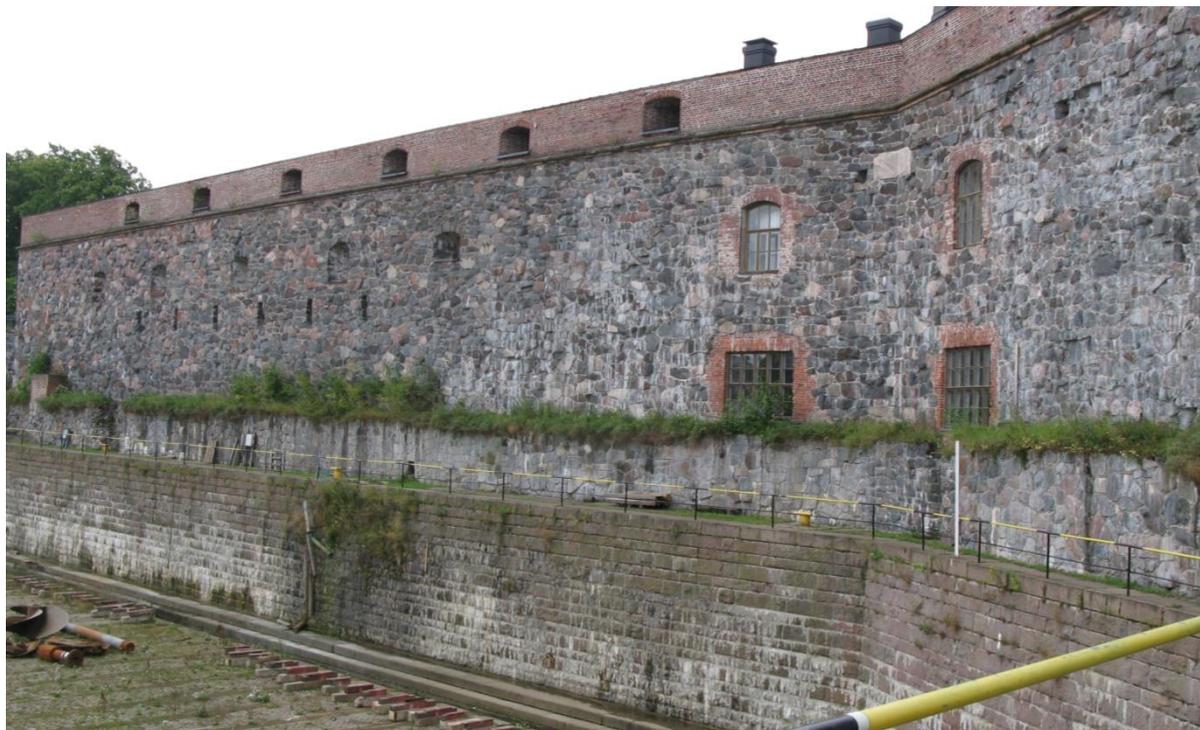
Figure 36 Diffused deposition of salt on the buildings facing the dry dock (Photo: H.Pirinen)

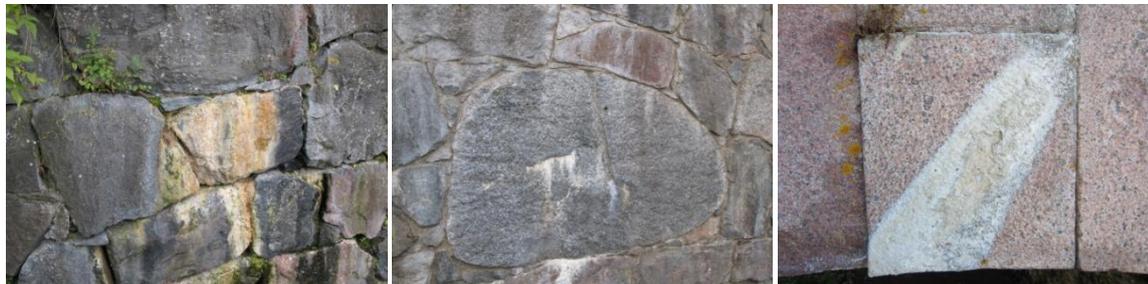
Figure 37 Examples of salt crusts, as migration of salts from the mortar or inner layers, or as deposition of salt mist. (Photo: H.Pirinen)

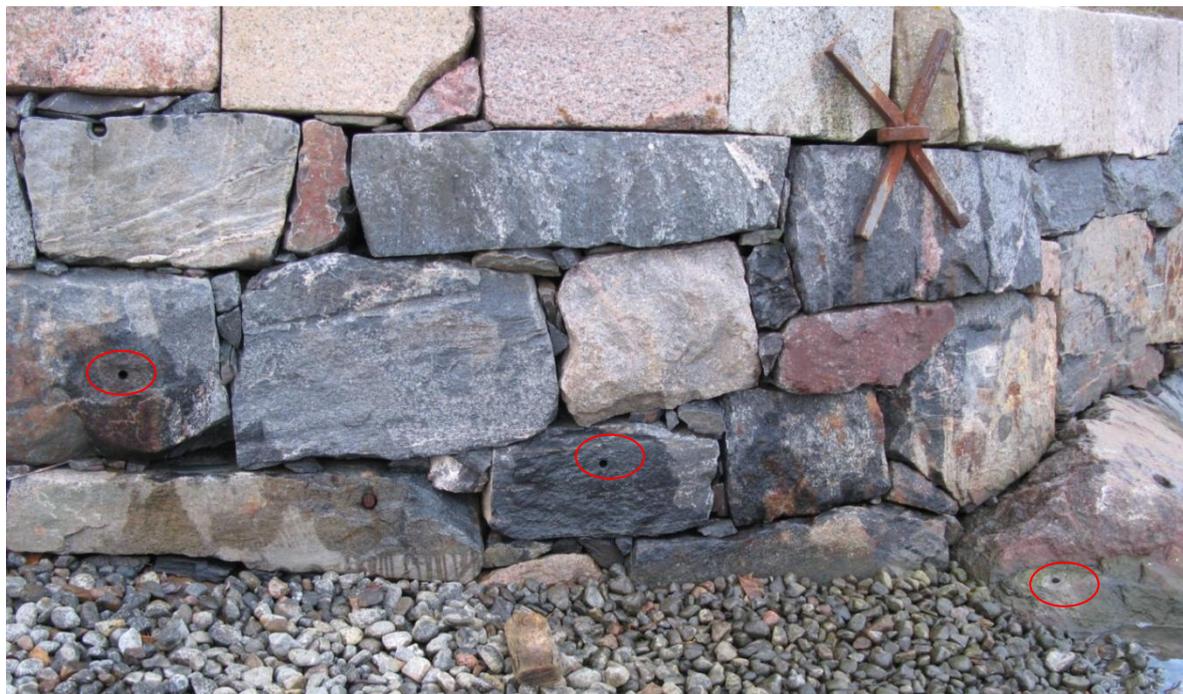
Figure 46 From left to right Suomenlinna 12 (HAPŞ-2012-13), Suomenlinna 13, Suomenlinna 11 (HAPŞ-2012-12)

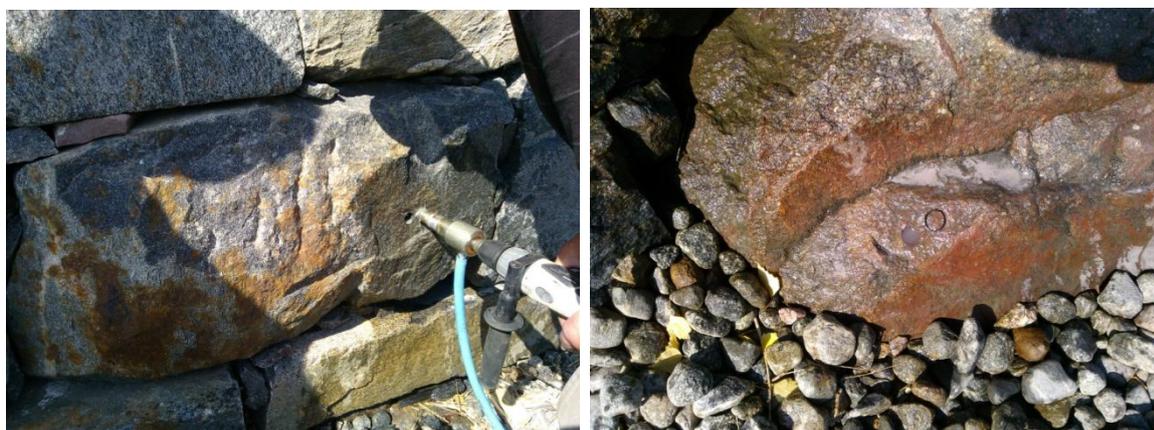
Figure 47 Second samples taken from blocks HAPŞ-2012-13 (on the left) and HAPŞ-2012-12 (on the right)

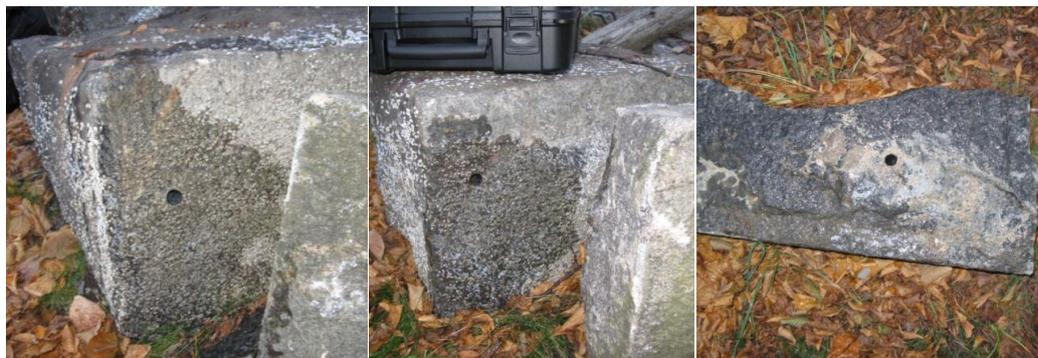
Figure 48 From left to right: Suomenlinna 14, Suomenlinna 15 (HAPŞ-2012-14), Suomenlinna 16 (HAPŞ-2012-15)

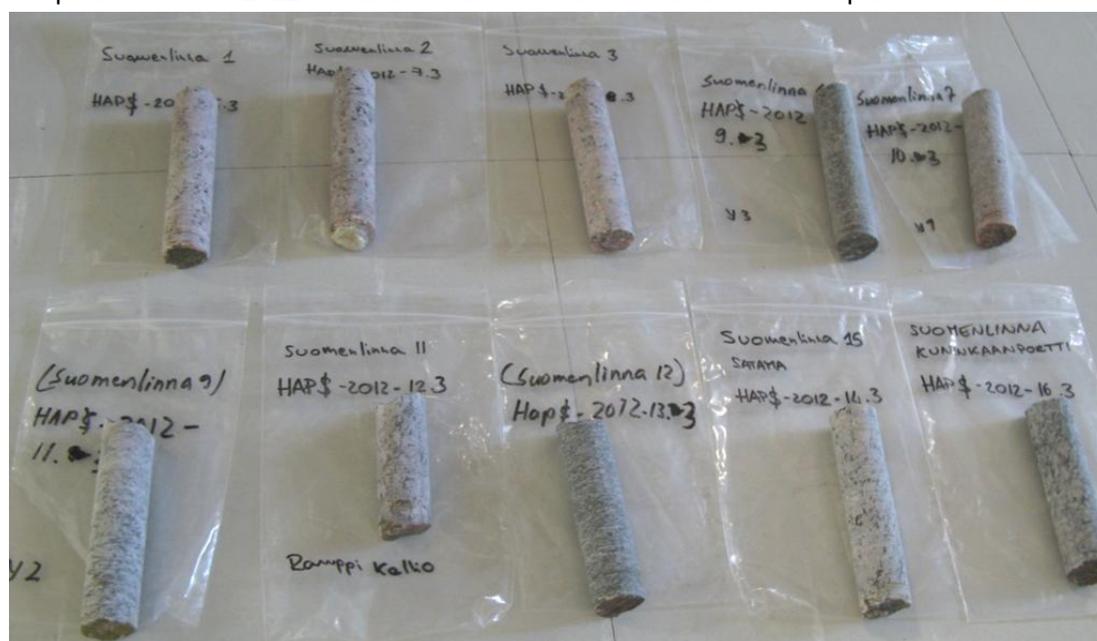
Figure51 Normal photo of the specimen from the fortress sampled in 2013.(Photo: N.Luodes)

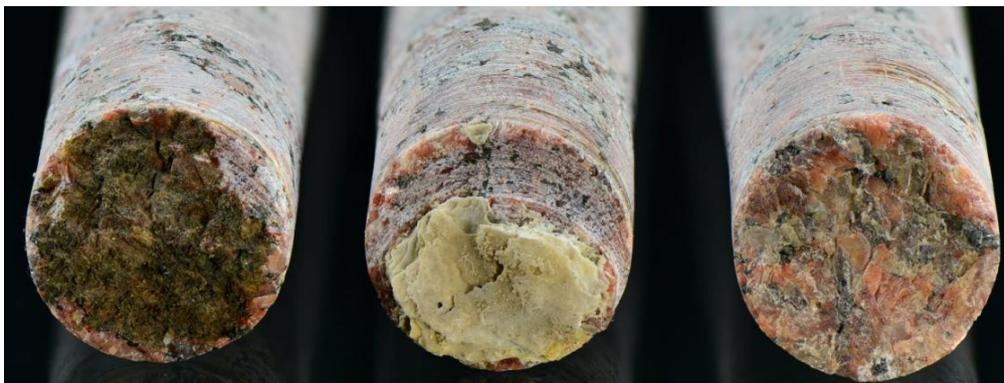
Figure 52. Samples HAPŞ -2012-6 to HAPŞ -2012-8 from left to right, weathered surface. (Photo by J. Ranua GTK)

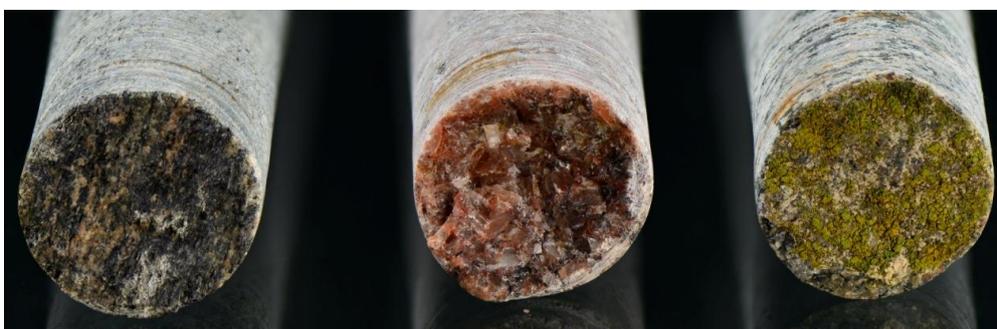
Figure 53 Samples HAPŞ -2012-9 to HAPŞ -2012-11, from left to right, weathered surface. (Photo by J. Ranua GTK)

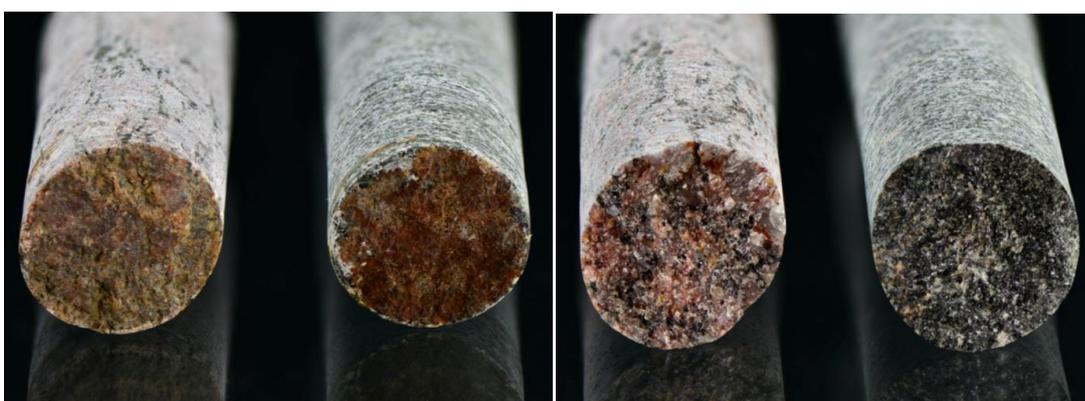
Figure 54 Samples HAPŞ-2012-12 and HAPŞ-2012-13 surface (on the left) and bottom part of the drill core (on the right) (Photo by J. Ranua GTK)

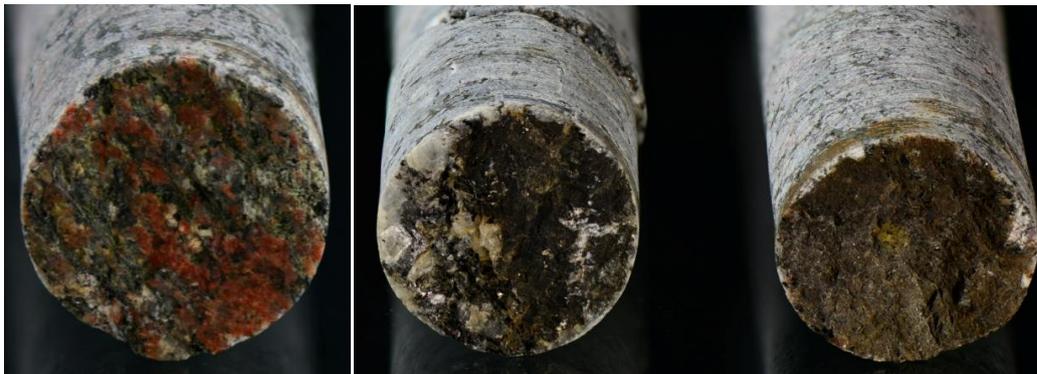
Figure 55 Samples HAPŞ-2012- 16, HAPŞ-2012-17, HAPŞ-2012-18 from left to right, weathered surface of the drill cores. (Photo by J. Ranua GTK)

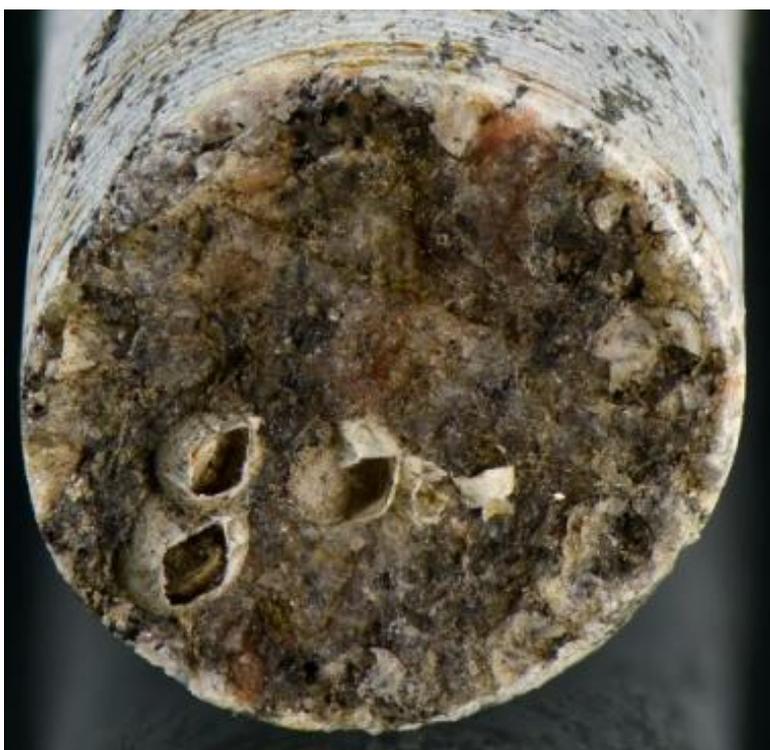
Figure 56 Detail of the weathered surface of the sample HAPŞ -2012-14. (Photo by J. Ranua GTK)

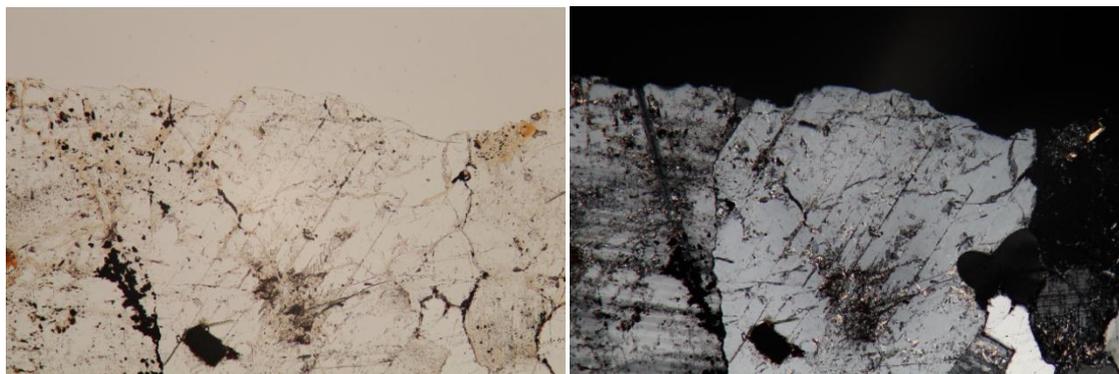
Figure 57. HAPŞ 2012-12 Disintegration and breaking of the minerals on the top surface of the sample, visible from the fracturing

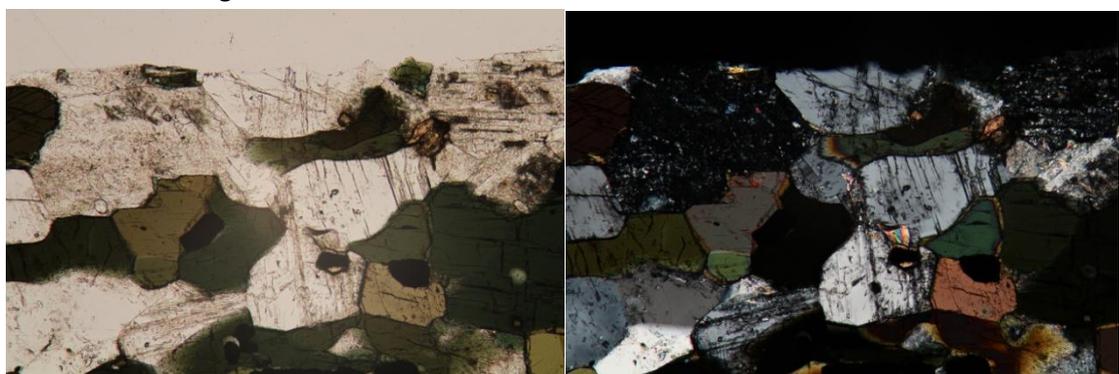
Figure 58. HAPŞ 2012-13, open fissures of the mineral visible as fractures interesting the mineral itself

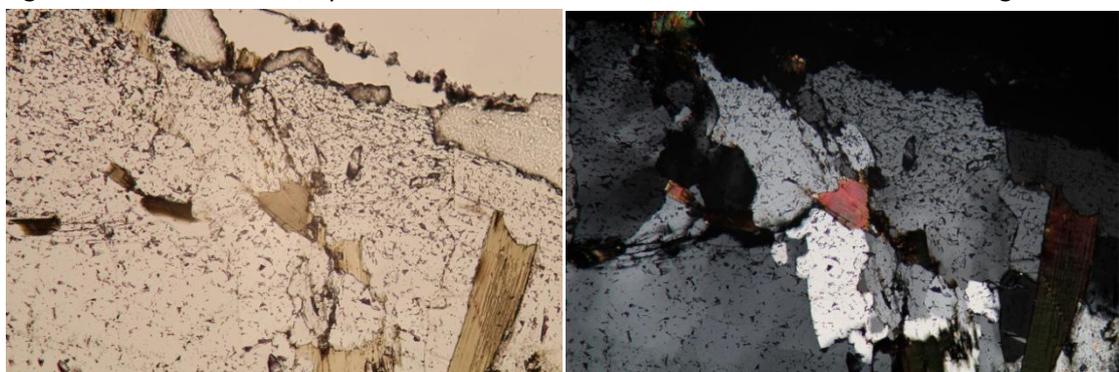
Figure 59. HAPŞ 2012-14 Opening of the mineral internal structure with small cavities.

HAPŞ is 2012-14 is a granite gneiss, composed by quartz, potassium feldspar, plagioclase, biotite, hornblende, with accessories magnetite, carbonate, epidote and serizite. Its structure is fine to medium grained matrix, with feldspar grains (porfiroclasts) and weak orientation and gneissic bending.

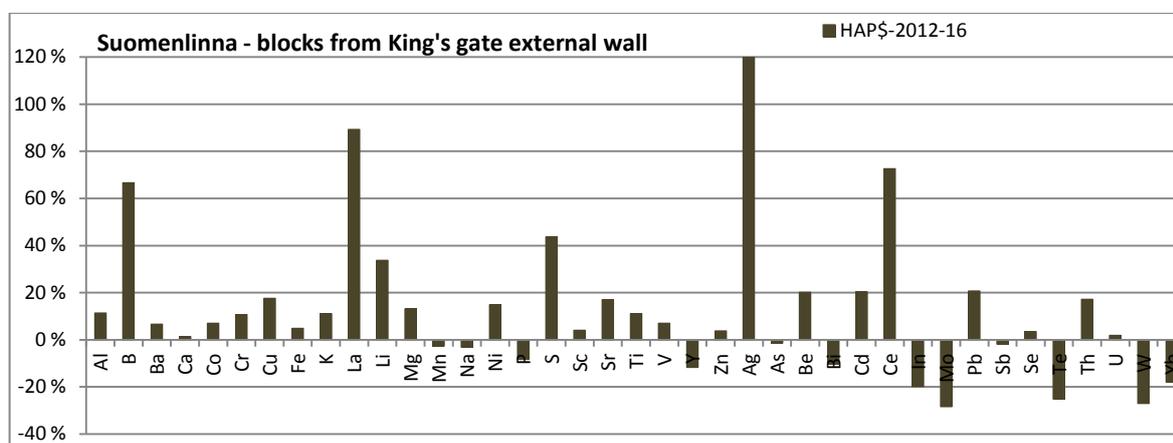
Figure 60.Changes in percentages between top and bottom samples of the sample from the external wall of the king's gate. (Ag is exceeding the scale and its value is equal to 344%)

High levels of Ag in Figure 60 could be due to a loss from the drill. The specimens HAPŞ-2012-6, HAPŞ-2012-7, HAPŞ-2012-8 are all from the lower part of the dry dock and are sampled on different surfaces. HAPŞ-2012-6 over a surface covered with seaweeds or organic film, HAPŞ-2012-7 covered by thick crust, HAPŞ-2012-8 clean material.

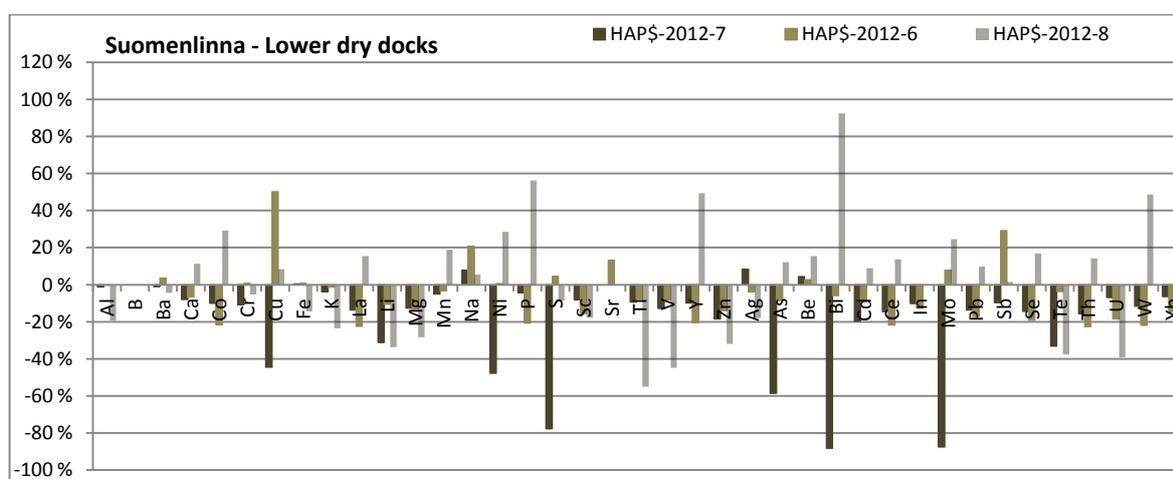
Figure 61.Changes in percentages between top and bottom samples of the sample from the samples collected from the lower walls of the dry dock

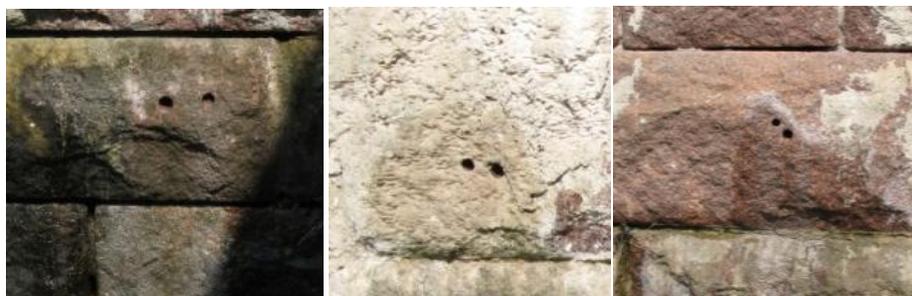
Figure 62. From left to right HAPŞ-2012-6, HAPŞ-2012-7, HAPŞ-2012-8

Specimen HAPŞ-2012-6 showed an increase of some heavy metals on the surface, as Pb, Mn, Co and W, Yb, P and Ni, while a higher leaching of Ti, V, Zn, Te, U compared to others. HAPŞ-2012-7 that presented the crust had a higher leaching of some elements but didn't show an increase on the surface of Ca as it would have been expected.

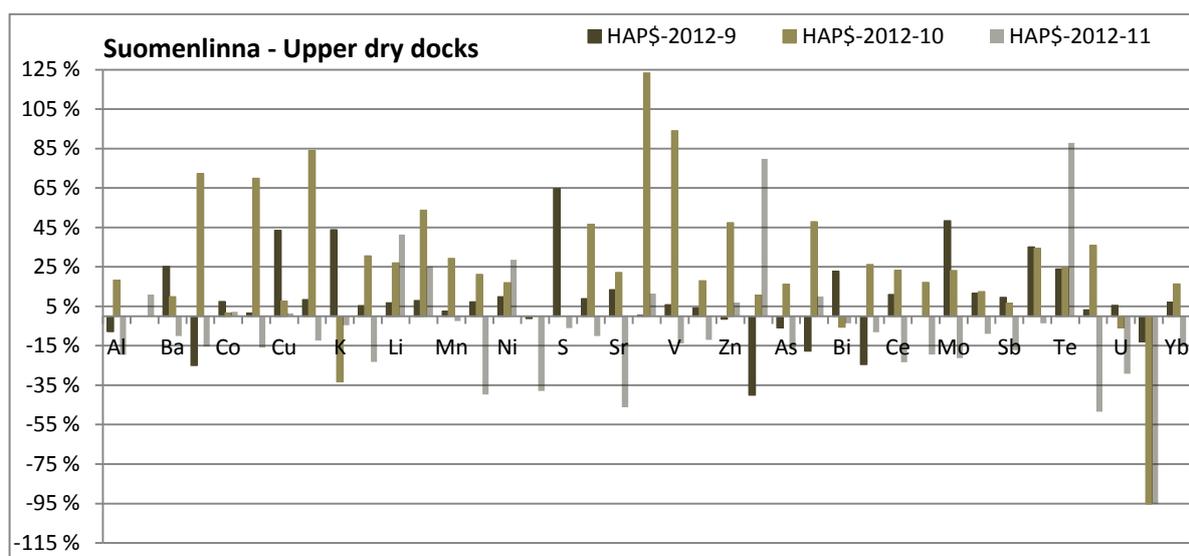
Figure 63. Changes in percentages between top and bottom samples of the sample from the walls of the upper buildings of the dry dock

Their exposition has been probably similar on the building site but their weathering level could have been different at the moment they had been picked up to be installed on the walls. Partially similar trend have been followed by sample HAPŞ-2012-9 and 10, while a completely different one has been followed by HAPŞ-2012-11 but the sample 11 has been also presenting lichens and biological activity over it.

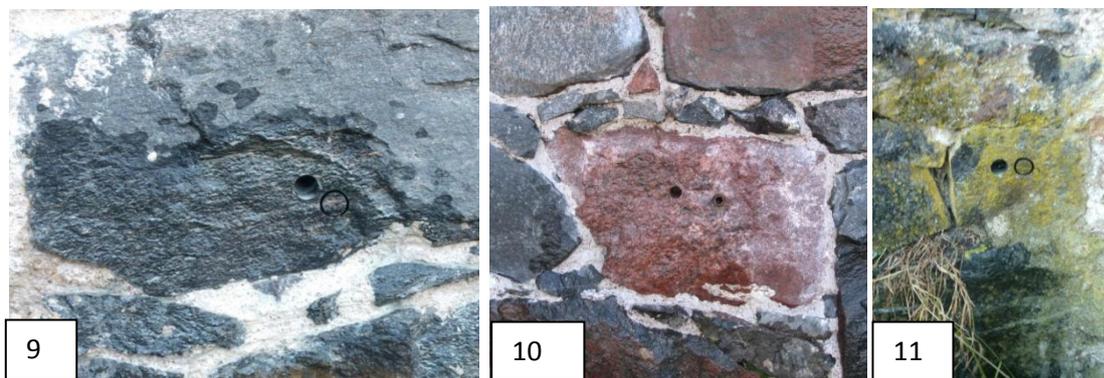
Samples are from different kind of stones and their composition has been different originally (Fig.64).

Figure 64. Blocks of the buildings over the dry dock

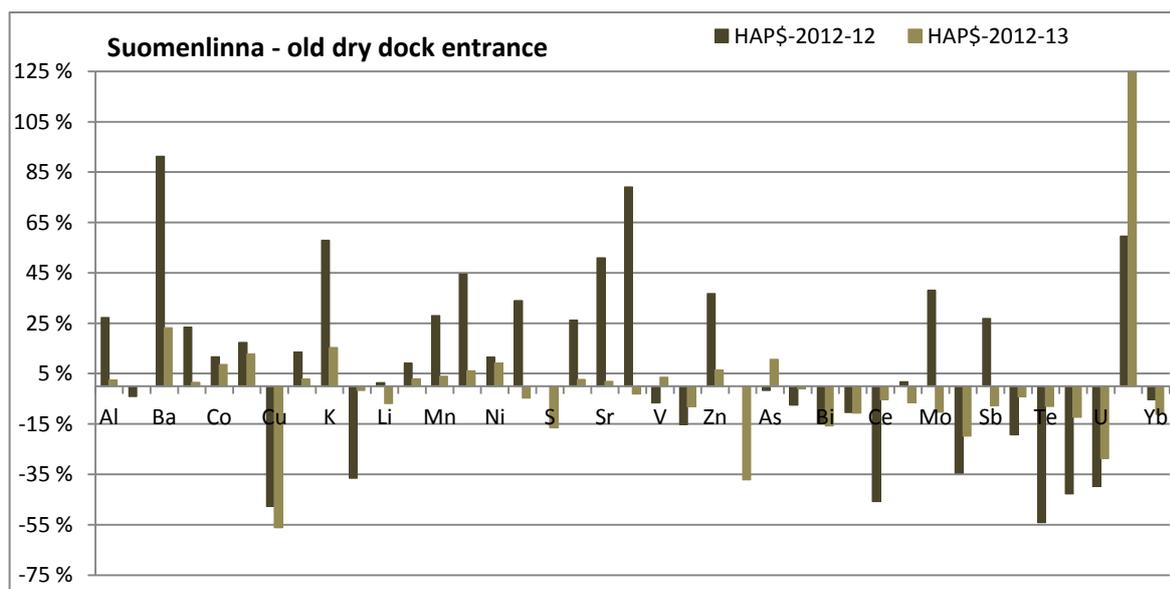
Figure 65. Changes in percentages between top and bottom samples of the sample from the old entrance to the dry dock (W is exceeding the scale and is equal to 1855%)

The excess of W could have been a mistake since it is so high. From the figure can be seen that Cu has been leached, so the surface present lower quantity compared to the bottom part. Same has happened for the radioactive elements. Surface has been instead enriched in quite all the other elements but not at the same rate for both of the blocks examined.

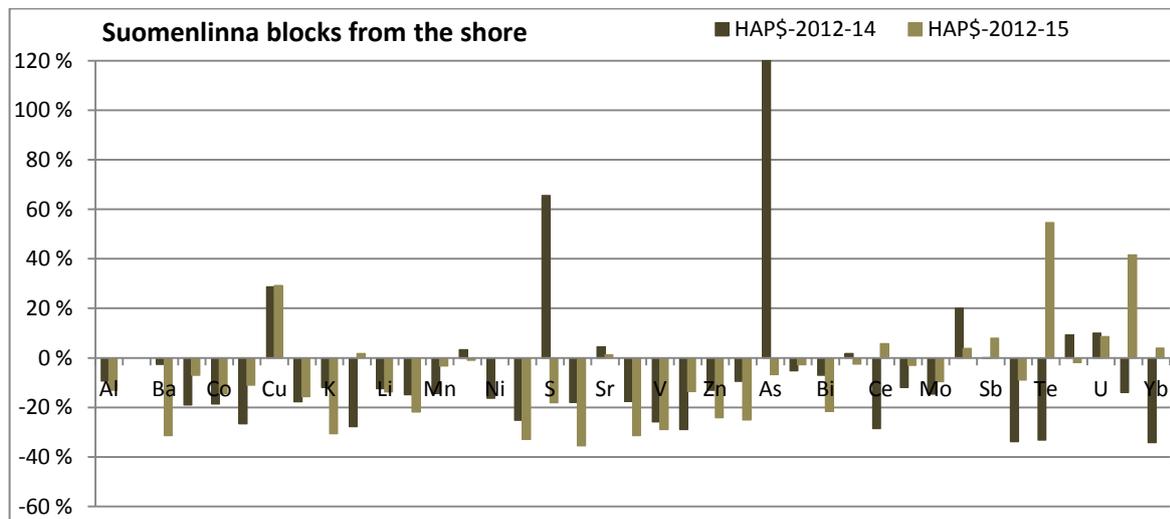
Figure 66. Changes in percentages between top and bottom samples of the sample from blocks dismounted from the pier-shore area. (As is exceeding the scale and it is equal to 234%)

The samples present quite similar trend except for As, S, Ce, Te, W and Yb. Looking at the images of the blocks it is visible that HAPS-2012-14 had been sampled over a clean surface while HAPS-2012-15 over a dirty one, either mortar or calcareous concretions, even if it does not show from the chemical analysis, where for both there has been loss of Ca.

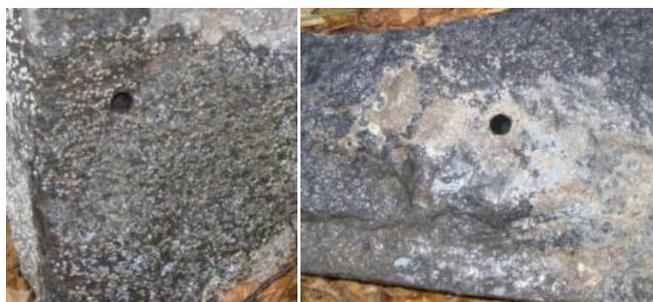
Figure 67 From left to right: HAPŞ-2012-14, HAPŞ-2012-15

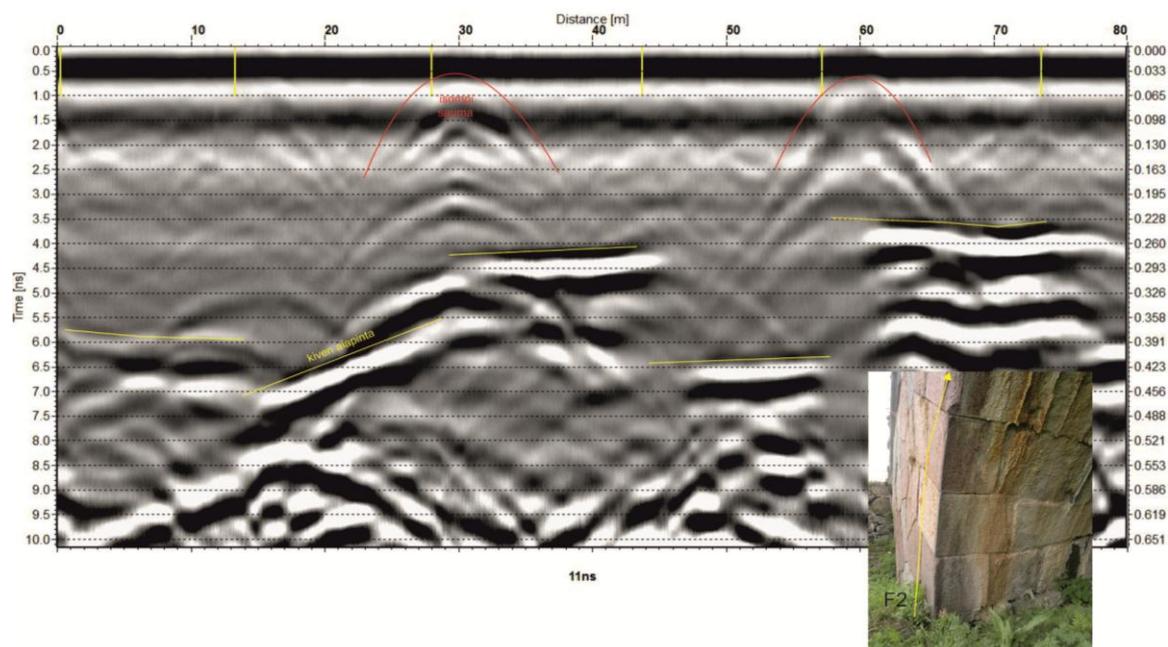
Figure 70 Blocks 5-7 from GPR measurement line 1,2.

In the interpretation of the radargram can be seen clearly the back side of the blocks, that are shaped in irregular way and present different thicknesses. A strong parable is visible in the area between blocks 2 - 3 and 4 – 5, this could be caused by the wide joint or a by an anchoring between the blocks. In Figure 71 are shown the next blocks of the arc: 8-14
