**SOUTH-EAST FINLAND - RUSSIA ENPI CBC PROGRAMME 2007-2013**  
**Efficient use of natural stone in the Leningrad region and South-East Finland**

## Site Inspections

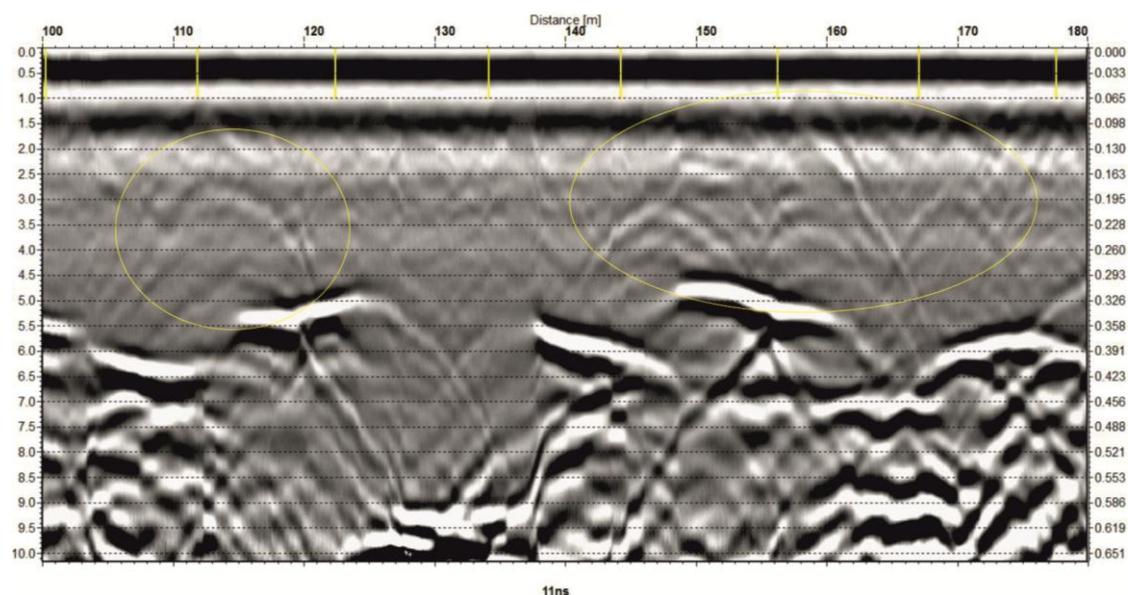
Figure 71 Blocks 8-14 from the left arc from GPR measurement line 2.

The material seems to present some discontinuities in mass, probably some veins, as there are weak internal refraction in the material itself. They could rapresent internal cracks while it is improbable that they would be iron

anchoring, because of their weakness, still could be possible that they would be wood anchors between blocks since their position is always at the right (quite in correspondence) of a joint between two blocks. Block n 9 is showing a very strong reflection, as visible from figure 72. It is might also be cause by a fracture or opening in the block.

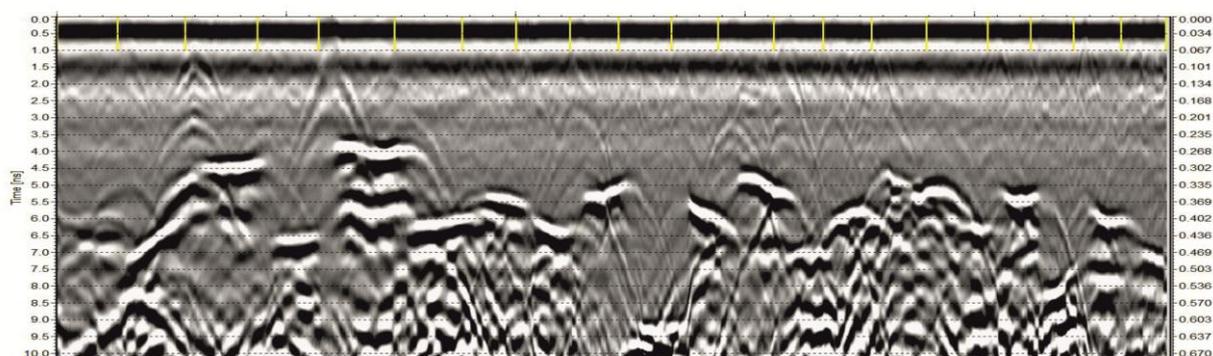
In Figure 73 is shown the radargram interpretation of the full arc. In it are visible the stronger reflections probably caused by anchoring, openings or cracks, and the weaker ones, more diffused, probably caused by reflection of the wave against the walls of the blocks or by the joints or still by the heterogeneity of the material.

Figure 73 Radargram interpretation of the whole arc

The back sides of the blocks are well defined and blocks show irregular thicknesses. Clear image of the backparts of the blocks is also shown in Figure 74 where radargram interpretation of the second arc of the Tenaille is analysed, in this case placing the antenna in the inside of the arc.

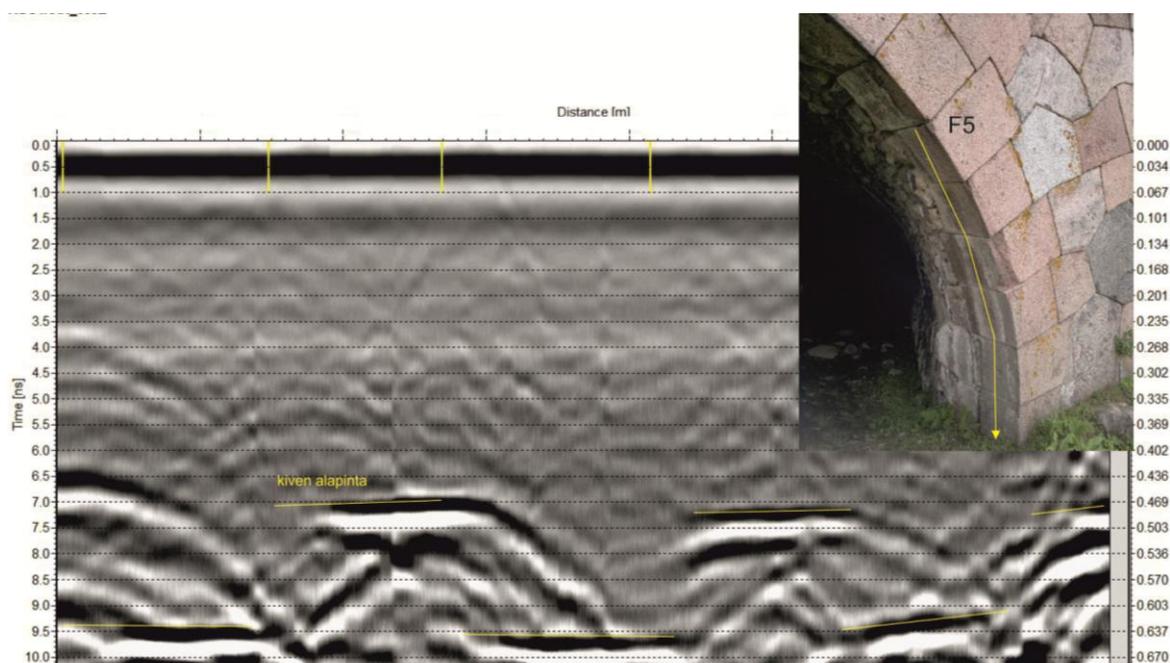
Figure 74. GPR measurement line F5 on the second arc of the Tenaille.

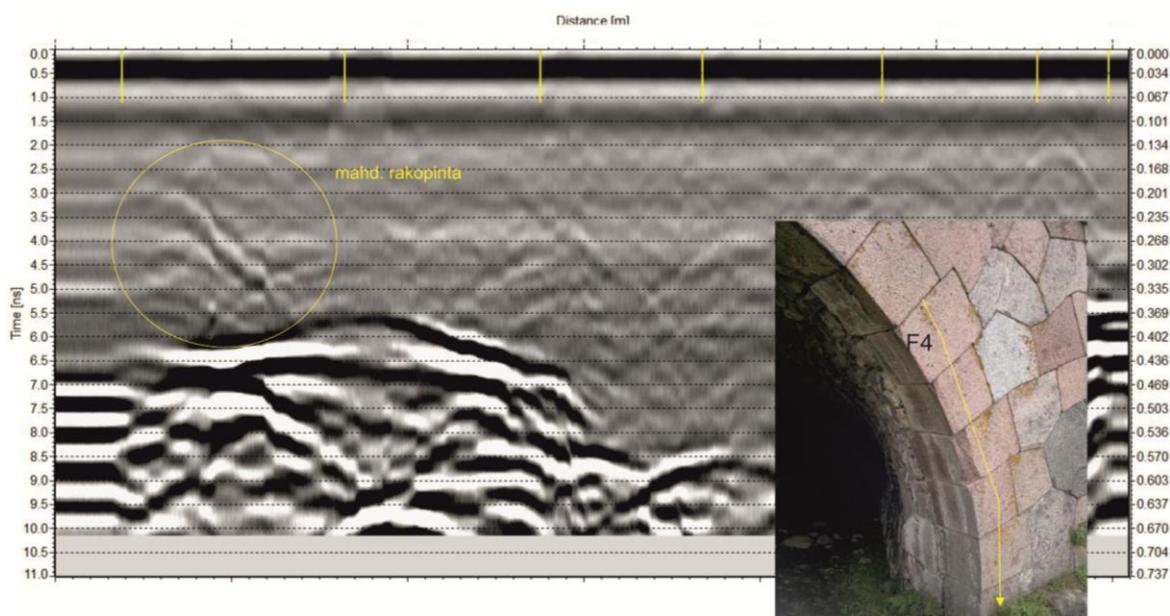
Even if from figure 74 is not visible presence of possible cracks in the material, in the measurements collected from the outside part of the arc (Fig.75) a reflection that is within the material and separated from the joints is visible. In this case the reflection could have been caused by an internal fracture in the back surface of the block.

Figure 75 Radargram interpretation over the right arc of the Tenaille along measurement line F4

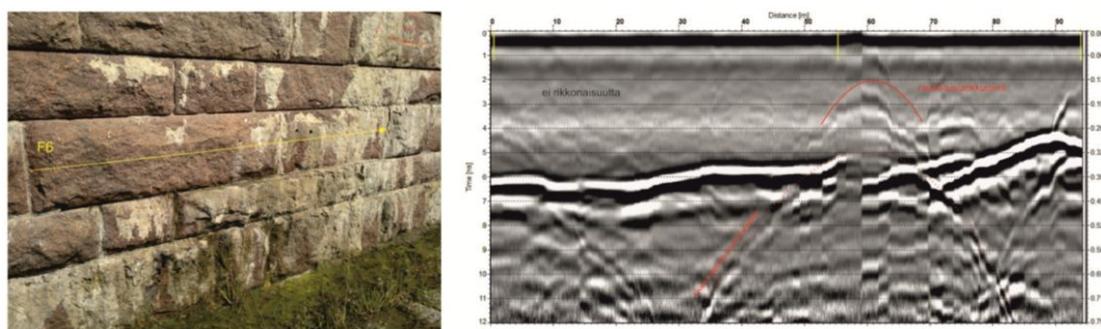
From the measurement along the wall (Fig.77) is visible that the thickness of the blocks varies and that the blocks lie on a compact back wall since the scattering of the wave is much lower compared to a wall back-filled with loosen or small size material. The external blocks tested do not present fractures and a reflection is just on the right of the joint and it could had been caused by the joint itself.

Figure 77. Measurement line F6 performed over the wall of the dry dock on the sampled blocks.

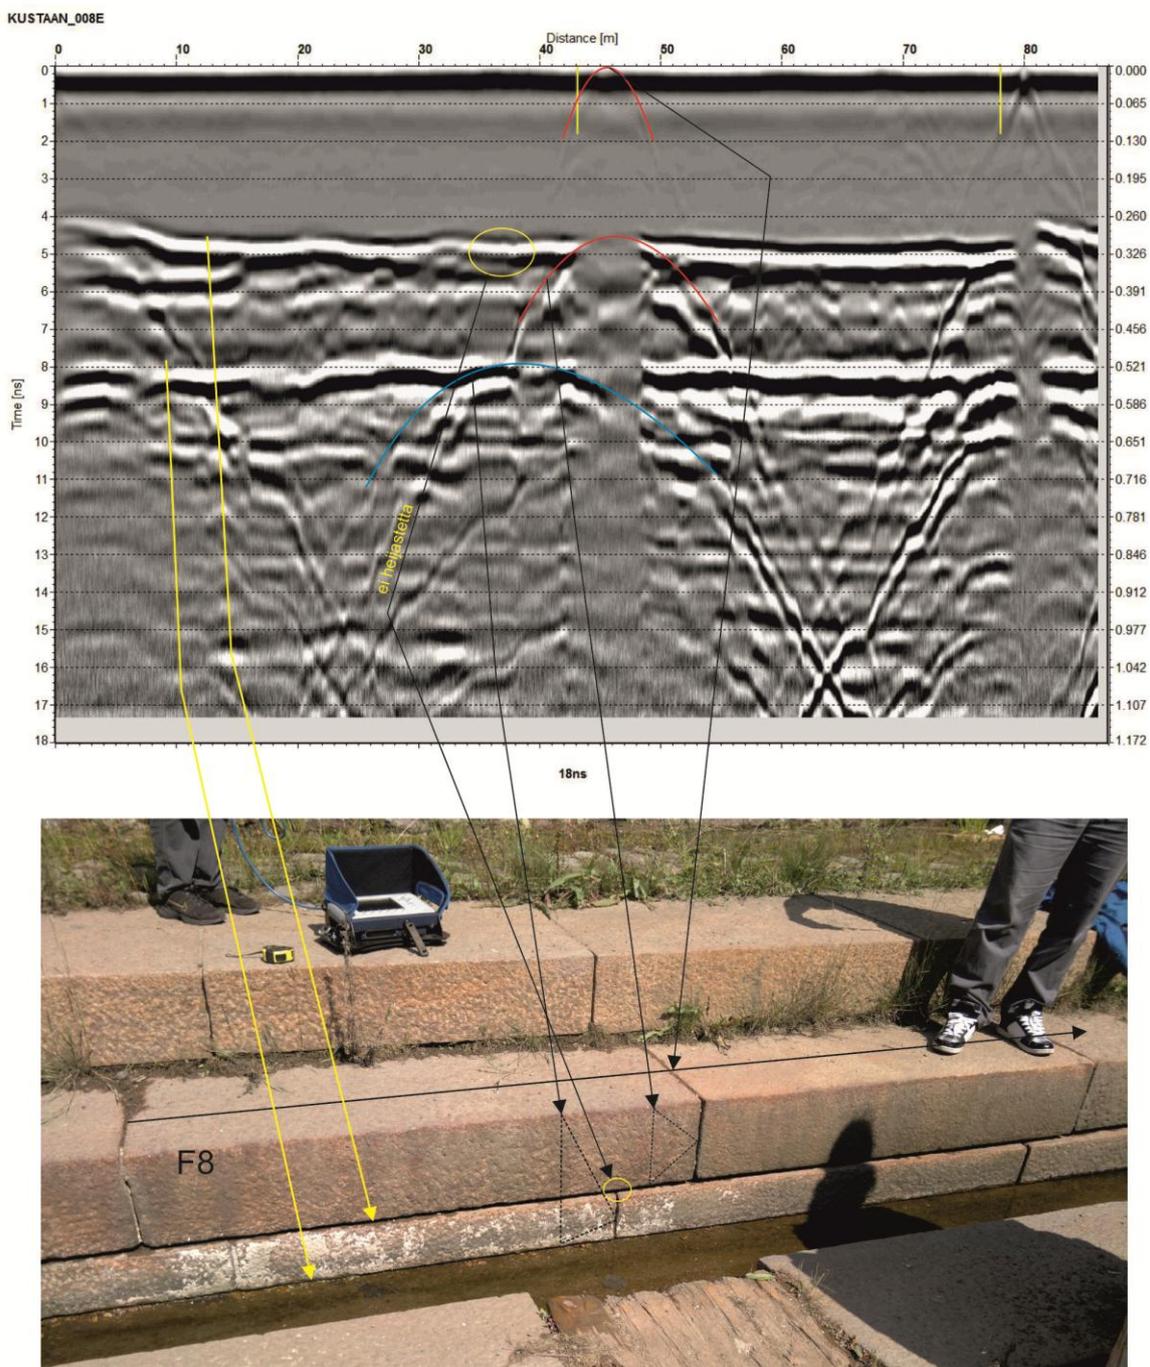
The steps represented an opportunity to understand what could be recognized using the instrument and evaluated at which definition could operate on stone constructions. In figure 78 is shown a comparison of the refraction of the signal and the construction element. It can be seen the different layers and back surface reflections of the blocks (in yellow), the paraboles given by reflections against the sides of blocks in correspondence of the joints, can be seen that it is visible also the second back face of the lower block but it is not shown the joint between blocks at that level, while in blue could be seen probably the parable given by third level of blocks downwards.

Figure 78. Comparison of the radargram analysis and the construction element of the steps.

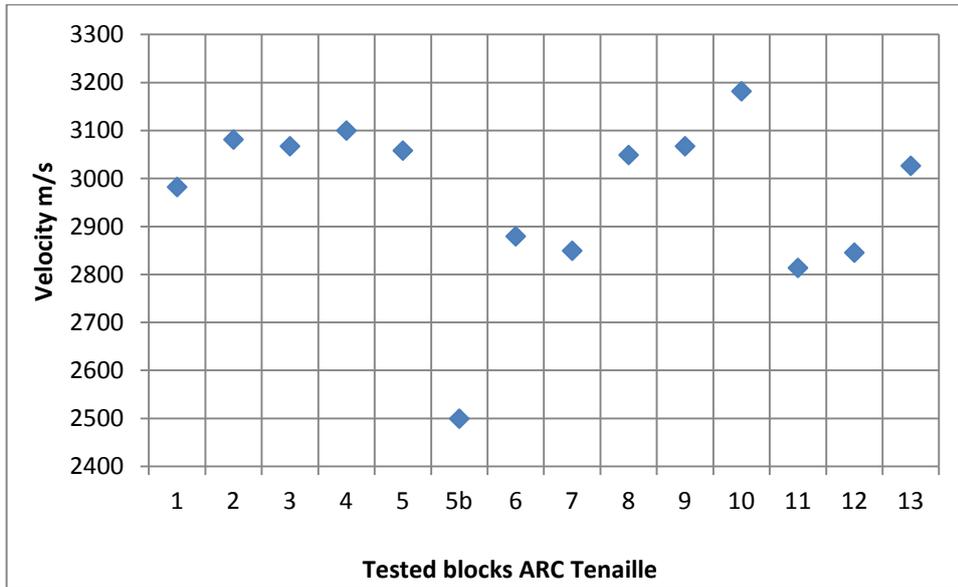
The measurement n 5 had been performed on two places, over the stone(5) and over the stone and white crust (5b). The results are shown in Figure 81 and it is visible that the measurements over the crust had been giving much lower velocity.

Figure 81 Graph of the velocities calculated for the blocks of the arc Tenaille.

Even if the blocks had been quarried the variation of velocities is high. Apart from the velocity estimated over the crust, that is lower, measurements 6 and 7 and 11 and 12 show lower results compared to the others. The interpolation line of the data collected is anyway very good and from the pictures of the blocks cannot be seen weathering or cracks (Figure 82).

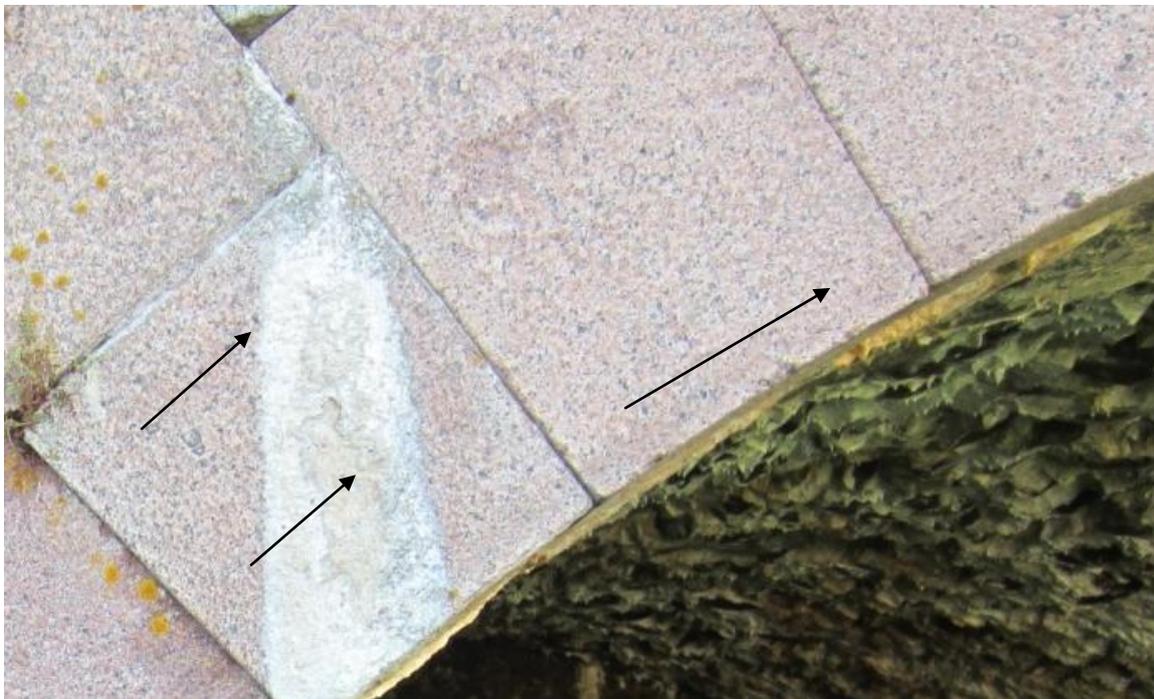
Figure 82. Measurements line 5, 5b (over white crust),6.

Measurement line 6 and 7 , on the other side, have been done near the edge of the block and in a high position, difficult probably to exercise a higher pressure over the transducers. In figure 83 are shown the values collected on the dry dock.

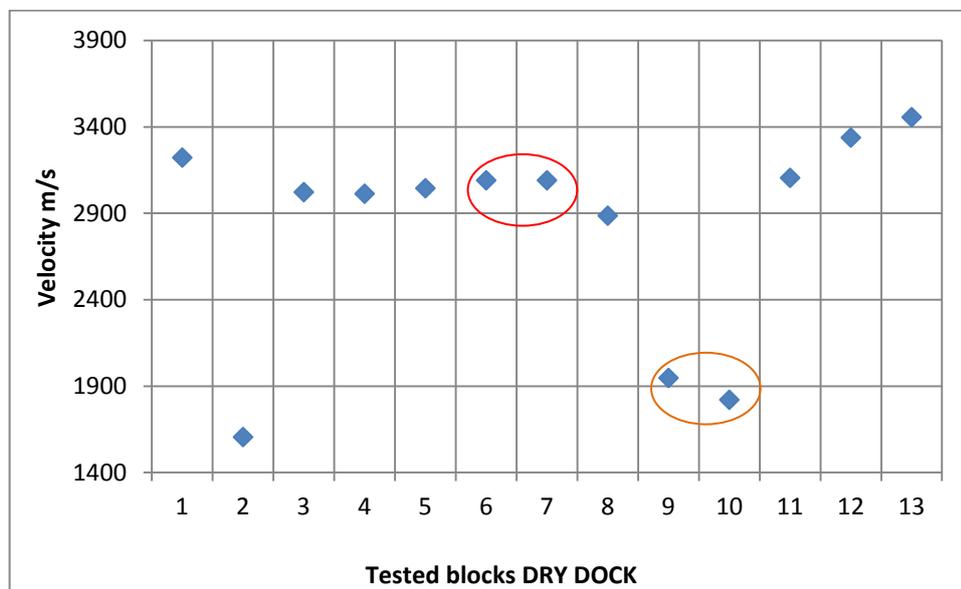
Figure 83. Diagram of mean velocity measured on the dry dock materials (lower and upper parts).

Measurements 1 to5 have been performed over the lower part, on the walls. The measurement 2 had been performed over the white crust, that has been measured being of 14 mm. The crust, probably of calcium carbonate, present much lower velocity compared to the clean rock.

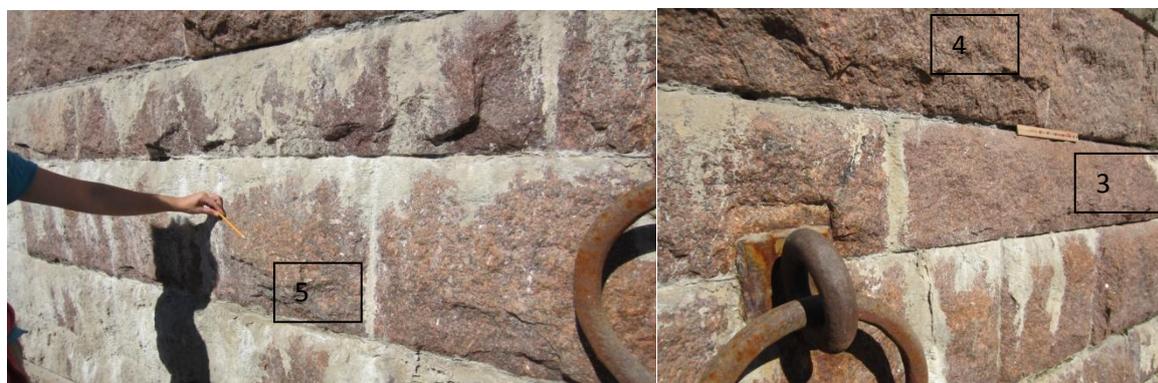
Figure 84. Measurement 5 on the left, and 3 (measured over the block sampled for testing) and 4 on the right

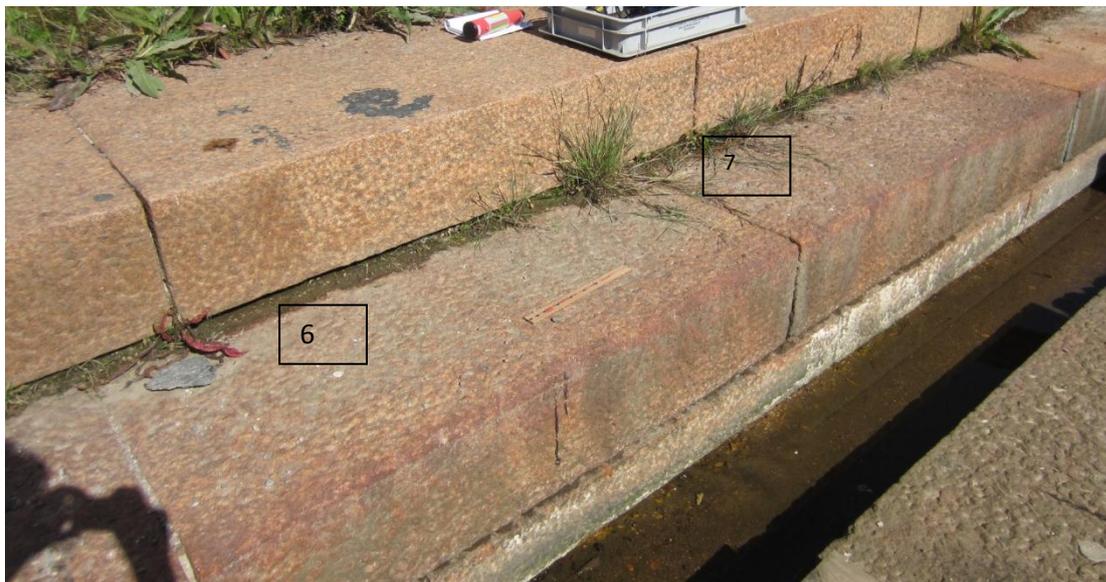
The measurements 6 and 7 have been done over the steps as also the georadar measurements have been performed.

Figure 85. UPV measurements 6 and 7, over the steps of the lower part of the dry dock

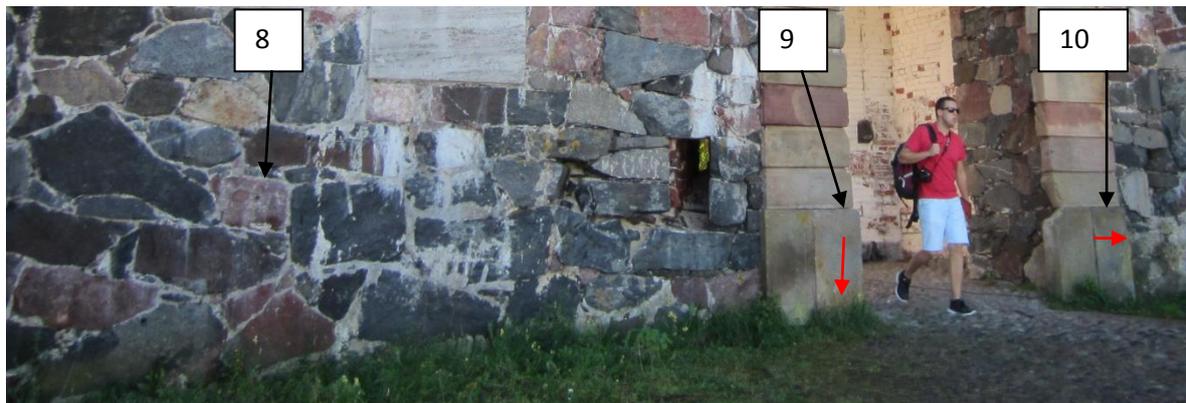
Measurement 8, 11,12,13 have been done over the upper part of the dry dock and on the blocks also sampled for testing. Their velocities are very heterogeneous and block n 8 present the lowest velocity. The blocks have different weathering levels also given by the fact that had been unshaped blocks collected from the site.

Figure 87 The upper buildings of the dry dock and position of the measurements of UPV.

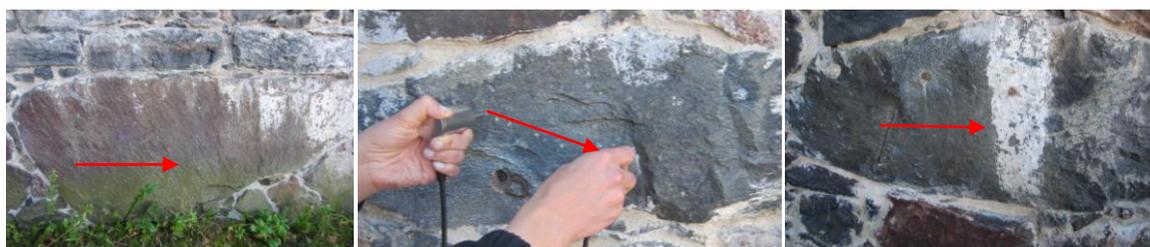
Measurements 13 and 14 have been taken over the blocks sampled. Measurement 11 over the block measured also with georadar (Fig.88)

Figure 88. Measurements 11, 12 and 13 on the other wall of the buildings over the dry dock.

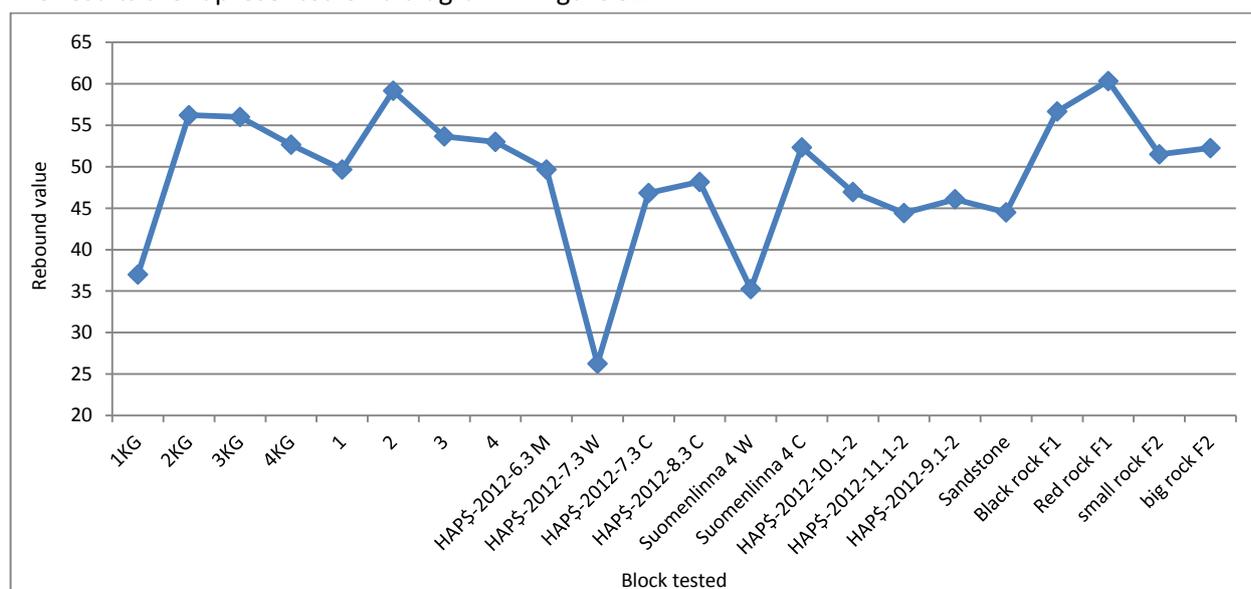
Figure 92 Diagram of the average rebound values for each block tested on site. C: Clean surface, M: biofilm, W:white crust

It is visible that the material is heterogeneous, but is also visible that the blocks that presented salt or limestone crust over their surface presented lower rebound values compared to the same parts of the blocks not covered by the deposition (example: HAPŞ-2012-7.3 W and C; Suomenlinna 4W and C). The blocks of the dry dock show high variation even comparing the results got on clean material. Sandstone presented quite good rebounds values compared to the other hard rock block tested.

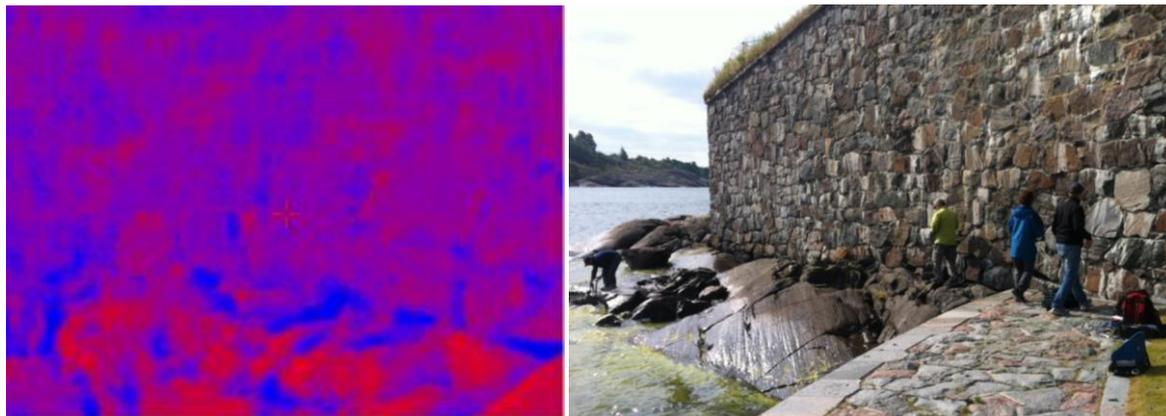
Figure 93 Thermal image and normal photo of the walls near the king's gate (Photos: A.Shkurin)

The walls present quite homogeneous temperature, showing as hotter points those that are reflecting mostly the light, as the bedrock in front of the wall towards the sea. When the drilling is performed and it is taken an image of the specific block can be distinguished as colder the hole. The joints have been appearing as colder.

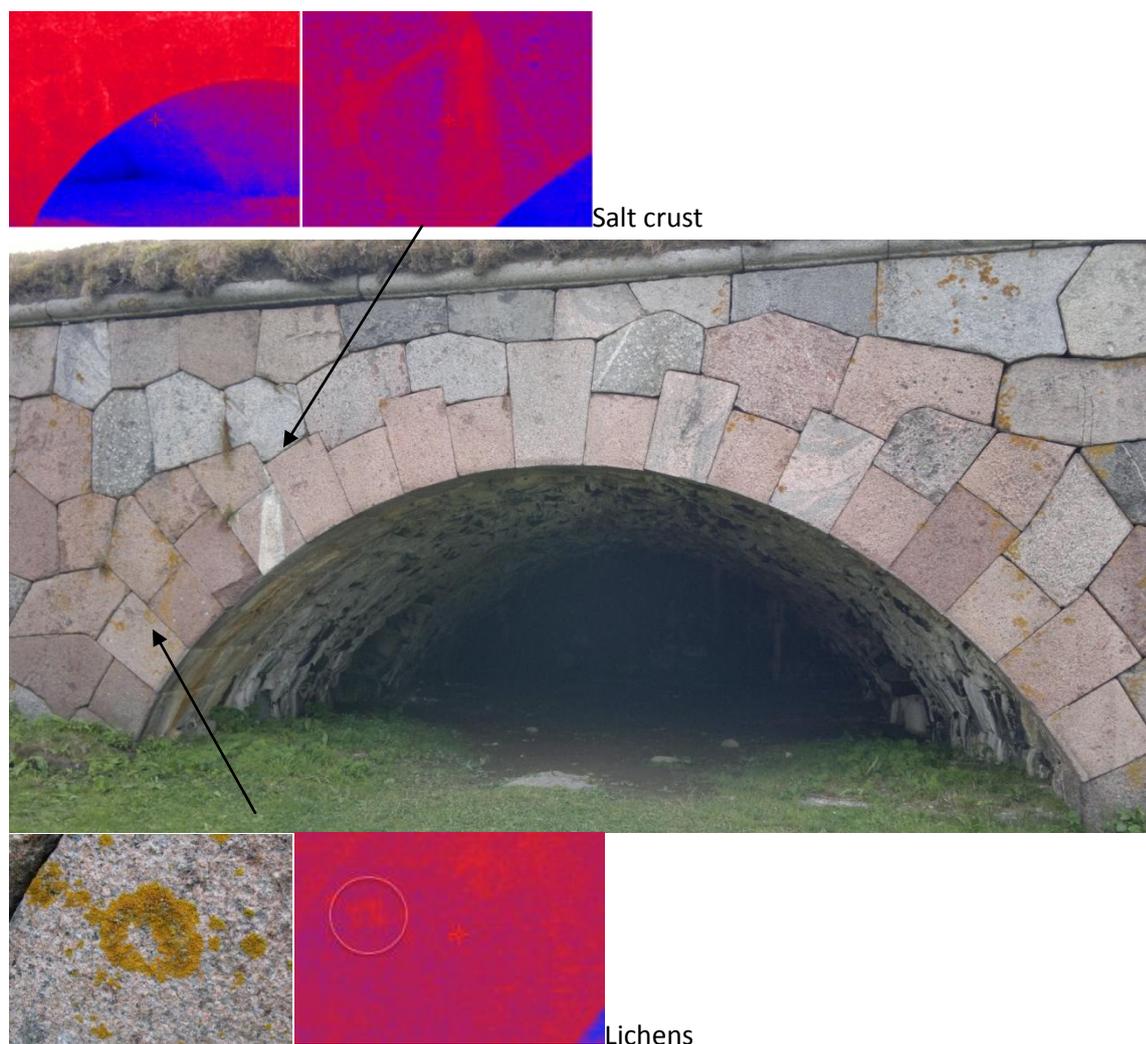
The images collected from the arc of the tenaille, taken in the morning and in the shadow, show that the inside of the arc is colder as visible from Figure 94, joints between rocks looks a bit colder and looking at a detail of a block can be seen the likens looks warmer. The deposition of salt over a block is also appearing as warmer, probably because of its different thermal conductivity.

Figure 94 Thermal camera images and their correspondent position on the arc (Photo: A.Shkurin, H.Sutinen, N.Luodes)

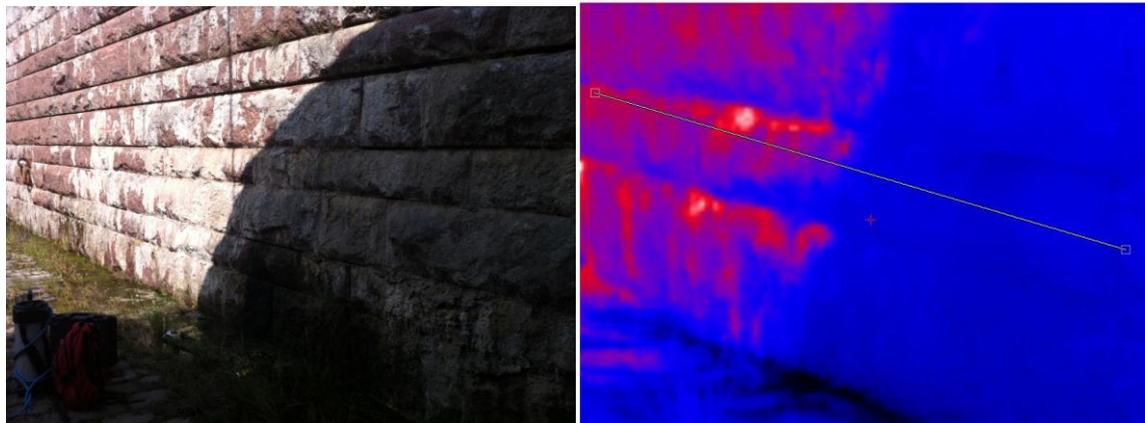
Thermal conductivity of the blocks can be noticed in the blocks that are partially exposed to shadow and partially exposed to direct sun as visible in figure 95 the temperature different of the blocks in this case been from 16 °C to 28 °C.

Figure 95 Lower part of the dry dock, photo and thermal image (A.Shkurin)

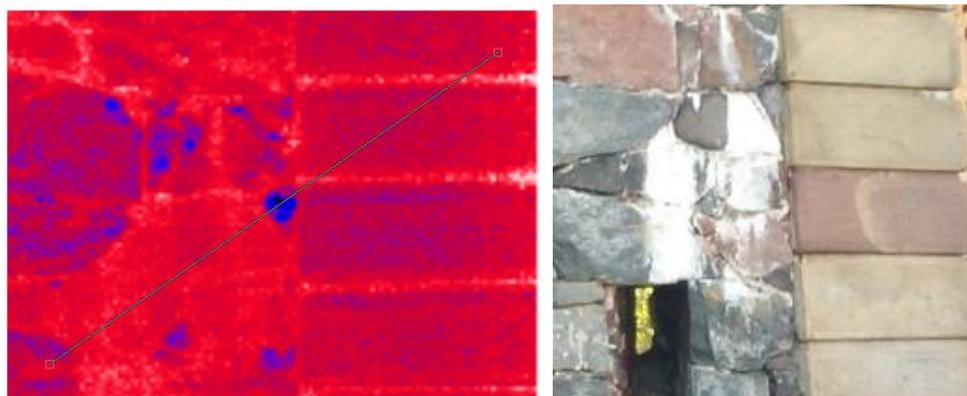
Measurements on the upper part of the dry dock have been performed in the afternoon. On that wall a spot presented a much lower temperature compared to the whole wall (12 °C against 17°C of average of the surface) as shown in Figure 96

Figure 96 Particular of the wall near the portal of the upper buildings of the dry dock.(Photo: A.Shkurin)

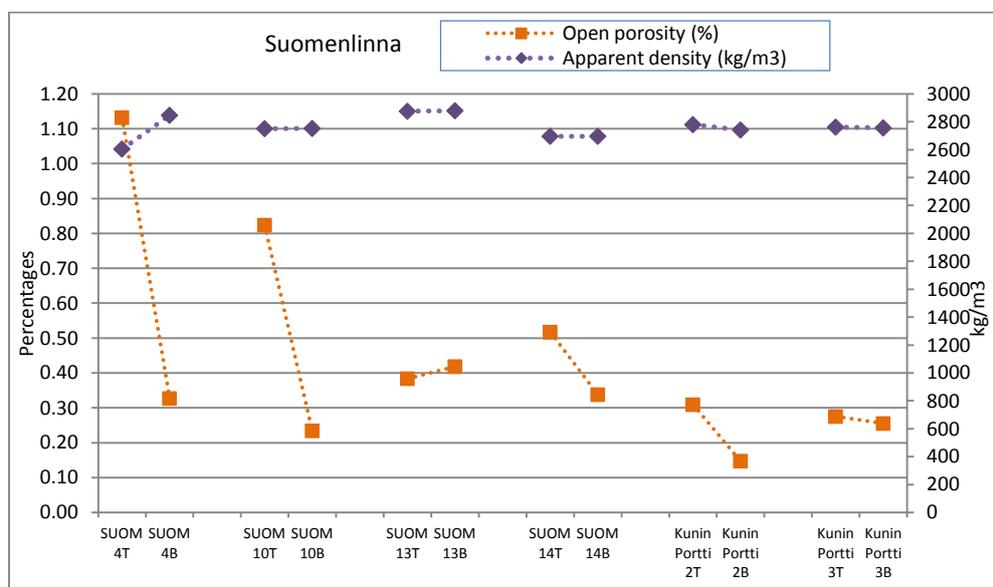
Figure 97. Graph of the values of densities and open porosities calculated for the specimens not tested otherwise. T= Top, B=Bottom

From the diagrams is visible that the bottom parts present generally lower open porosity compared to the surface ones, especially in specimens that present salt or limestone crusts that alter completely the performance of the stone surface. All the specimens have been presenting different kind of weathering effects and they all have shown a change in the porosity, while densities have been quite constant except for the dry dock material Suomenlinna 4.

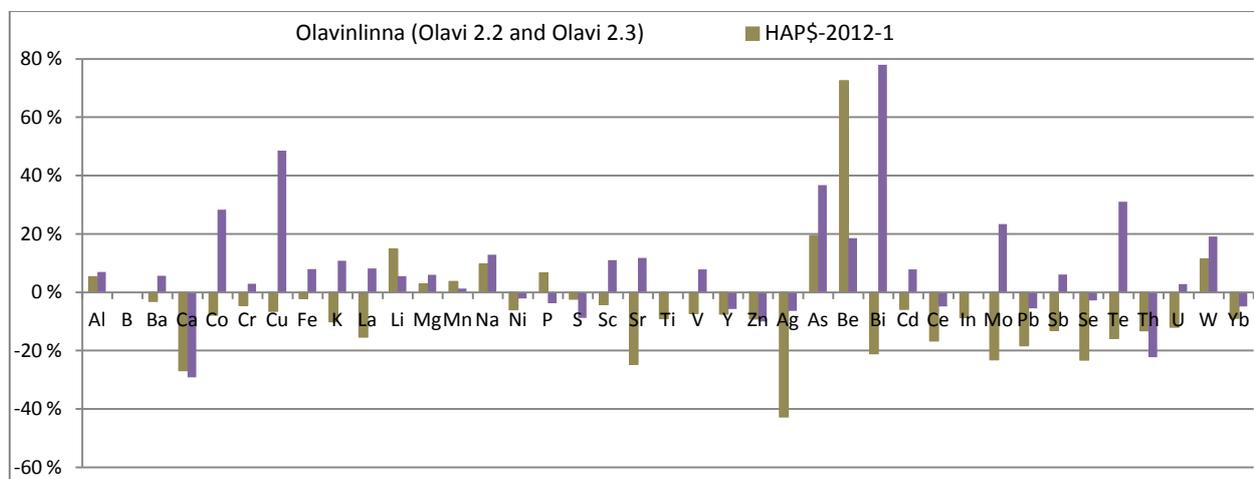
Figure 8 Depletion of elements from the blocks of the Kello Torri, belonging to the oldest part of the castle

There is a similar behaviour in some elements from the oldest part of the castle, as for example the increase of A and W on the surface, opposite in behaviour to the material sampled from the more recent Russian bastion. Lead had been depleted in all the samples. In Figure 11 are shown the percentages of the oxides that show high content of iron and aluminium oxides besides the silicates

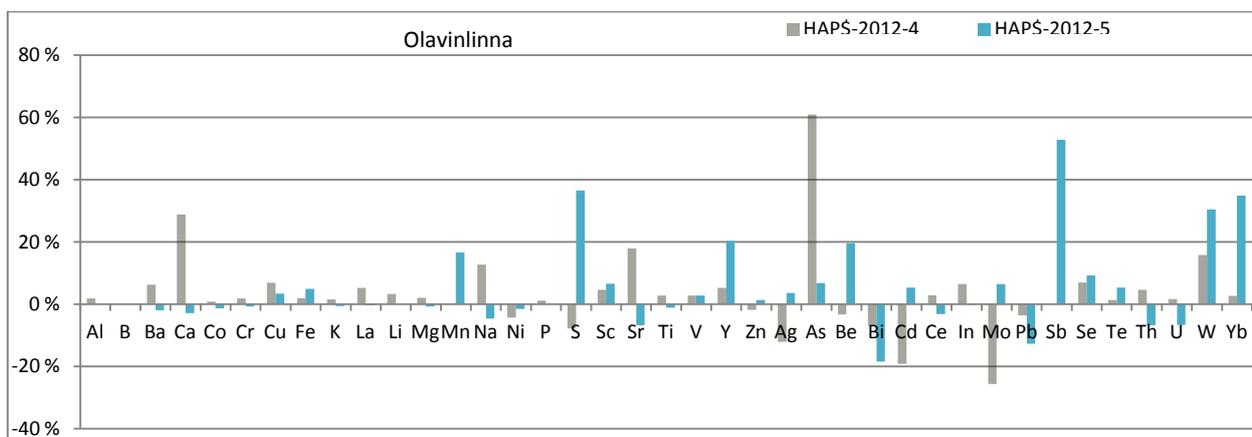
Figure 9 Depletion of elements from the blocks in the internal yard, belonging to the oldest part of the castle

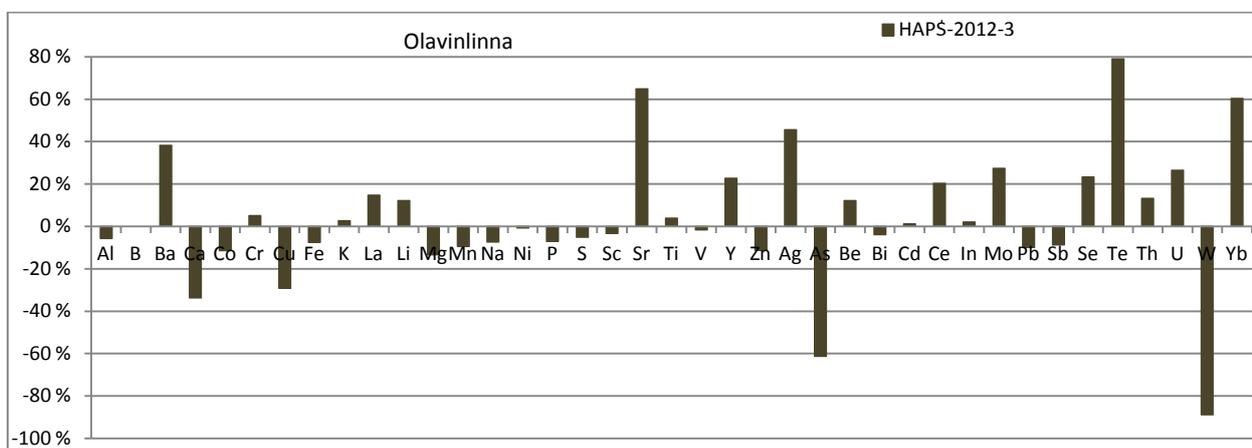
Figure 10 depletion of the elements from the blocks from the bastions built in the more recent Russian time.

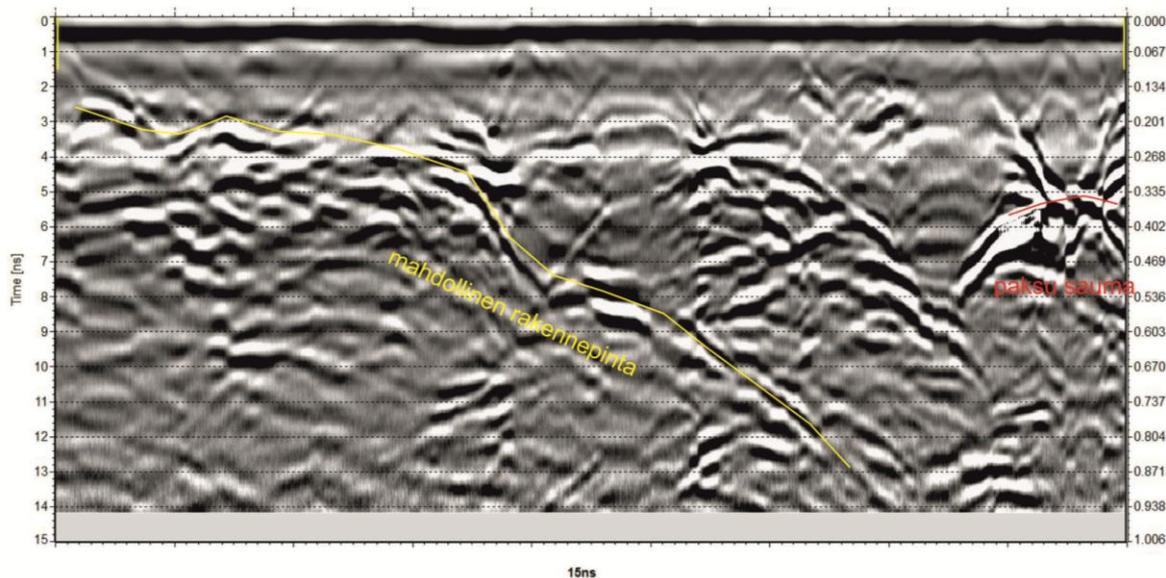
Figure15 Radargram of Line F1 done with the antenna of 1,5GHz

The measurements with the 1,6 GHz antenna had shown two anomalies that are highlight in the radagram of figure 15

The measurements with 1,5GHz show the first row of blocks quite clearly, reaching 20cm depth and with joints between the blocks. The inner structure of the wall is then affected by the several reflections and refractions on the surfaces, it would anyway be possible to tell that inner wall has some smaller blocks and less regular structure compared to the visible one. There is a clear continuous line that could represent an internal wall surface and anyway represents presence of a discontinuity in the wall. Other two strong reflections could be given by internal joints or by the fact that there are fractures around the blocks. The 900 MHz antenna show a bit the same trend, as visible in Figure 16, but in this case is also visible a line between 0.4 and 0.5 m and another one at 1.34-1.47 m, that would probably show the surface of the internal wall of the tower

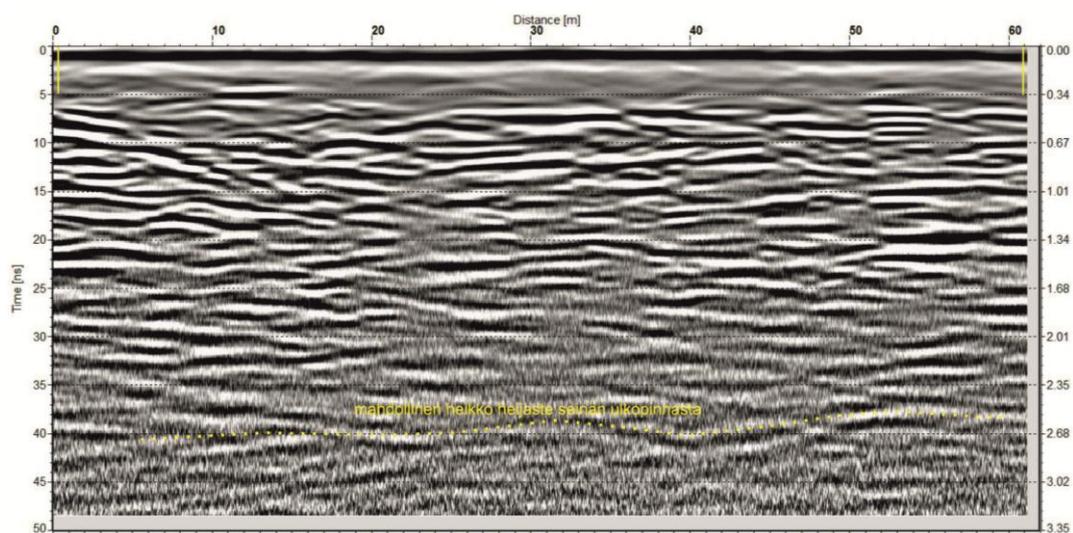
Figure18 Radargram of measuring line F9 over the inner yard wall

Between 2,35 m and 2.68 m is visible a continuous line that could represent the surface of the external wall. The radargram show that the wall is full and blocks are placed regularly visible from the linear and rather parallel reflection lines running along the measuring line. There are some higher reflections given by the change of surfaces and probably the inner wall has smaller material size compared to the surfaces.

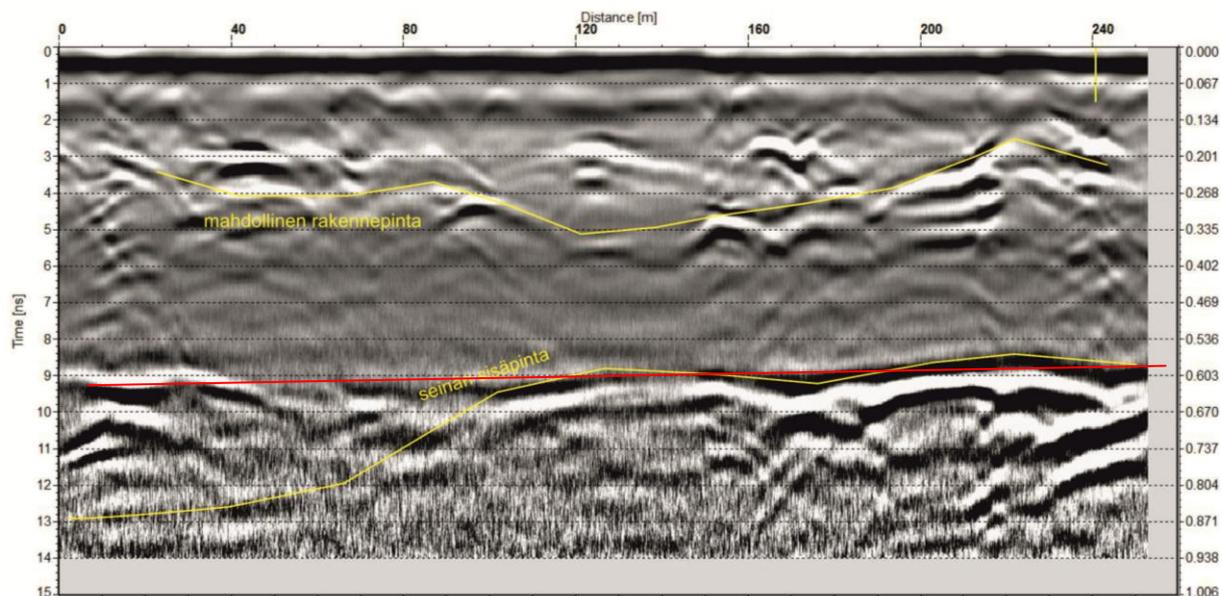
Figure 20. Radargram of the wall over the terrace. (10ns)

In the radargram of Figure 20 are visible the internal wall structure, with some reflections between blocks that would show presence of air possibly by thicker mortar or slightly open joints between the blocks (yellow line named mahdollinen rakennepinta). The second line shows the internal wall surface (seinän sisäpinta). This, also signed in red, is the internal part of the wall, done with very homogeneous material thick approximately 30 cm. Considering the regularity of the surface (visible in Figure 21) they are possibly bricks.

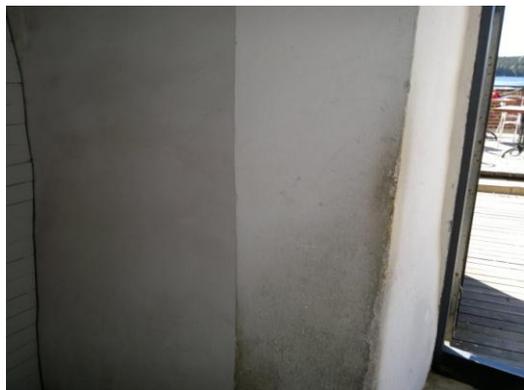
Figure 21. The internal wall where the Line F10 had been collected. The first 60cm of measurements are done over a wall thick 90 cm, while after that the wall is about 55cm.

The radargram show also a strong reflection in correspondence of the thickening of the wall, probably the corner is formed by two separate walls presenting a joint between them.

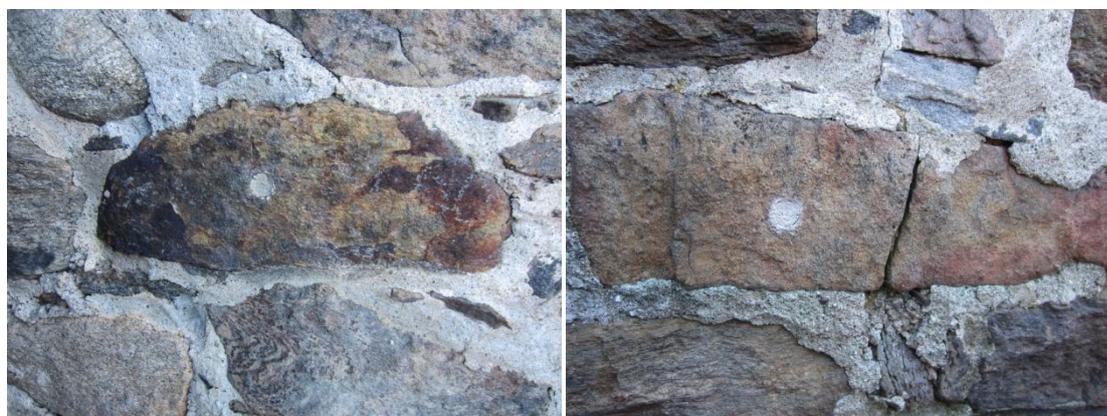
Measurements had been performed over the Kello Tornii and the blocks tested are shown in figure 23. It is visible for both of them the sealing of the drill hole after sampling.

Figure 23. Detail of the first blocks tested on the Kello Tornii (left: savonlinna 1, right: savonlinna 2)

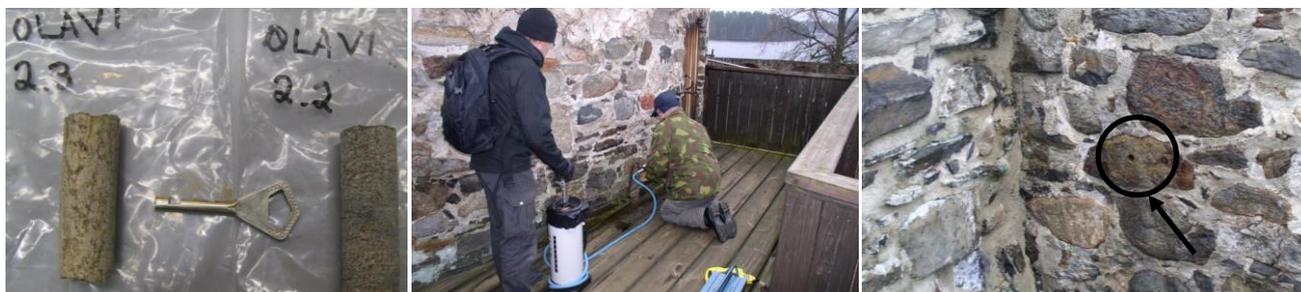
Sample 2.1 does not exist since the sampling numbering started from 2.2. Samples 2.2 ja 2.3 are 20mm diameter drill cores from the oldest part of the castle, Kello Torni. Their sampling position is shown in detail in Figure 4 and their image and sampling place in Figure 5. Sample 2.2 is 30cm high from the walking balcony, while sample 2.3 is 90 cm high from the level of the balcony. Samples 2.4 and 2.5, visible from figure 6 and 7, are parts detached from the wall facing the lower terrace. Sample 2.6, figure 8, is a small piece fallen down from the Kello Torni (Bell Tower), that has been covered by copper alteration products brought by the drainage water, probably malachite.

Figure 5. Samples 2.3 and 2.2 (Olavi 2.3 and Olavi 2.2) on the left, in the center sampling of sample Olavi 2.2 and on the right the place where sample Olavi 2.3 had been collected.

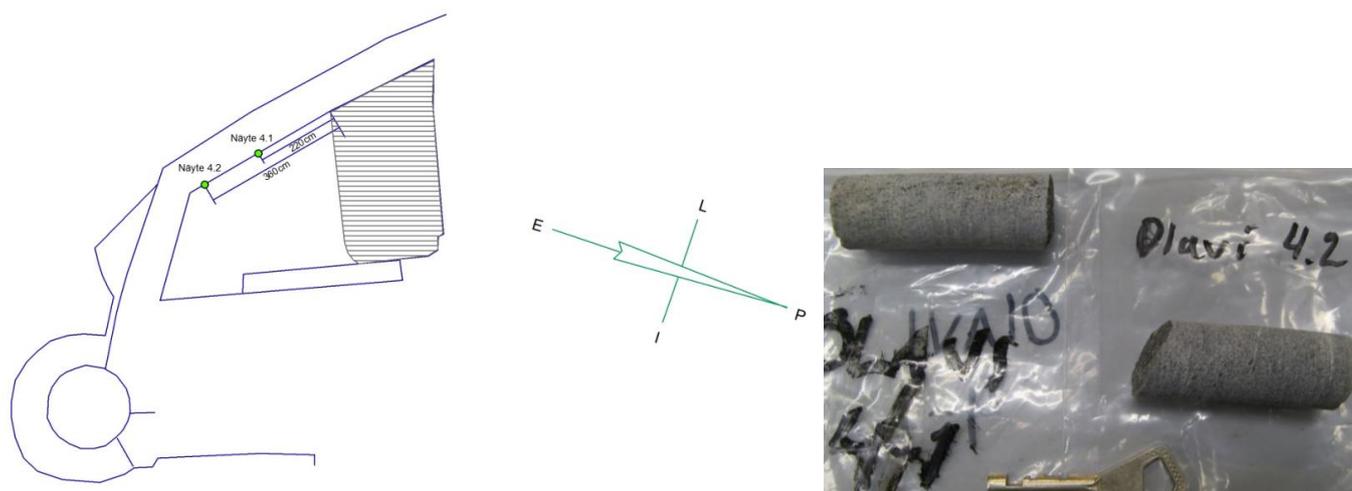
Samples 4.1 and 4.2 (Figure 12) are 20mm diameter drill cores collected from the oldest part of the building in an internal yard. The sampling points are shown in detail on the map in Figure 12 and in the photos in figure 13. The samples had been collected from 20cm above the ground in a place affected by humidity where visible vegetative growth had been noticed.

Figure 12. Map of the sampling points of samples Olavi 4.1 and 4.2 on the left, samples are shown on the right: Olavi 4.1 (left one), Olavi 4.2 (right one)

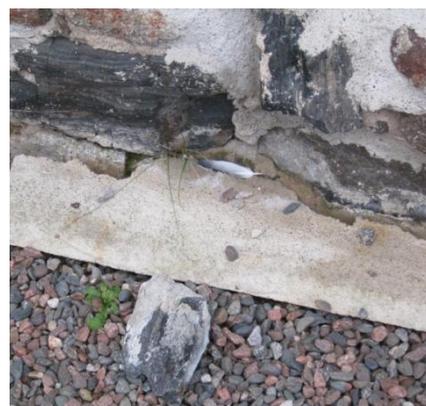
Results showed that granite has been a durable material. The material that probably had shown the lowest performance values had been the boulder blocks used in the basements and in the castles. The weathering could had been occurring much before the put in use of the boulder, during the ice ages. In these the impacts of detached fragments caused by rock structure is higher compared to other materials, also because of the small dimension of the blocks, but the walls that are thick and composed by blocks connected with mortar minimize the structural problem of the event.

Figure 1. Detachment of a piece from boulder block in Olavinlinna

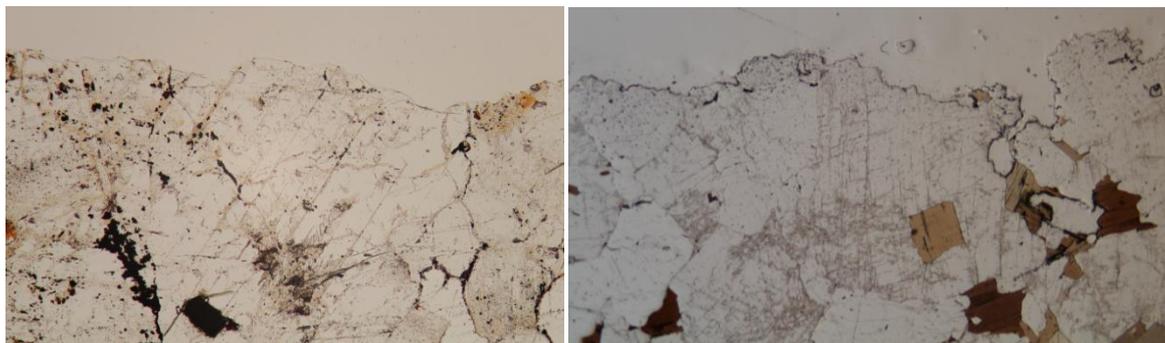
The results showed that the material had been affected by light surface weathering, visible from chemical and petrographic analysis and by visual inspection. From some places it had been possible to see through weathering indexes that there had been a surface weathering. The petrographical analysis had shown presence of mineral disintegration and surface cracking both in boulder blocks and in quarried blocks, as an example the images from Suomenlinna and the National Museum, Figure 2.

Figure 1. HAPŞ 2012-12 Disintegration and breaking of the minerals on the top surface of the sample, visible from the fracturing (on the left). HAPŞ-2013-36 (on the right) weathered stone surface characterized by intensive fracture formation in feldspar grains.

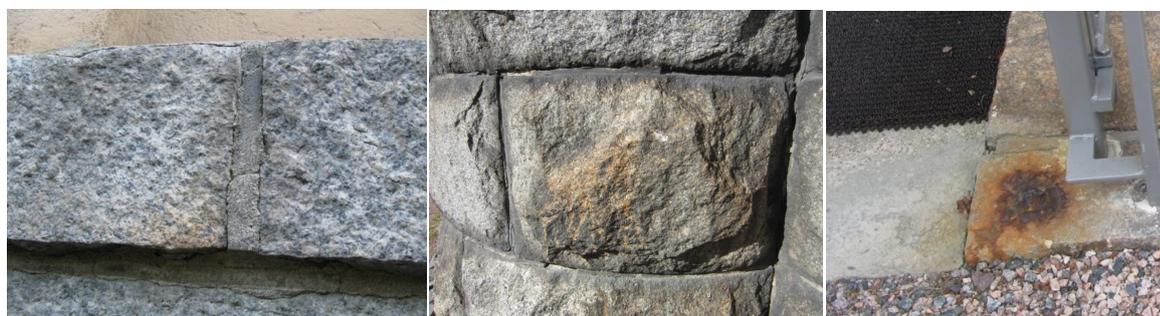
While from visual analysis the main problems had been oxidation of minerals that determined local or diffused change of colours and in more serious cases fracturing in correspondence of the part and vegetative growth on wet and shadowed areas. Atmospheric particle deposition and fixation had affected the building exposed to traffic areas, but not always had been visible since building had undergone maintenance in recent years. Construction solutions had affected the durability of the material on site, as salt migration from sealing mortar had penetrated and stained the rock, or deposition of copper and iron oxide had come from metal anchoring, roofing or pipes (Figure 2). Problems had also come from movement of the structure causing breaking in correspondence of the compressed block but fractures had also been caused by impacts.

Figure 2. Changes of colour determined by migration of the salts of the mortar (on the left), by leaching of elements (in the center) and by deposition of oxides (on the right)
