#### Two mine cases

- Kotalahti, a closed Cu,Ni-mine
  - Operating time 1957-1987
  - Kotalahti intrusion was about 1,3 km long,
    200 meters wide and 1 km deep.
  - Mine area is about 100 ha.
  - Located in Eastern Finland, community of Leppävirta
  - After care has been done since the mine was closed
  - Total water volume of the mine (including shafts) is estimated about 3 million m<sup>3</sup>.
- Vammala's concentration plant

#### Vammala concentration plant and tailings area

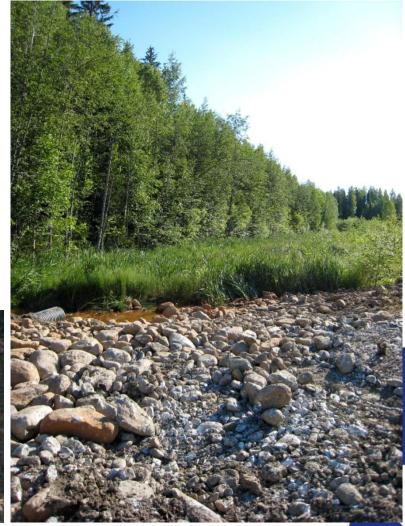
In 2010: a new direction of mine water and **construction of wetland**

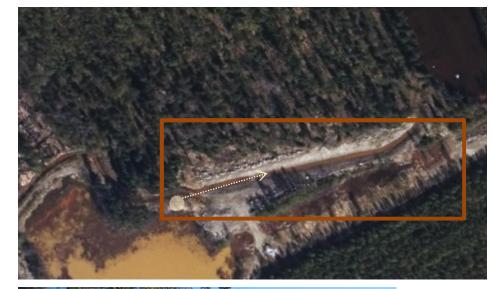
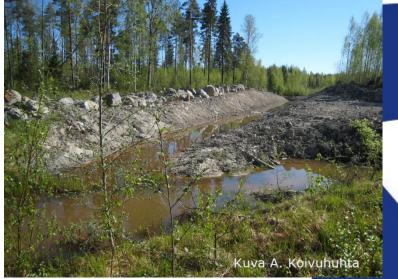
- In 2011 a new channel for cleaner water was constructed
  - To cleaner water
  - Iron oxidation and precipitation to the bottom of the previous channel → Fe-load will diminished to the nearest water system Oravijoki

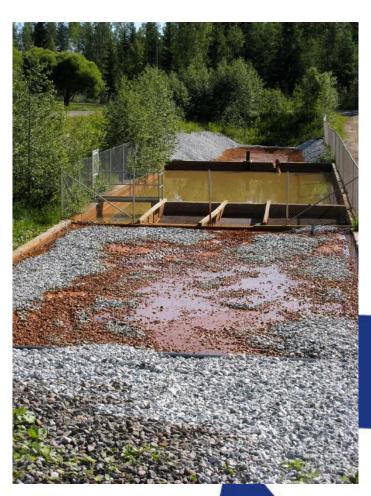
- Water treatment plant
  - ca. 100 meter long and 10 meter wide
  - three different funtional parts:
  - 1) dry filter (crushed calcite product), which increase the pH (Ni).
  - 2) Slowing filter-part middle of the treatment plant to settling down the suspended solids (in the spring time the flow can be too high)
  - 3) Chrushed stone above and peat-layer under to precipitate iron.
- All these actions helped the treatment plant to work properly
  - Iron precipitation get better
  - Water quality has reached the environmental limiting values
    - Fe ≤ 2,0 mg/l
    - Ni ≤1,0 mg/l (almost)
    - pH 6 -9

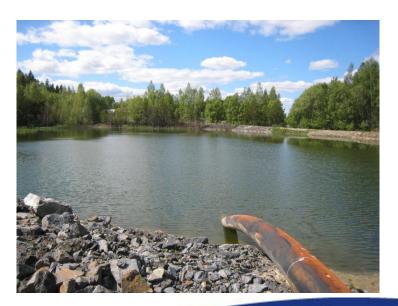
#### Vammala process plant – water circulation

- Process water from the plant
  - There is four different pump stations
    - Two in plant area
    - One in river Ekojoki
    - One in an old, underground mine
  - Water (to the process) is taken from the underground mine
  - From the process, water is pumped to the tailing area → clarification pond → clarified water goes back to the process via pumpstation in Ekojoki
- Drainage water from the plant area flows to the nearest ditch → pump station → tailings area
- Seepage water of tailings area, partly collect via pump station (when water level is high enough) → back to the tailings area. Meanwhile water flows to the Kovero-oja

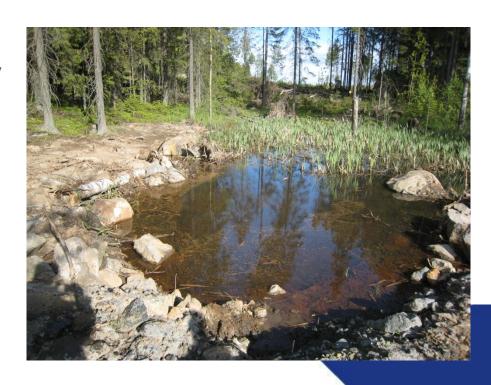
## Some results of the seepage water study

- Wetland areas surrounded the tailings area and iron was mostly precipitated in wetlands sediments.
- Sediments elemental concentration were higher close to the tailings area than the natural surrounding area

Fe: 2- to 7-fold higher

Ni: 3- to 21-fold higher

S: 5- to11-fold higher

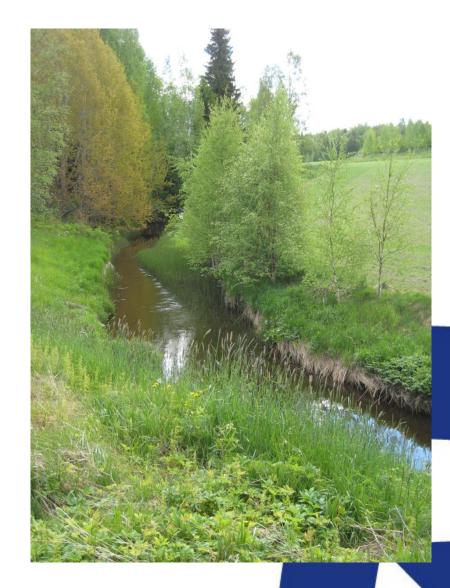
## Some results of the seepage water study

- Seepage water flows two directions
- Elevated sulfate and nickel concentrations were seen in the nearest ditch Kovero-oja
  → and slighty elevated concentrations in Ekojoki
- Other elemental concentrations (Cu, Co, As) decrease or stayed at the natural level in downstream (Ekojoki)
