## Efficient use of natural stone in the Leningrad Region and South-East Finland

Southeast Finland and Leningrad region

Durability of stone on construction

South-East Finland - Russia ENPLCBC 2007

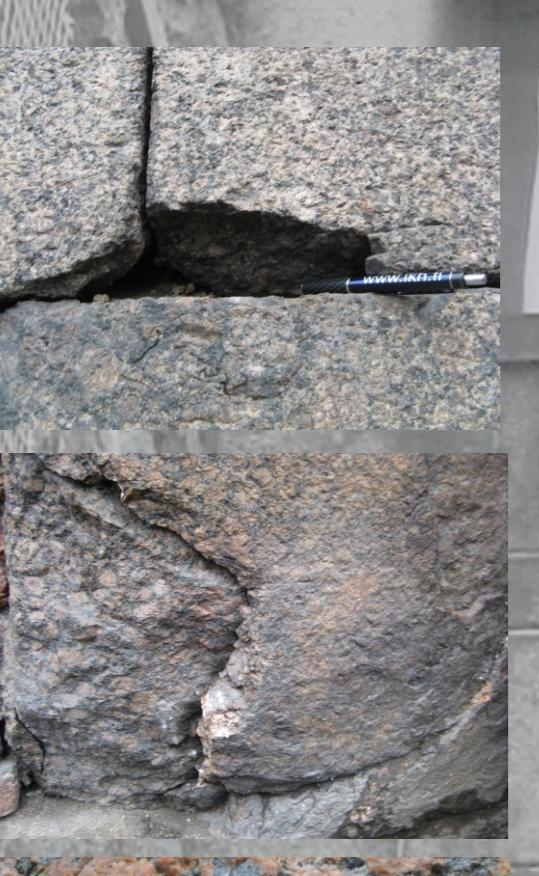
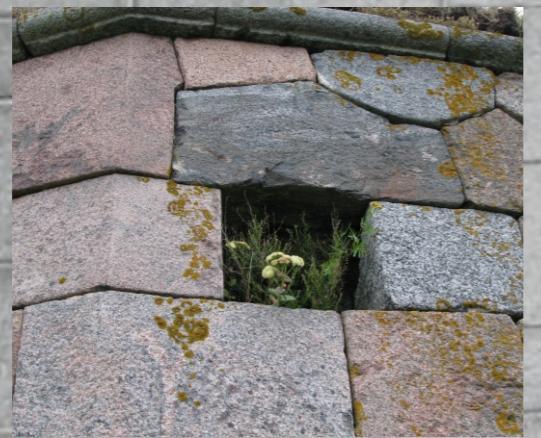
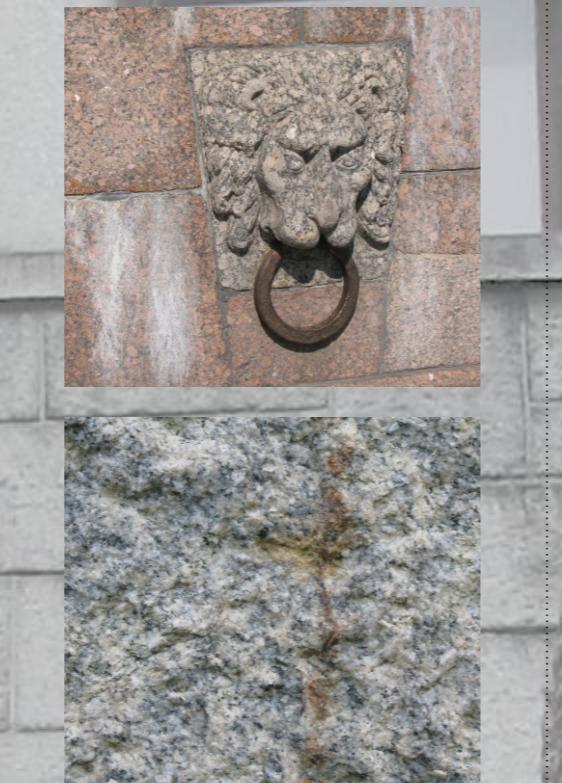
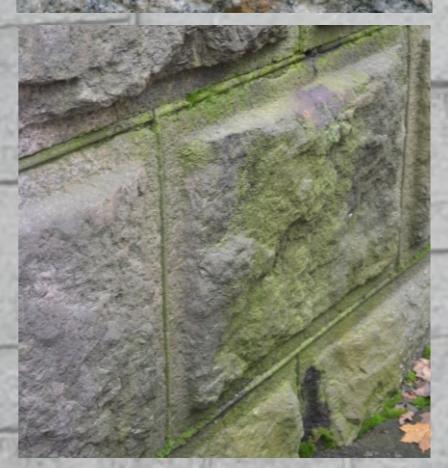
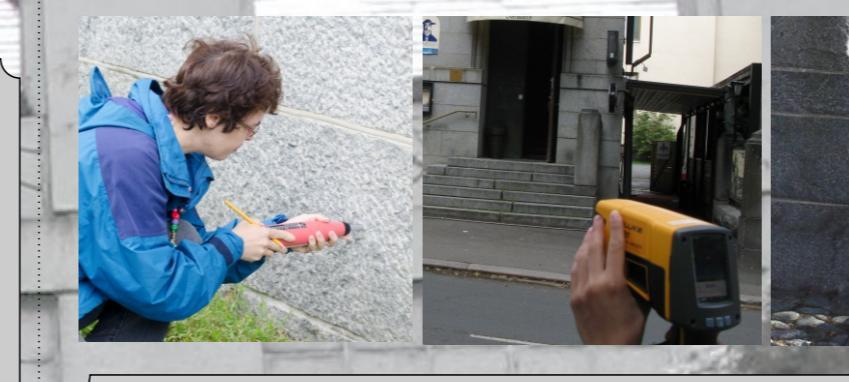
On site the following weathering effects had been analysed:

Peeling and exfoliation, Rudd surfaces, Deepenings and cavities, Hollows and chipping, Stone flaking-off, Fractures and fissuring, Deformations, Mushrooms, Seaweed, Lichens, Mosses, Dung of birds, Atmospheric mud depositions, Granular disintegration, Loss of colour, Crusts. Bio-films of different composition, Ovoid weathering, considering the climatic and microclimatic condition of the site.

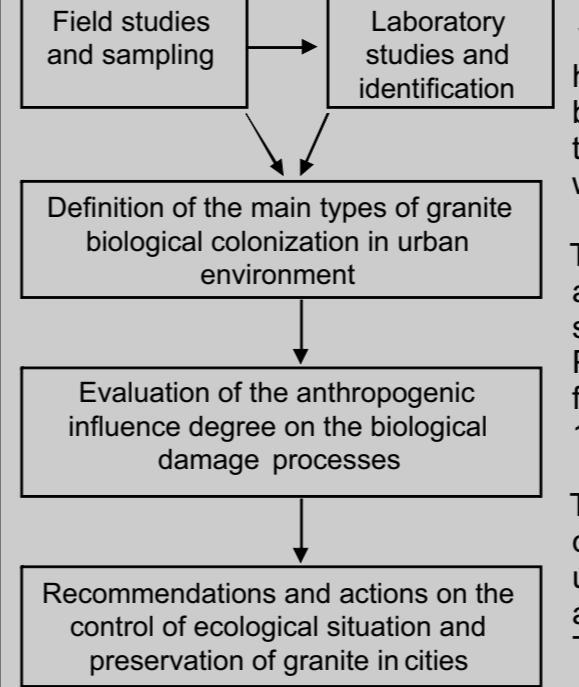
Schematic view of the research conducted:

Evaluation of stone deterioration has been conducted coupling field and laboratory analysis, using both destructive and non destructive tests to assess the properties of the structures and of the materials.

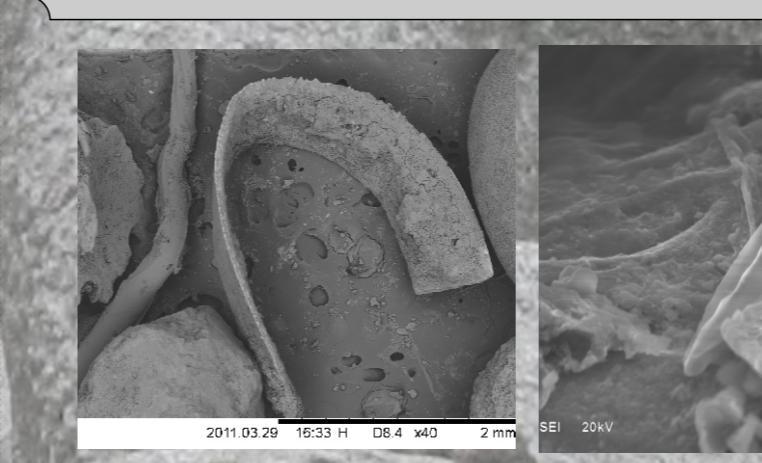
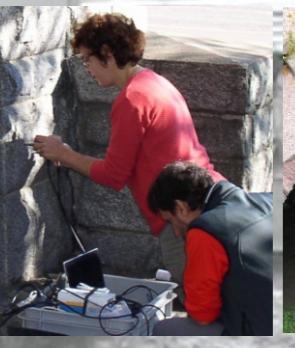
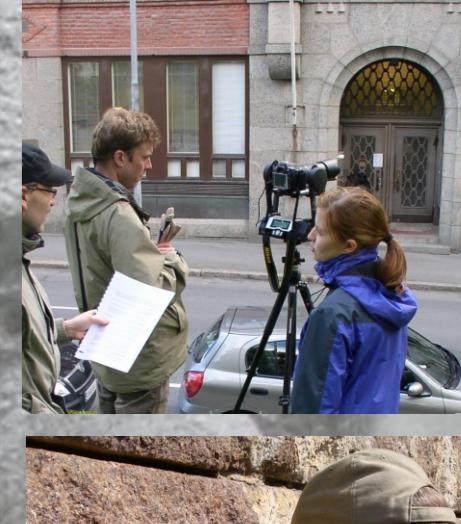
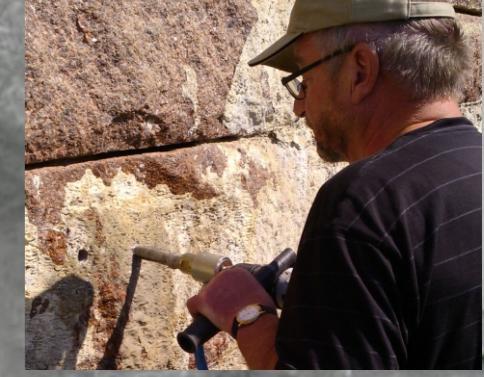
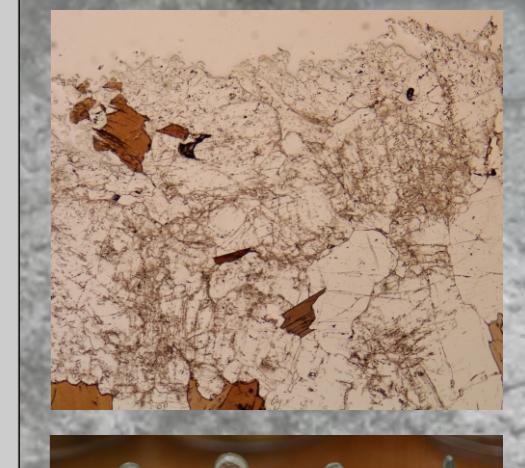
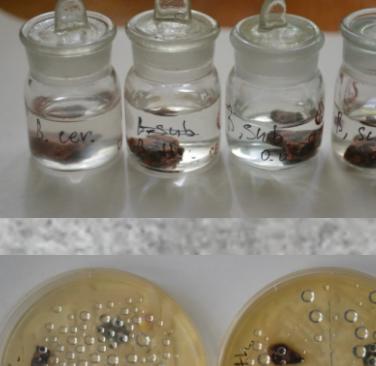
Visual inspection, supported by high definition images, has been essential for visualizing the macroscopic effects of the weathering.

The typology of construction and its characteristics were studied using Ground Penetrating Radar with two high frequency antennae (900 and 1600MHz).

The properties of the material on site had also been assessed using Ultrasonic Pulse Velocity and Schmidt Hammer Hardness Test.

Thermal camera image analysis has been performed to assist assessment of both interior and surface weathering to reveal differences in humidity and temperature.
